Cruise Report

**R/V ENDEAVOR Cruise 274
to Georges Bank**

29 September - 5 October 1995

GLOBEC R/V ENDEAVOR CRUISE EN-274

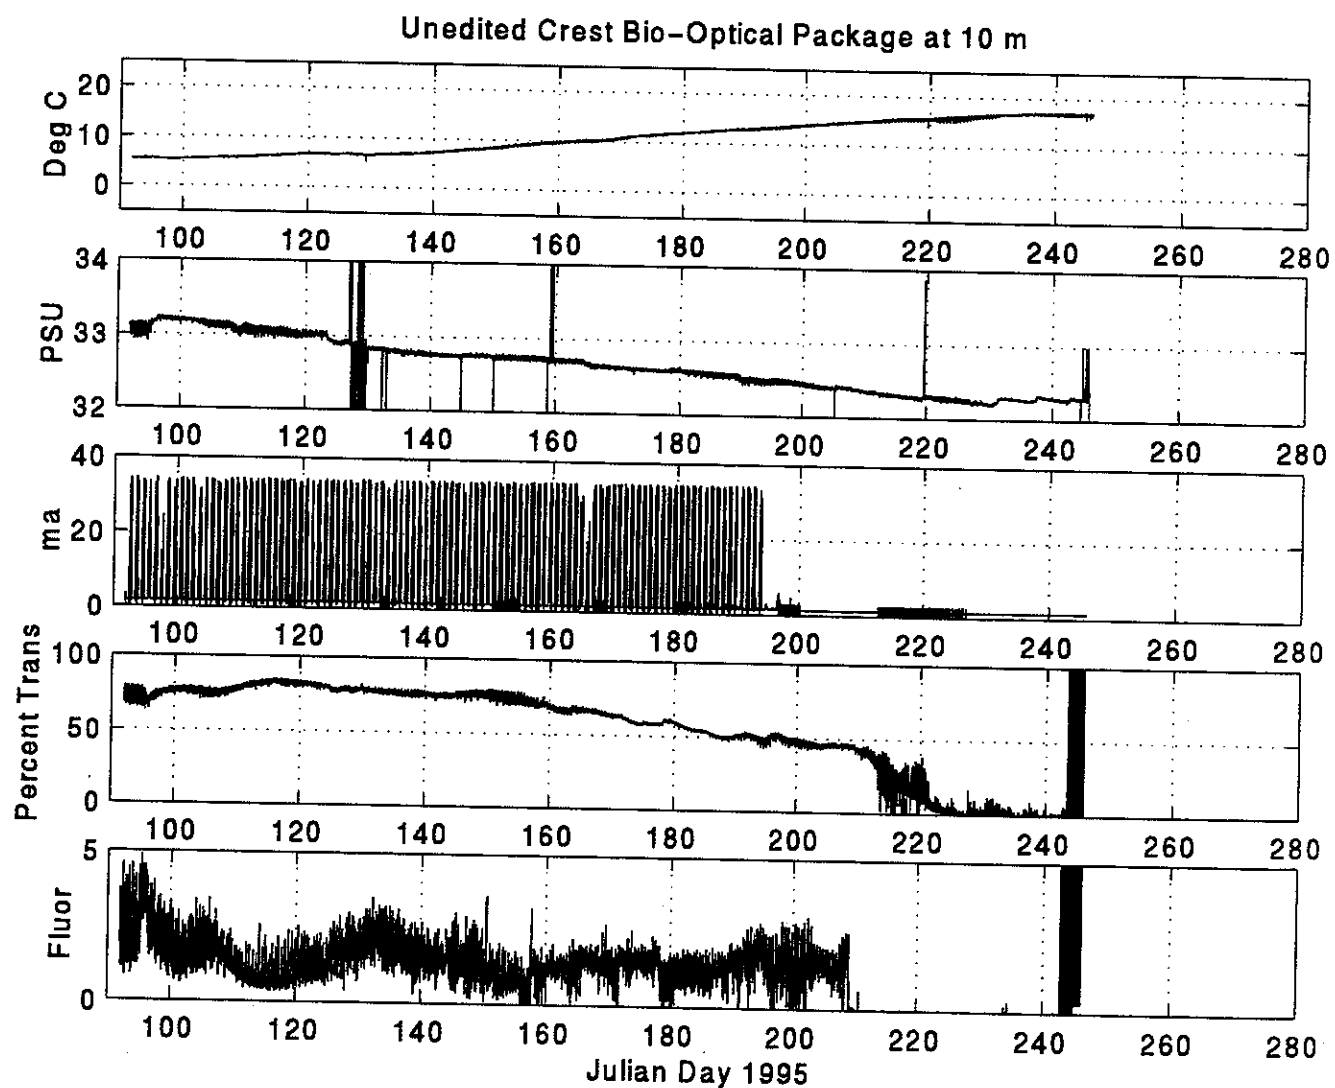
The PAR sensor on the surface buoy shows more variability, but the low radiation about JD165 is clearly seen in both PAR and solar panel/battery records. The fluorometer record abruptly stops around JD210 because of cabling problems. The transmissometer shows a steadily deteriorating record from about JD140 due to biofouling and is unusable after about JD210.

Figure 4. Crest mooring bio-optical package at 10 meters depth. The temperature overlays nicely with the SST record shown in Figure 2. The salinity is also very similar to the surface salinity with the exception to what may be sediment effects causing the “bumps” as seen around JD330. The PAR, transmissometer and fluorometer show effects of connector problems and biofouling.

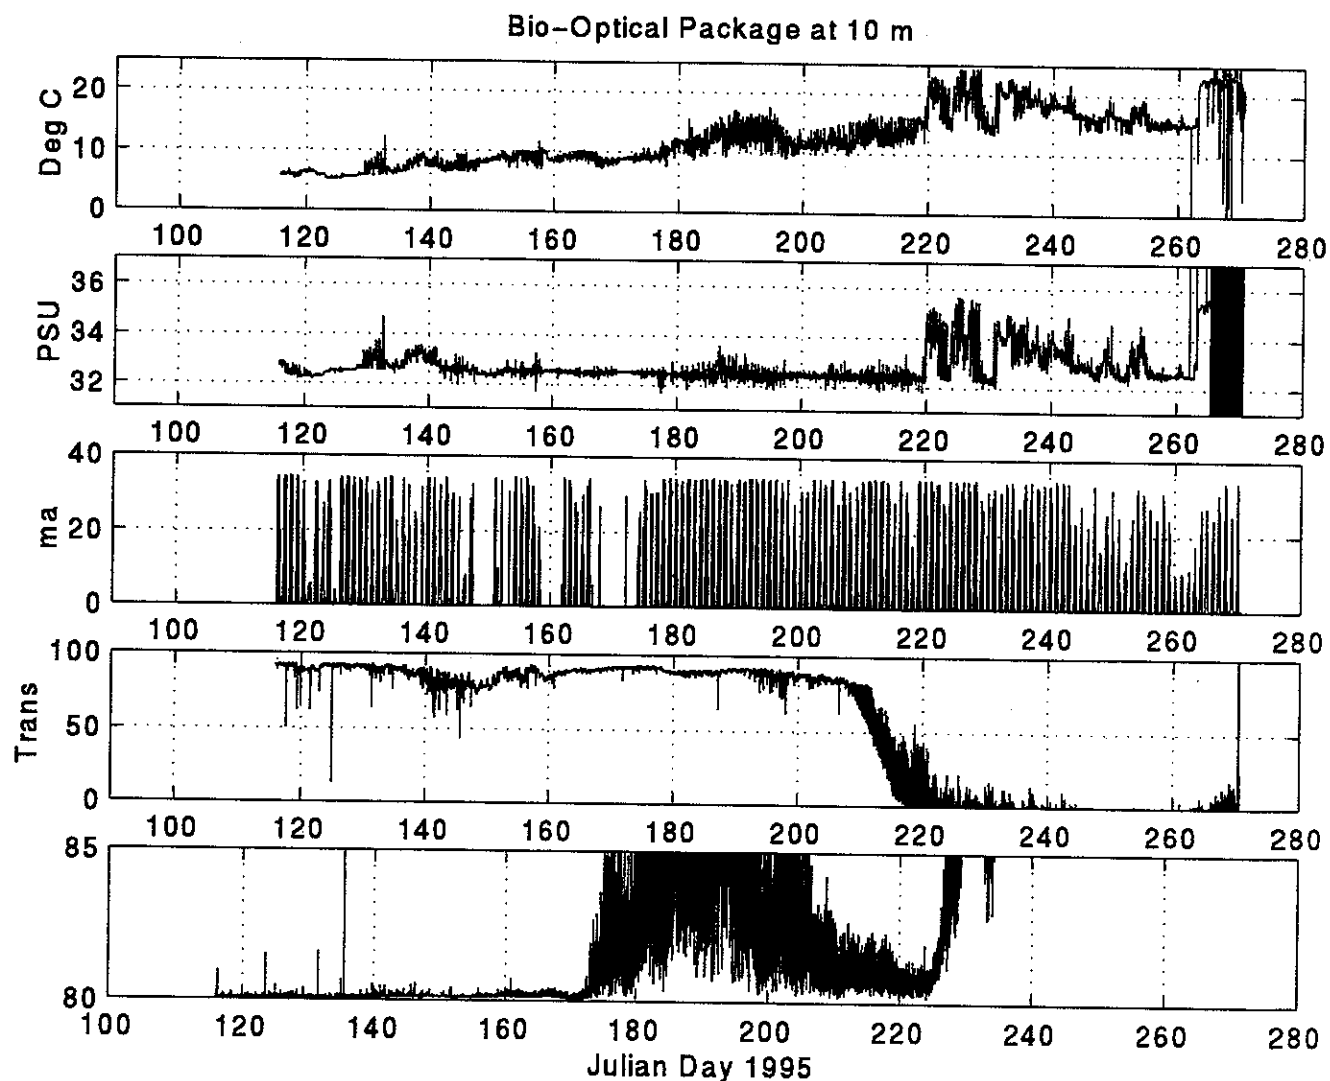
The Southern Flank bio-optical packages (Figures 8 and 9) also show the same results as the temperature and salinity shown in Figures 6 and 7. The PAR at 40 meters is an order of magnitude smaller as expected. Biofouling and connector problems shortened the useful records obtained. The loss of the external temperature record at 40 meters can be recovered by utilizing a slower thermistor in the recorder pressure case. It is obvious that the limiting factor in the optical records is biofouling, and that we will have to do better or service the moorings mid-summer.

Figure 8. Southern Flank mooring bio-optical package at 10 meters. The temperature and salinity records are shown in the top two panels, the PAR in the middle panel, and the transmissometer and fluorometer results in the bottom two panels. Biofouling limited the optical observations after about 100 days.

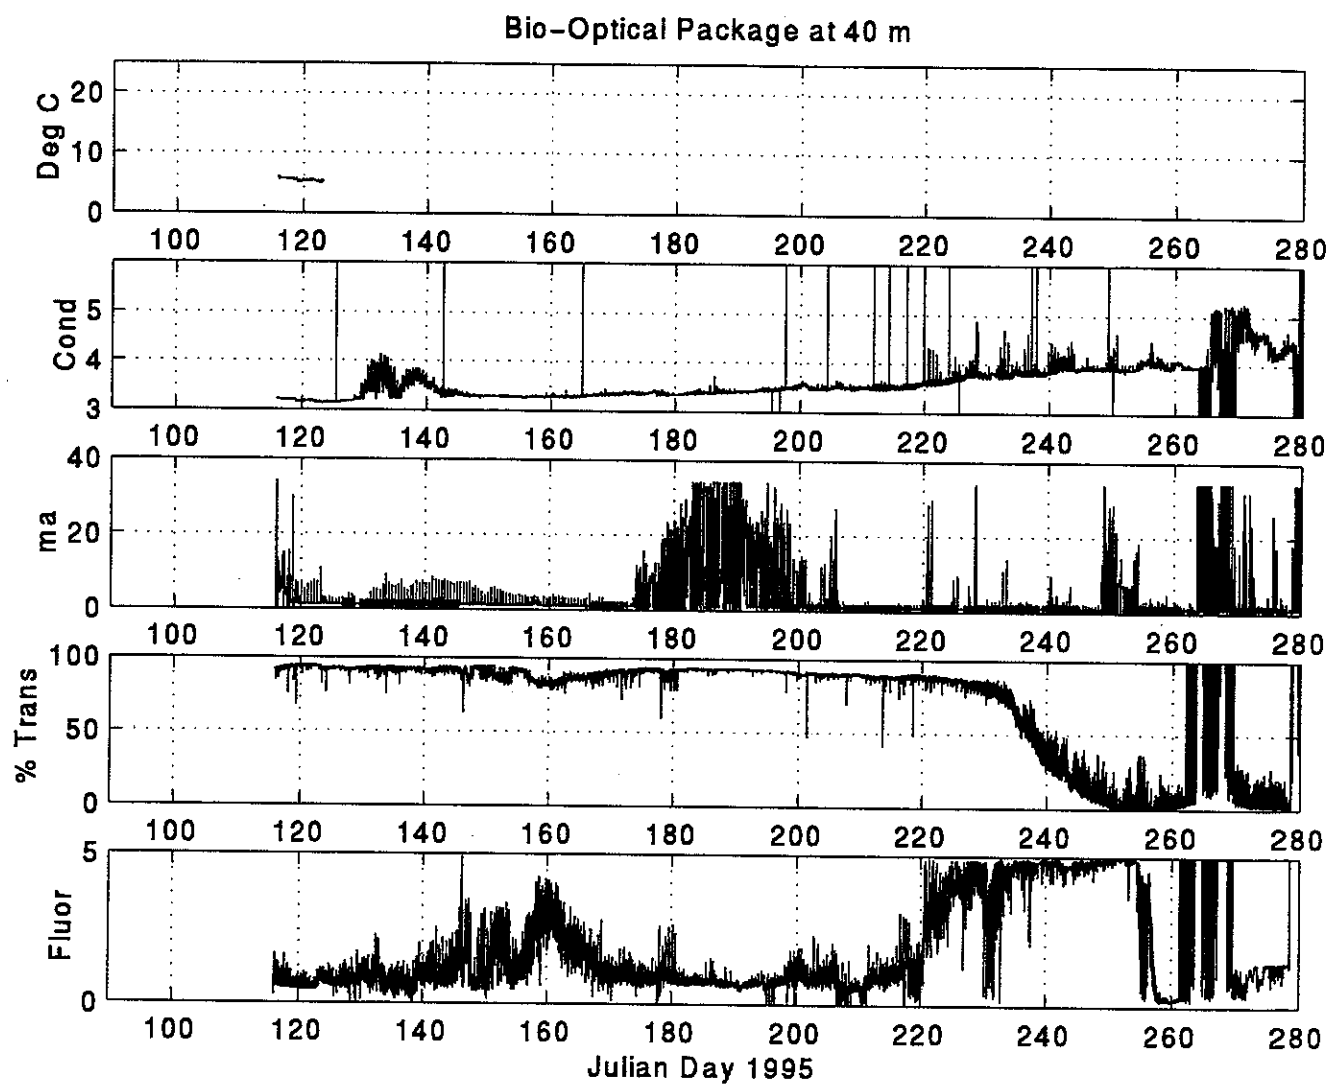
Figure 9. Southern Flank mooring bio-optical package at 40 meters. The temperature and salinity records are shown in the top two panels, the PAR in the middle panel, and the transmissometer and fluorometer results in the bottom two panels. Biofouling limited the optical observations after about 120 days.

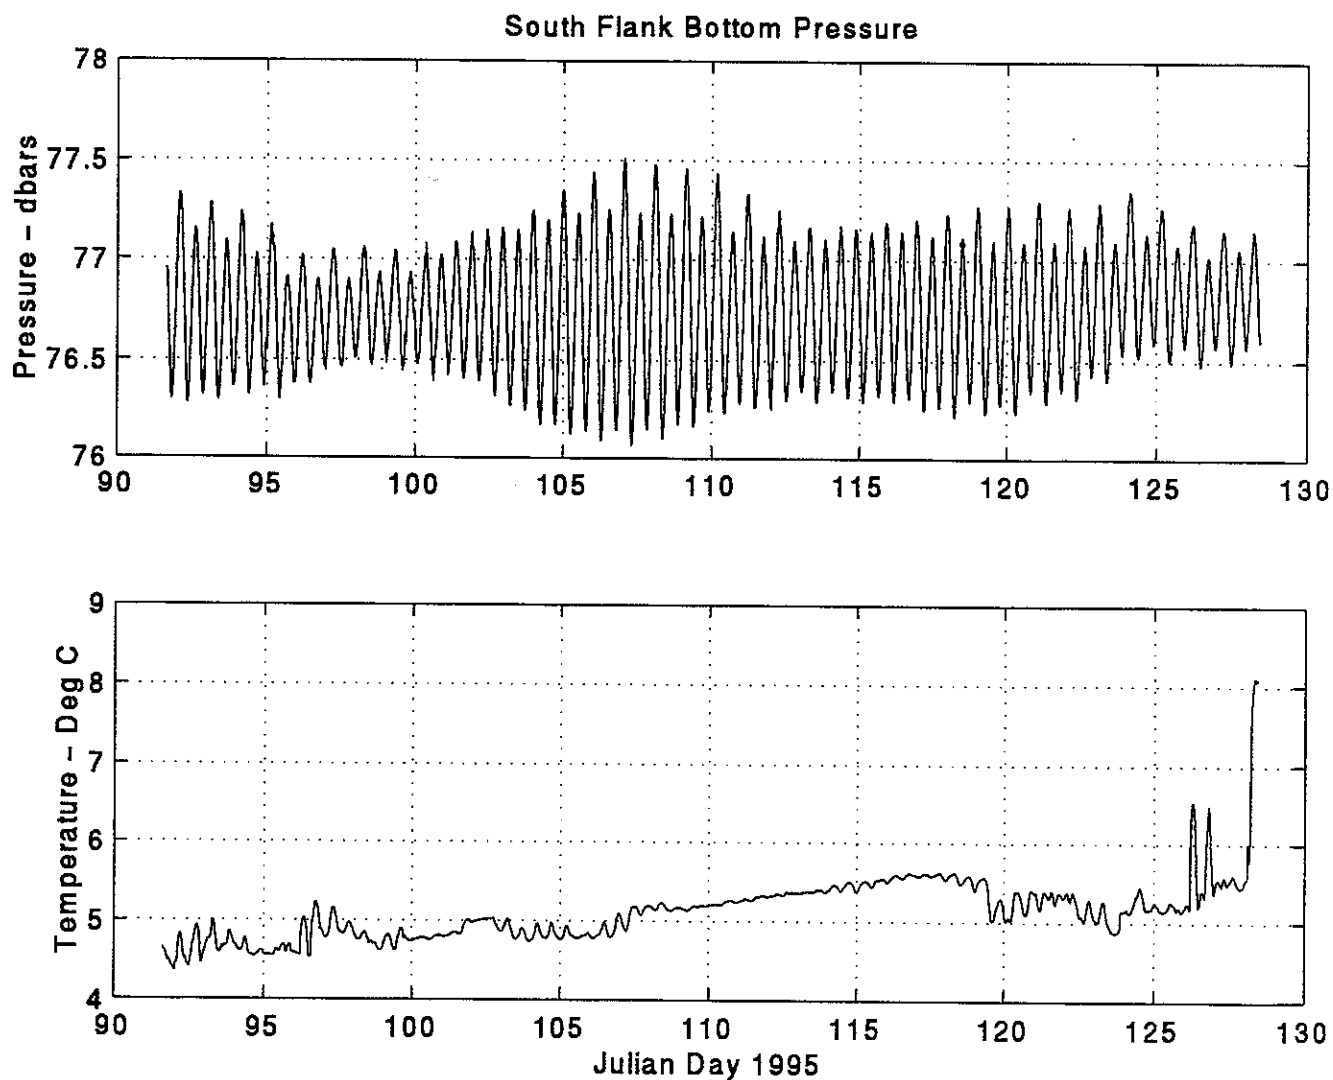
The bottom pressure instrument had an electronic failure in the recorder which terminated the record after 37 days, but good pressure and temperature records were returned before that. Figure 10 shows the records returned. The mean water depth of 76.76 meters agrees well with the 76.5 meters determined during the site survey and deployment cruises.

Figure 10. Southern Flank mooring bottom-mounted pressure/temperature instrument. The normalized pressure record is shown at the top and the temperature record from the end cap thermistor shown at the bottom. A pressure sensor internal temperature measurement is essentially the same as the thermistor record shown.

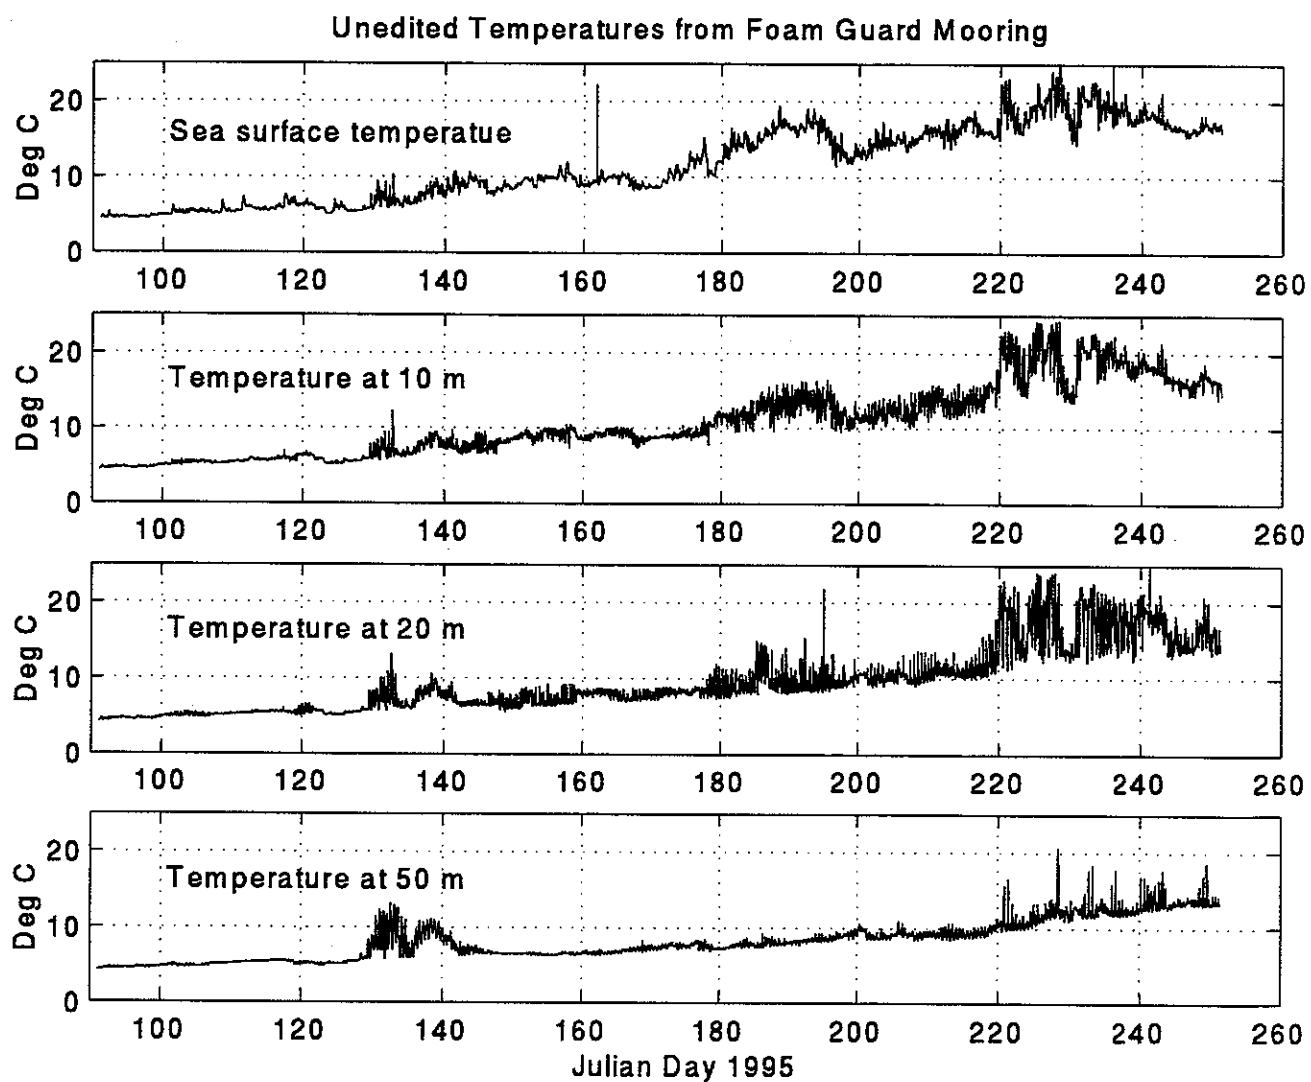
This buoy was missing when we arrived on station. It was assumed that it had broken loose, and was lost. However, when dragging for other instrumentation, this mooring was recovered. Sometime in the afternoon of 8 October 1995, the mooring sunk. This may have been due to a storm, but was most probably caused by a fishermen who dragged the buoy below the foam's crush depth, so that the buoy then lost buoyancy and fell to the bottom. It is not clear that this was not partially caused by the 500 pounds additional weight of the chain mooring over 3/8" jacketed wire rope. To prevent this in the future, the foam size will be increased to provide 3000 pounds of buoyancy to more than double the reserve buoyancy. This foam buoy weighs less than 1000 pounds, or about half that of the steel guard buoys.

The four temperature sensors worked well, and full data sets were recovered, which allowed us to determine when the mooring sank. Post cruise calibrations showed no significant change (with the exception that one sensor did not work during calibration), so the sensors were "adjusted" to read the same temperature at the start and end when they were together in a box in

the laboratory, and when they were all on the bottom in mid-October. The adjusted temperature record obtained (Figure 11) shows that there was little temperature variability until mid-May when the Southern Flank Scientific mooring was installed and working.

Figure 11. Temperature records from recorders on the guard mooring at the surface, 10, 20 and 50 meters depth.
