Cruise Report

**R/V SEWARD JOHNSON Cruise SJ95-04
to Georges Bank**

27 March - 4 April 1995

GLOBEC R/V SEWARD JOHNSON Cruise SJ95-04

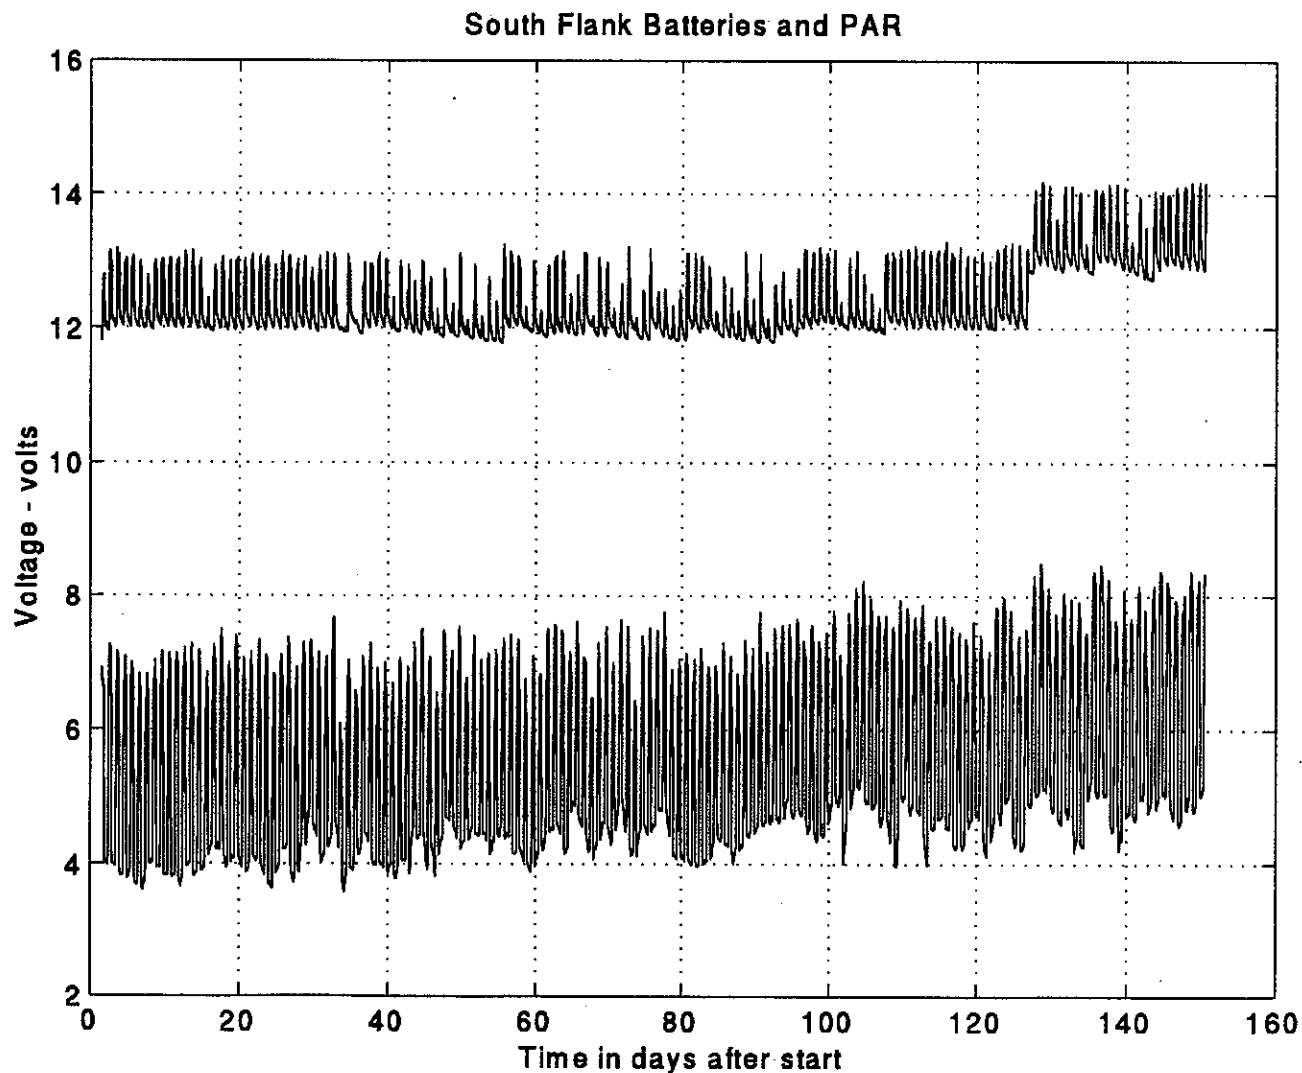
Figure 4. South Flank Moored PAR and Battery voltages. There are three batteries in the system whose voltage is plotted on top of each other at the top. The voltage is very uniform. The PAR sensor times 25 is plotted at the bottom. There is a correlation between the height off the battery charge cycles and the PAR sensor as one would expect.

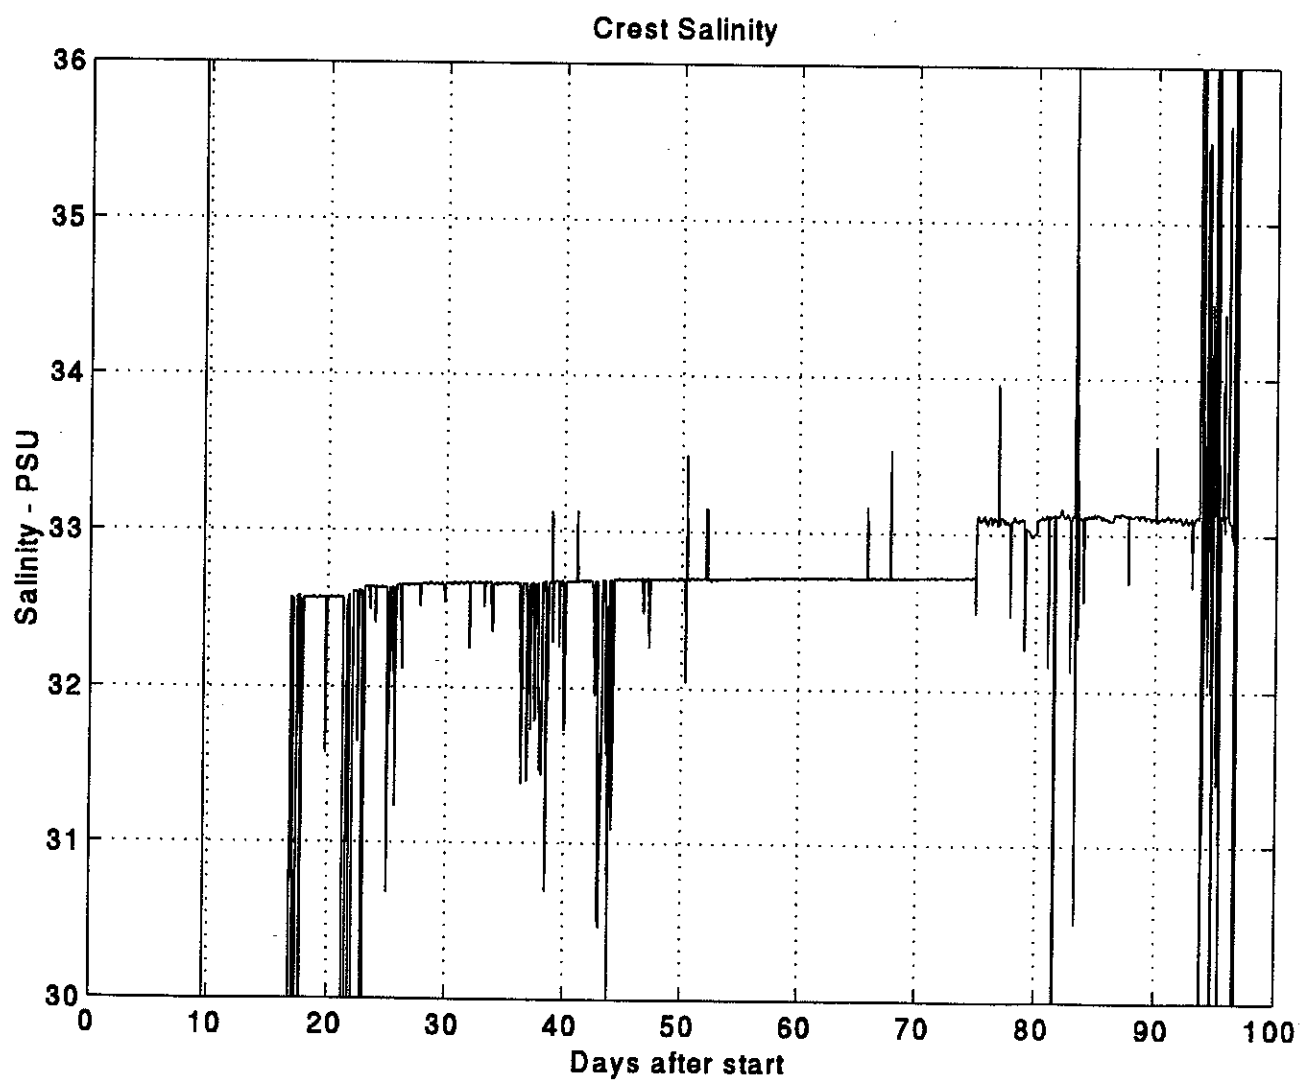
Figure 8. Crest Moored Salinity. The salinity record is contaminated at times by air bubbles which make the negative going spikes in the record. The offset at 75 days is due to a short in the load cell nearly.

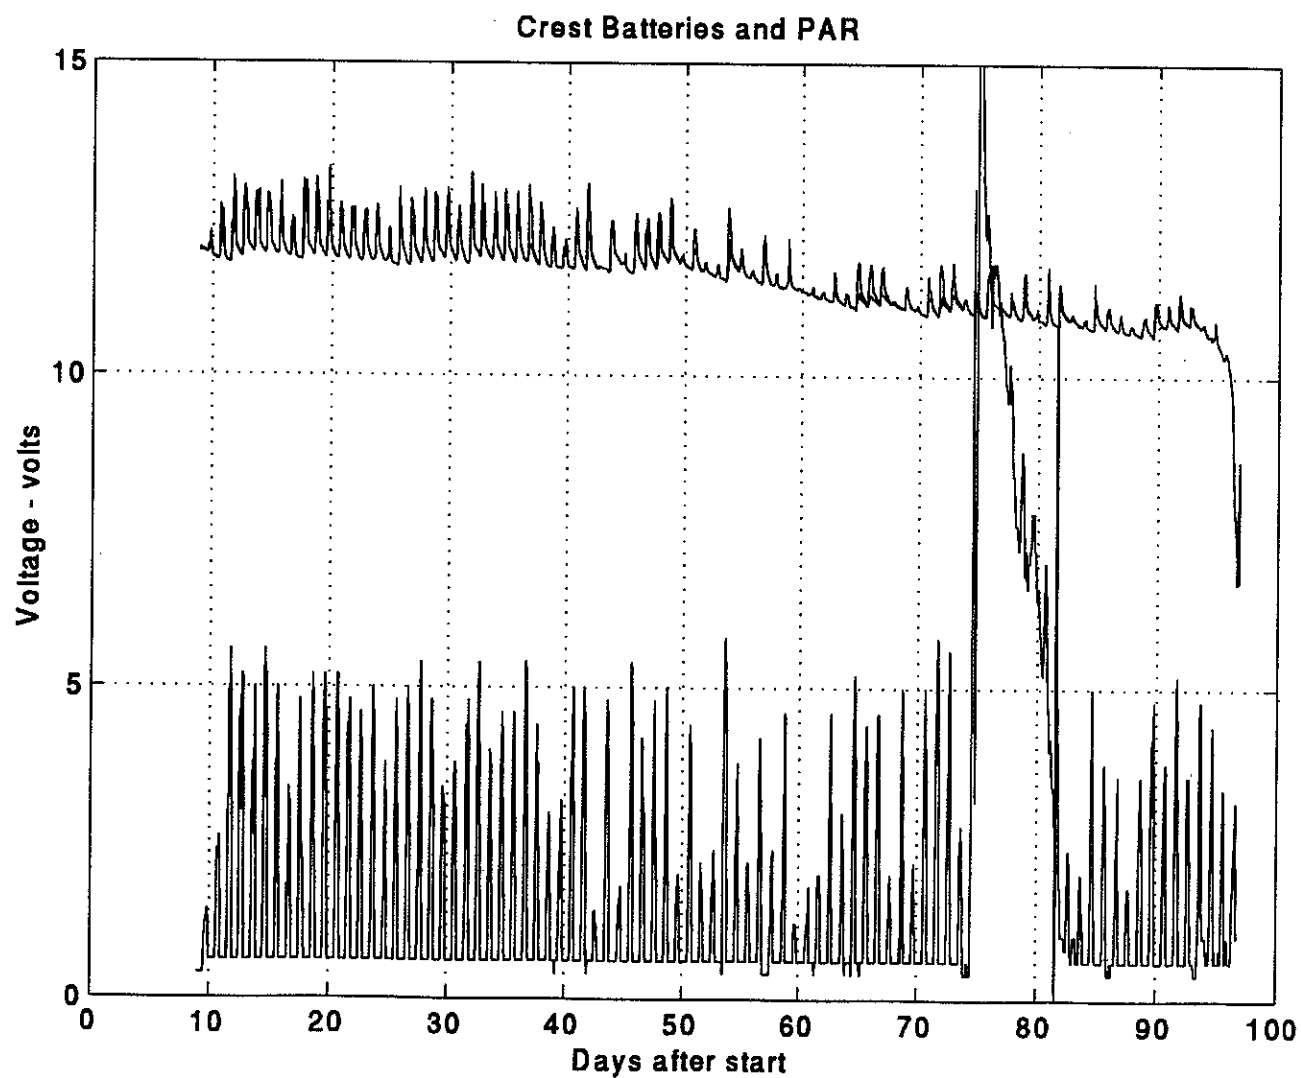
When the buoy was recovered, the batteries were indeed low (about 11.5 volts). The system responded when a computer was attached to the command port. When the system power drops below about 8 volts, the Synergetics data system begins to have problems and shuts down. This then reduces the current drain to about 25 ma, so the solar panels could begin to recharge the batteries. As an indication of the low voltage, the sampling program was lost from the controller's EPROM. (This also could indicate further damage to the system by lightening.) The GOES and ARGOS transmitter and Master Controller Module were replaced, and will be sent back to Synergetics for evaluation. In 6 buoy years experience with this data system, no major problems such as we experienced this were with the telemetry were encountered. Why they should fail on this deployment is yet a mystery. In addition to the transmitter, the antenna wire and antenna were replaced. There was indication of corrosion in the antenna cable which may have attenuated the signal. Again the wire is being brought back to WHOI for evaluation. Revised termination and weatherproofing were tried for the redeployment.

Figure 9. Crest Moored PAR and batteries. The battery voltage shows the slow decay with time and the eventual failure of the system about day 95. The Par sensor indicates less radiation than anticipated after day 40 (mid-December).

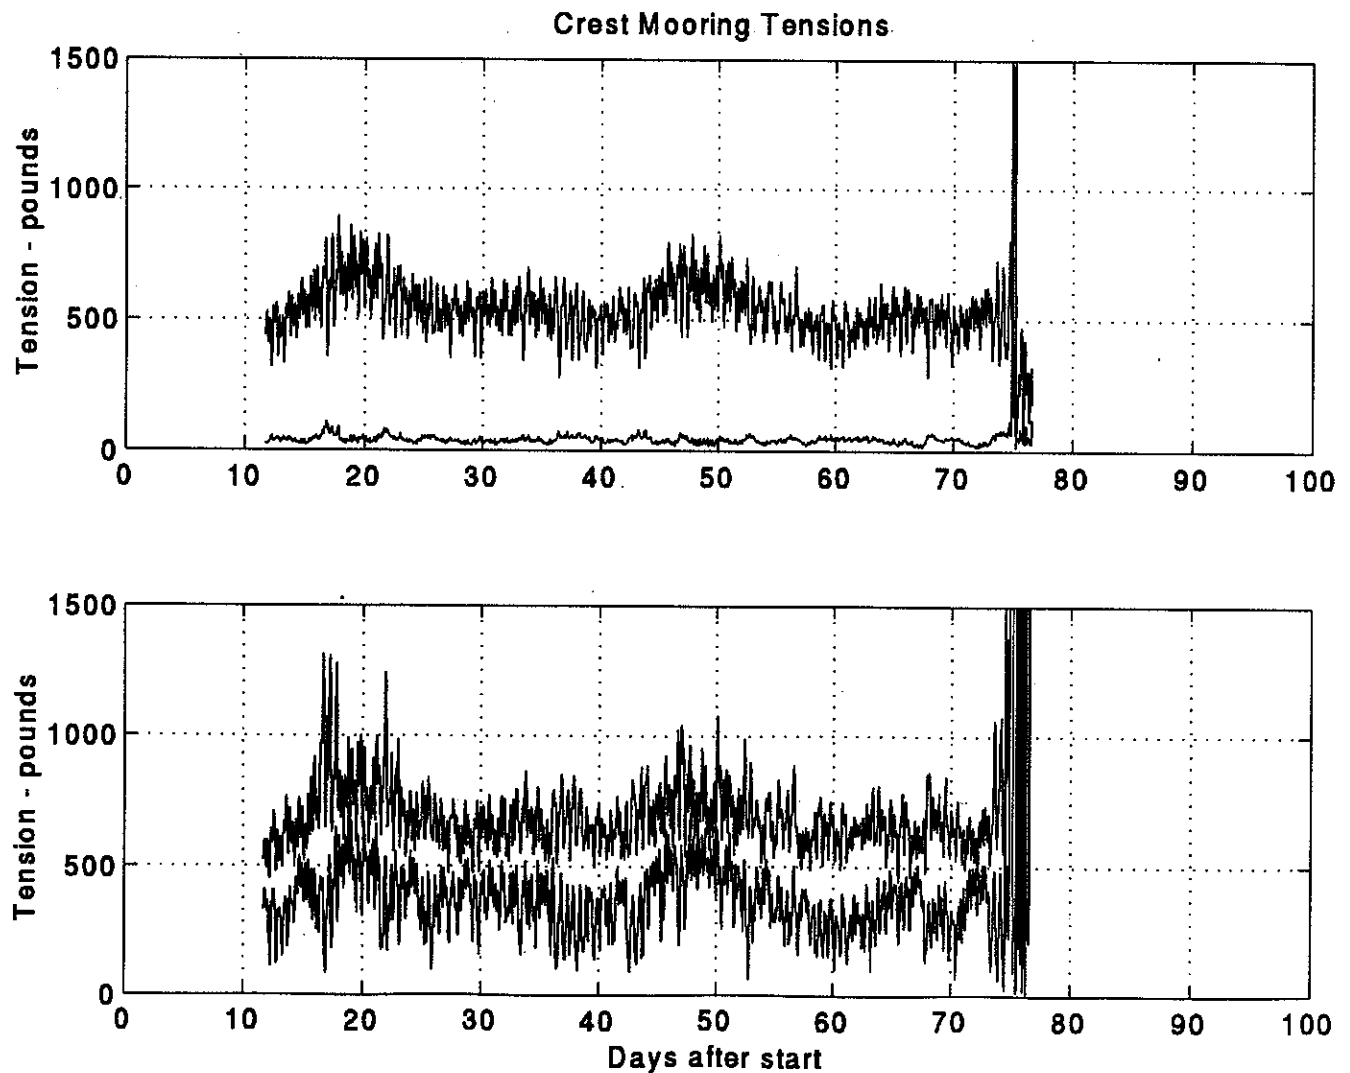
The mooring tension from the load cell is plotted in Figure 10. The maximum tension appears to be less than 1300 pounds. Strong tidal variations are evident, along with the slower changing wind/current variations. The minimum tension did not go below 100 pounds. A tension of zero would imply that the tethers were slack, and could possibly tangle and be cut on the mooring hardware. The mean tensions (hourly averages) show 500-800 pounds tension, which is in good agreement with our predicted mooring performance. The minimum and maximum tensions are individual samples taken at 1 second intervals during the hour. The high frequency wave component is appears as the standard deviation of the tension, and is typically 50 to 100 pounds, very acceptable.

Figure 10. Crest Load Cell Tensions. The hourly mean and standard deviation of the hourly record are plotted on top, and the maximum and minimum tensions during the hour are plotted on the bottom. The minimum tension get down to 100 pounds, but do not go to zero, which would indicated that the tethers were slack, and could tangle and cause failure. Also the maximum tensions do not go above 1300 pounds. (Note that the estimated breaking strength of the 6 tethers used is about 6000 pounds.) The standard deviation of the tension is due to wave activity, and is typically 50 to 100 pounds.

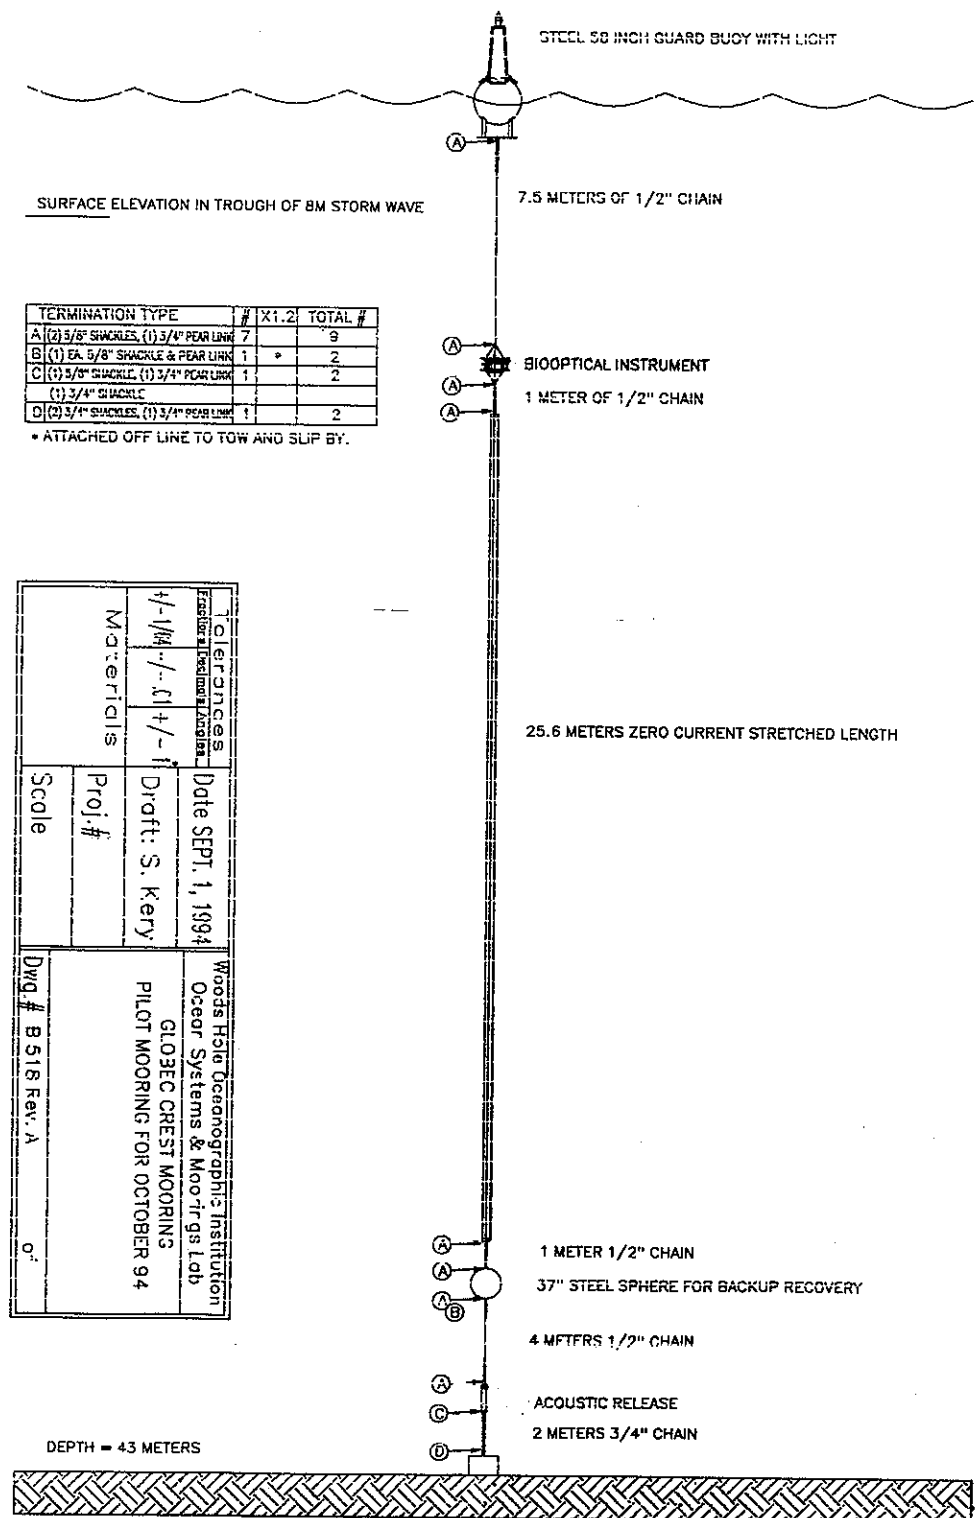
Figure 12. The revised Crest Mooring configuration as deployed on SJ9504. The mooring is the same as used successfully over the winter with the deletion of the load cell and the addition of the bio-optical package at 10 meters.
