**R/V OCEANUS Cruise 338
to Georges Bank**

8 - 13 March 1999

Acknowledgments
R/V OCEANUS Cruise OC338
U.S. State Department Cruise No. 99-014
8 – 13 March 1999

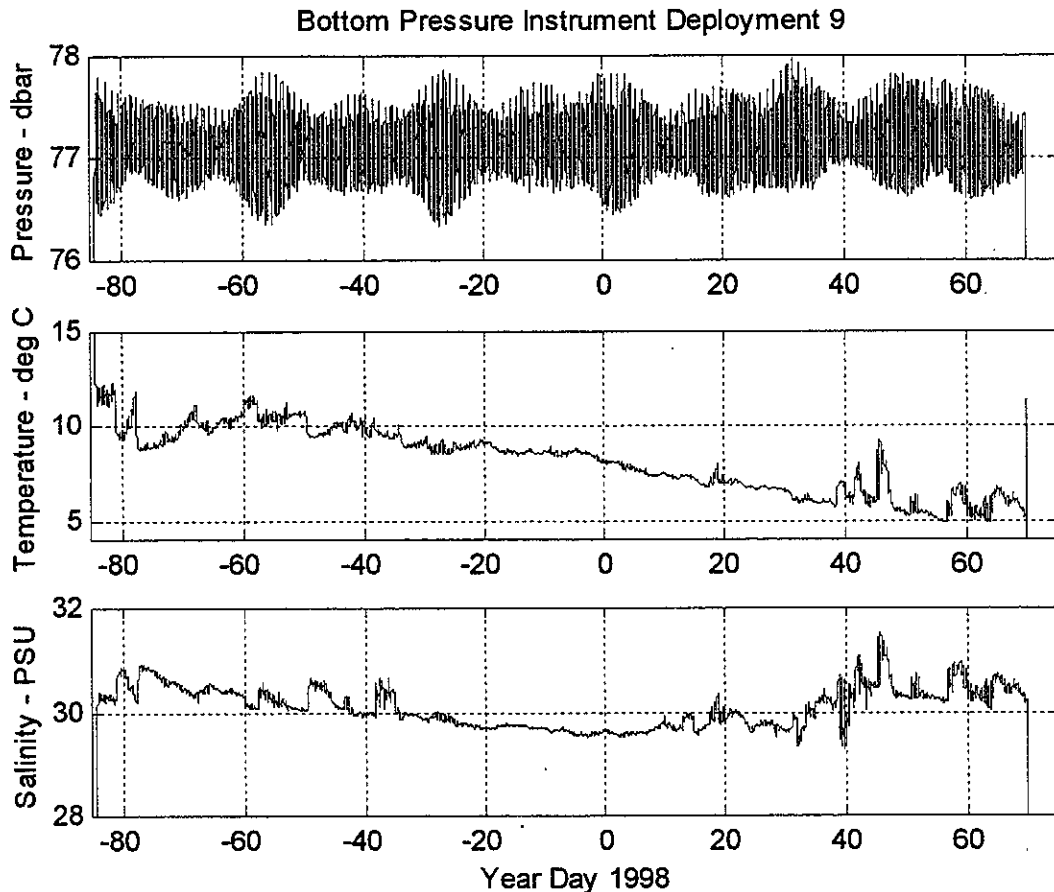
Figure 2. Bottom pressure instrument data. The top panel shows the unedited, normalized pressure record in decibars relative to one standard atmosphere. The middle panel shows the unedited, normalized temperature in degrees C. The bottom panel shows salinity calculated from raw conductivity and temperature. The sample interval in the tidal mode shown was 15 minutes. The salinity record includes an apparent sediment-induced offset and drift.

Southern Flank Bottom Pressure: The bottom pressure instrument, deployed at the southern flank site on 7 October 1998, was the first to be recovered. It was recalled by command to an acoustic release, and returned to the surface on the buoyancy of its flotation. The acoustic release, frame and Sea Bird Seagauge pressure instrument were mildly fouled with hydroids but otherwise in good condition. The heavy barnacle growth that has been observed during the summer months during past years was not apparent at this time. The package was cleaned, the acoustic release changed, and the Seagauge pressure instrument was serviced (new batteries, data dumped, time checked and set, etc). The instrument (see Table 1 for sensor serial numbers) worked well and returned a full set of ~5 months length. The data returned (Figure 2) shows the tides and weather forced sea level variations in the pressure record, and the seasonal cooling in the temperature observations. The salinity record is lower by about 2 PSU than expected from comparisons with observations made higher in the water column. This is probably due to sand (non-conducting medium) collecting and staying in the conductivity cell.

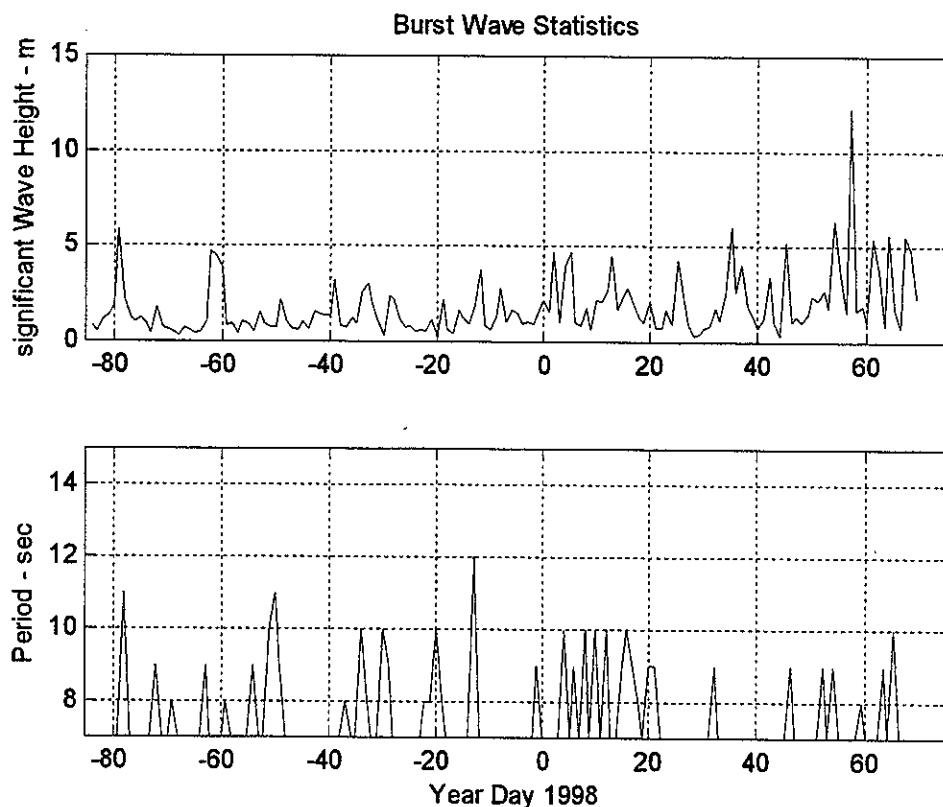
Figure 3. Wave statistics gathered once per day at 0130 UTC from the bottom pressure sensor as an indication of the long-wave activity that penetrates to the bottom in 76 meters of water. The minimum period of about 7 seconds reflects the attenuation with depth that removes the effects of waves with periods smaller than about 7 seconds.

In addition to the 15-minute tidal samples, the bottom pressure instrument was also burst sampled for wave activity once per day for about 10 minutes starting at 0130 UTC. Because of the attenuation of surface waves with depth, waves with periods shorter than about 7 seconds were not observed at the bottom. Each burst sample consisted of 300 samples at 2-second intervals. The 2-second sample interval will resolve 7-second and longer waves. The 10-minute record length is the minimum that will obtain accurate wave statistics. The daily significant wave height (average of the highest 1/3 of the waves) as calculated by the instrument and shown in Figure 3 along with the period of the waves. The largest wave event was a storm at the end of February (26 February 1999). The storm a few days before the cruise that delayed us leaving port did not create a significant wave height larger than many other winter storms during this past year.

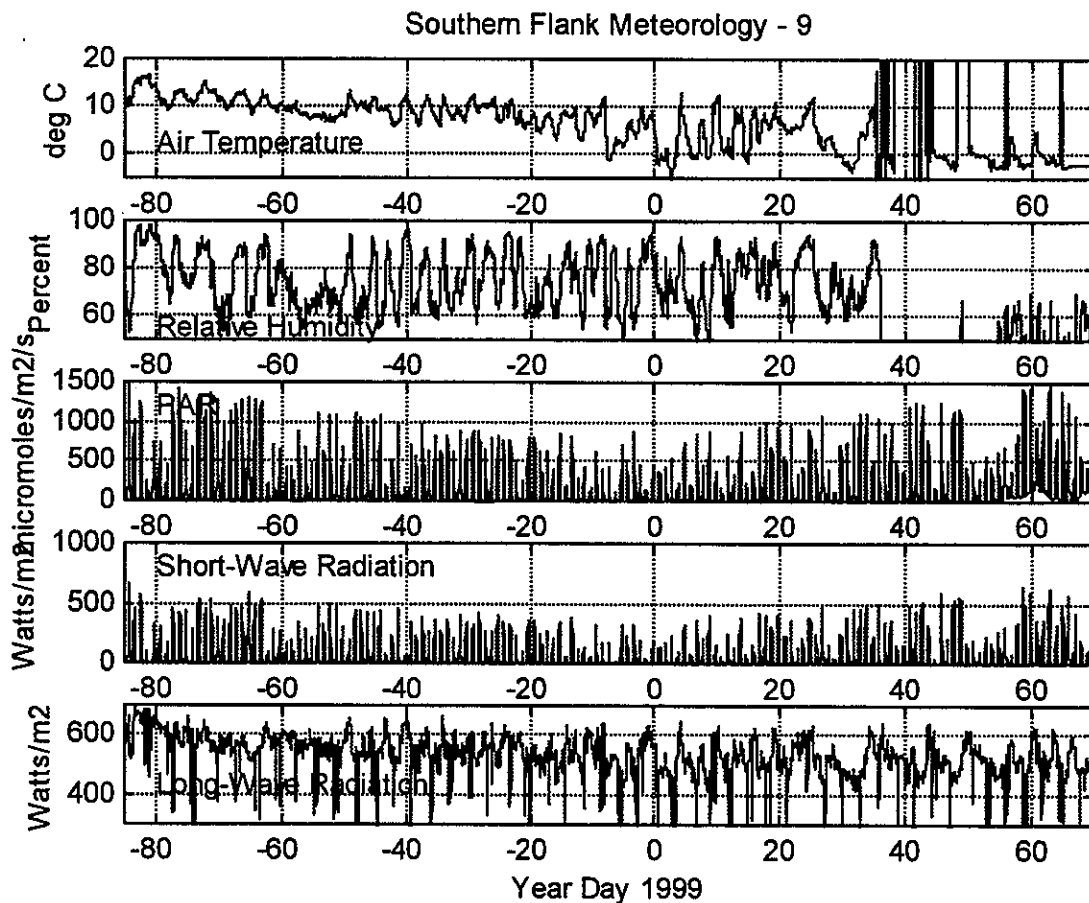
Figure 5. The Southern Flank Meteorology/Radiation. The normalized, unedited air temperature (top panel) and relative humidity (next panel) show a problem that developed in early February. The PAR and short wave radiation are next, and show similar pictures of incoming radiation. The normalized, unedited long wave radiation shows the negative going spikes due to the influence of the GOES transmissions on the sensor.

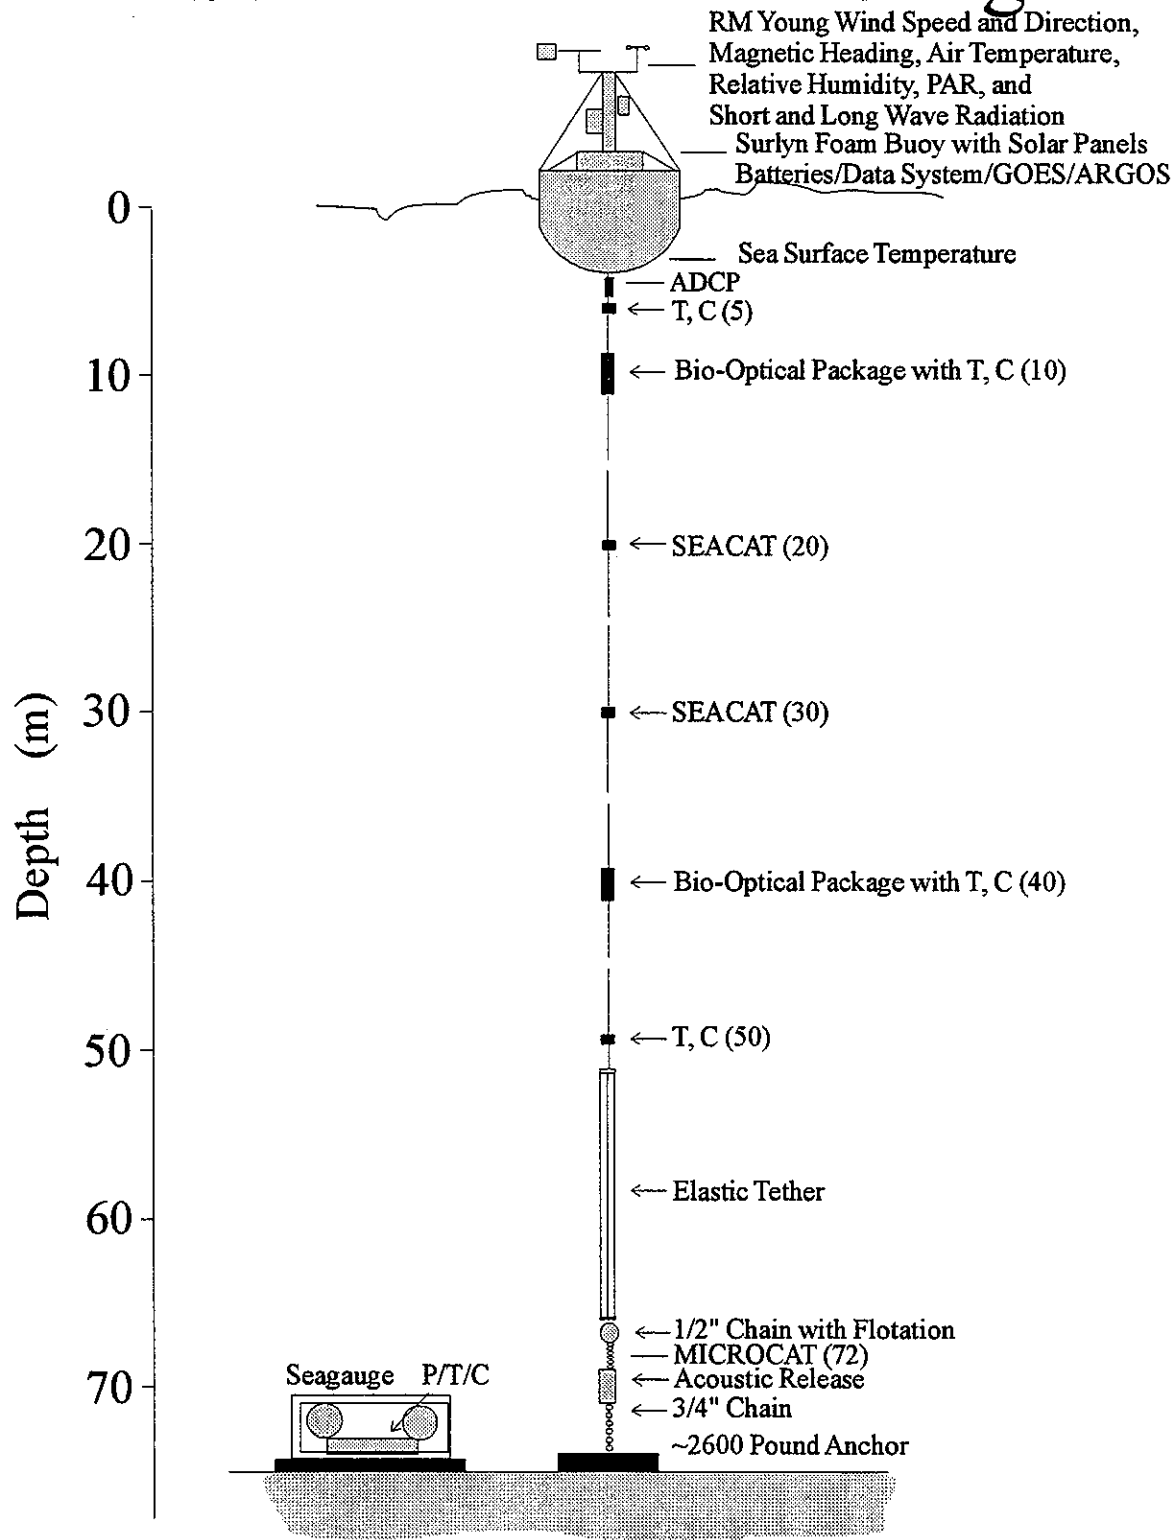
Figure 4. Southern Flank Mooring Schematic for Deployment 9. Due to the lack of vertical structure in water properties during winter months, the vertical sensor spacing was 10 meters.

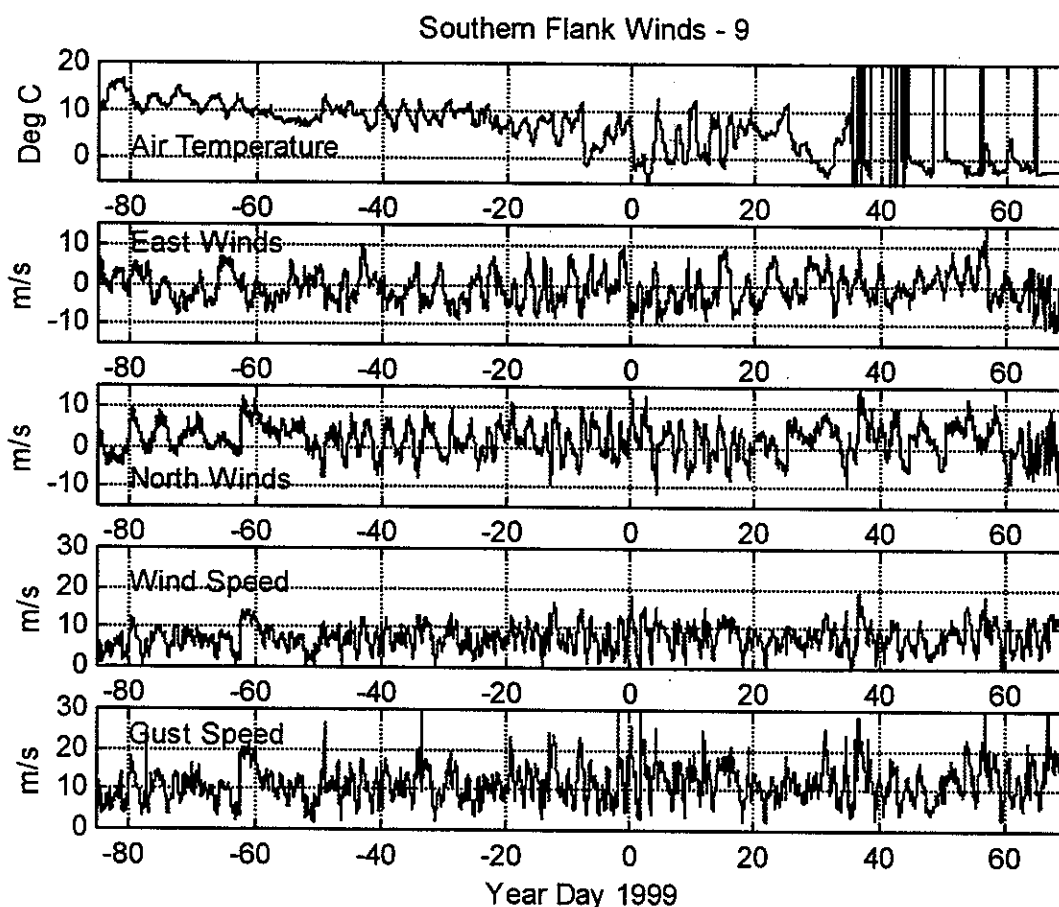
Figure 6. The Southern Flank Winds. The normalized, unedited data is plotted: air temperature, East and North winds (meteorology convention of direction from), hourly averaged wind speed, and gust (the individual 1 Hz measurement with the maximum speed during the last hour).

Another change is seen in the visual check of the data in the wind velocity components during the last week of the record in Figure 6. The "look" of the record changes indicating a possible hardware failure. The fact that the wind speed and gust do not show these effects, implies that there might be some problem with the compass or vane direction sensors that are used to calculate the vector averaged velocities but not the wind speed or gust. Further tests indicated possible failures in both the digitizer and in the wind sensor signal conditioning electronics, and not in the compass. As usual, the gust (highest reading of the 1 Hz data during the hour) is nearly twice the hourly averaged wind speed. The strongest storm was the late February storm seen in the significant wave record (Figure 3). There were about 14 storms during the past winter where the wind gust exceeded 20 m/s.

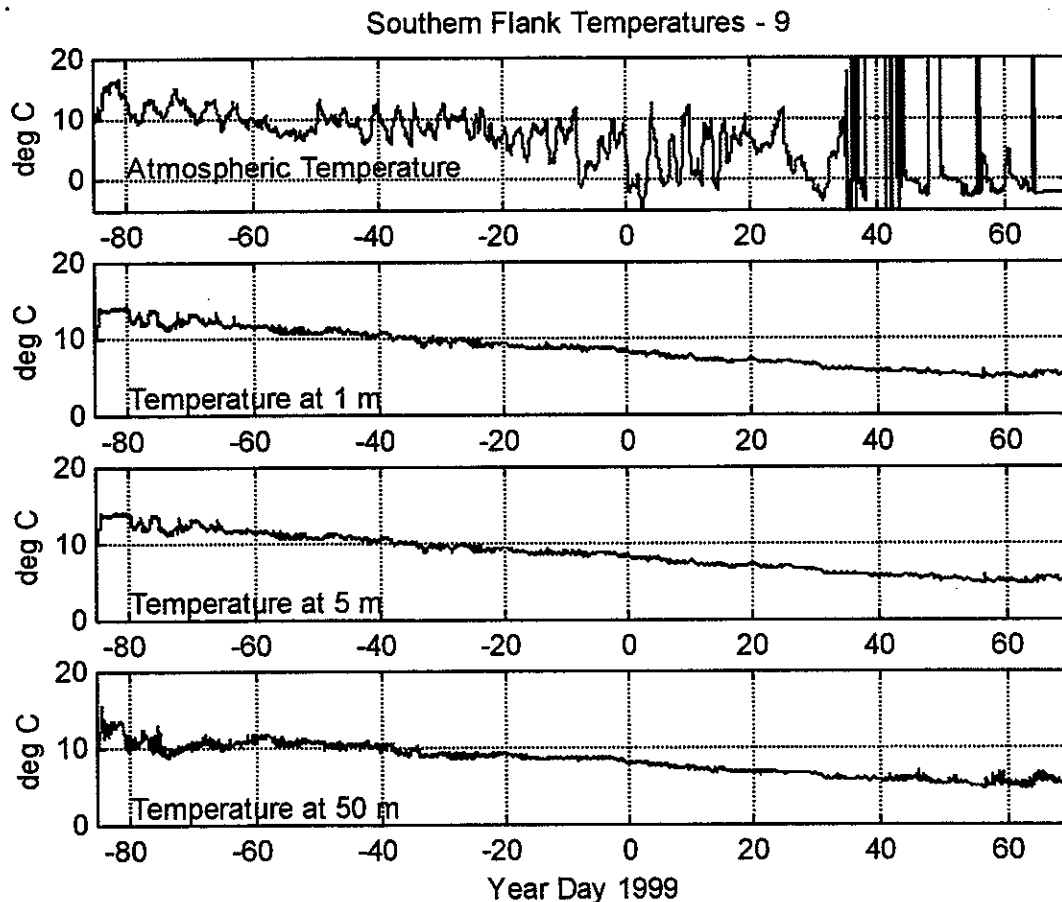
Figure 7. Southern Flank moored temperature. The normalized, unedited temperatures are shown for 1, 5, and 50 meters depth with the air temperature on the top for reference.

The hourly averaged temperatures on the mooring (Figure 7) appear to be good with the only problem that in the air temperature mentioned above. These temperatures (Figure 7), the Seacat temperature (Figure 9), and bio-optical package temperature (Figures 11 and 12) show a remarkably smooth and uniform winter cooling with no obvious crossover events (cool spikes in the surface waters) as seen in previous winters. The water column shows some stratification in

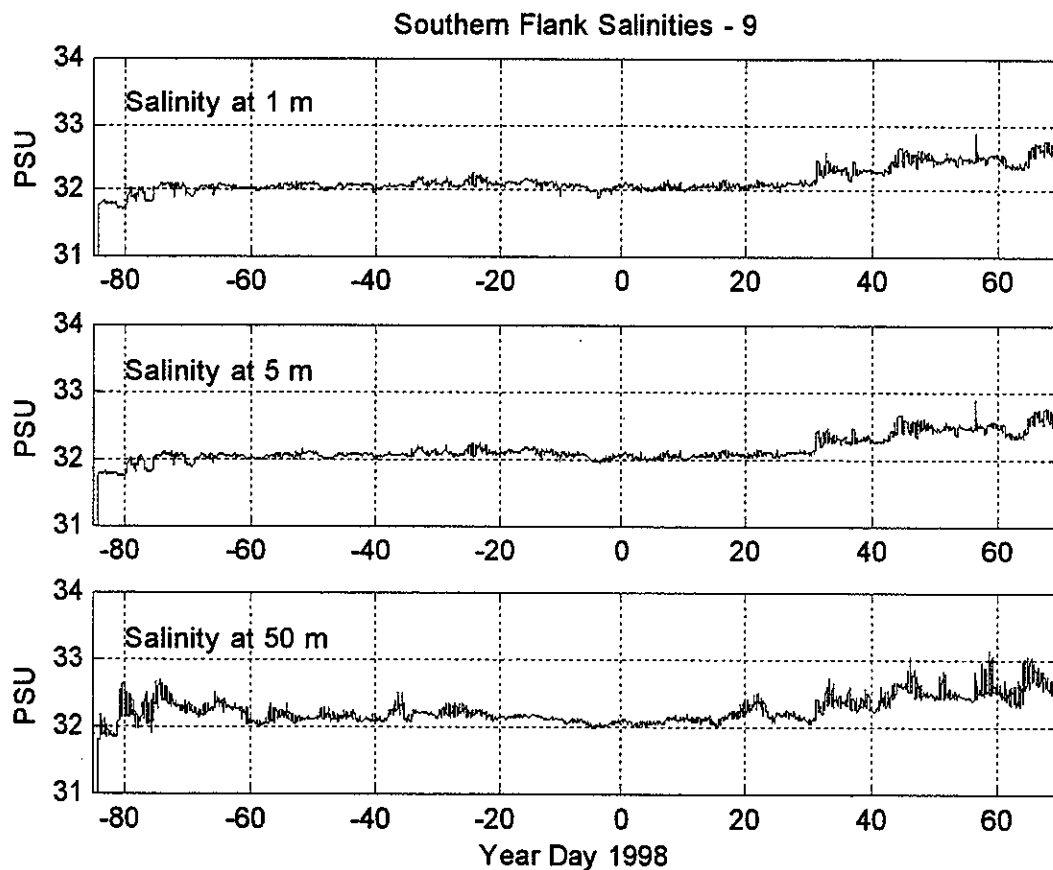
Figure 8. Southern Flank moored salinity. The normalized, unedited salinity calculated from the temperature and conductivity records is shown for depths of 1, 5, and 50 meters.

In the 72 meter record (Figure 10) and to a lesser extent at 50 meters (Figure 8) there are indications of warmer saltier intrusions throughout the late fall and early spring (year days -55, -45, 22, 50, and 57). There are temperature, but mostly salinity effects that are seen at all depths about year day 30 and during the past week of the record. These are probably due to advection of new water masses past the mooring. However, there are no indications of cooler fresher Scotian Shelf water masses seen in the surface waters as in past winters.

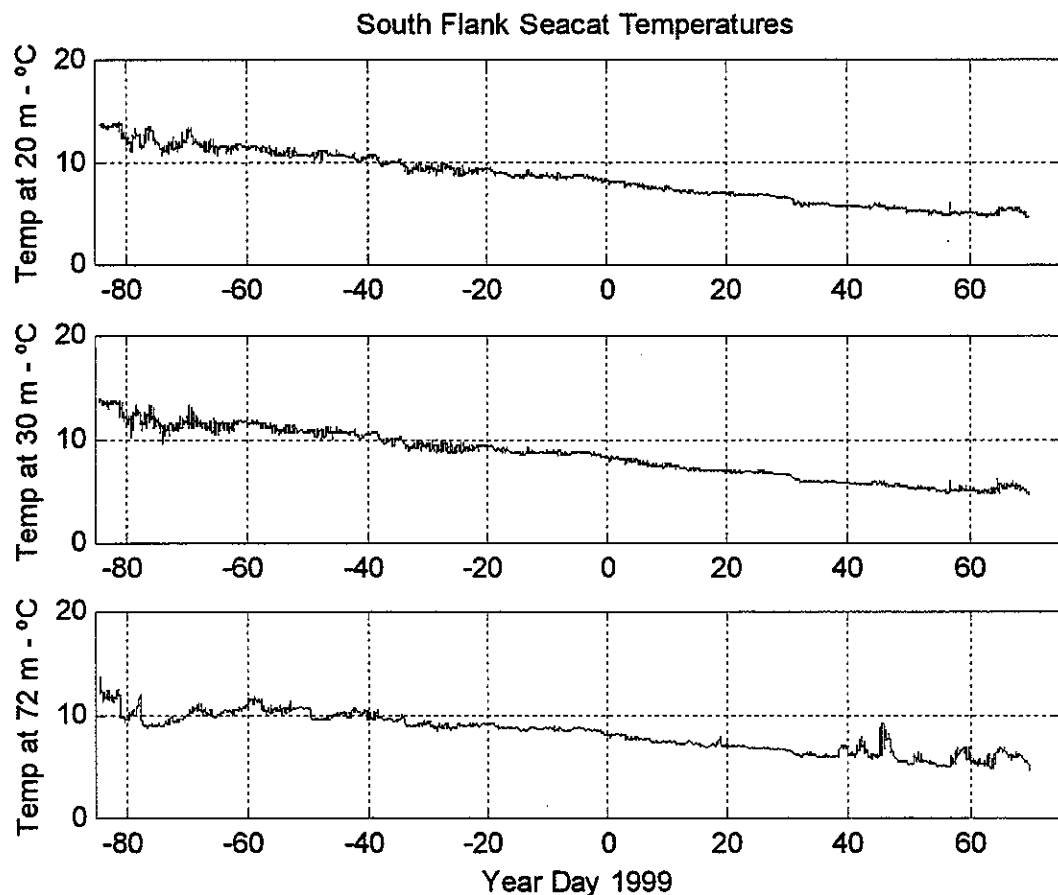
Figure 9. Seacat Temperature. The raw, normalized, but unedited temperatures are shown for 20 m (top panel), 30 m (center panel) and 72 m (bottom panel).

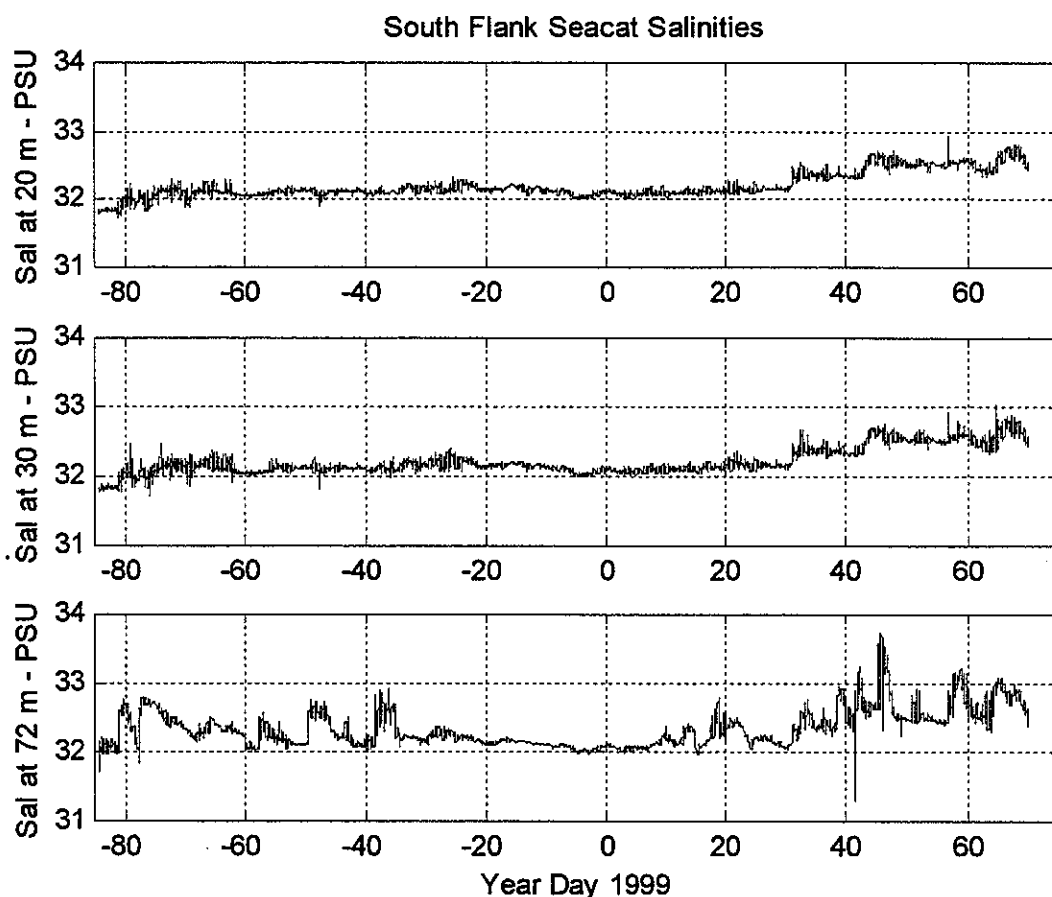
Figure 10 Seacat Salinity. The raw, normalized, but unedited salinities are shown for 20 m (top panel), 30 m (center panel) and 72 m (bottom panel).

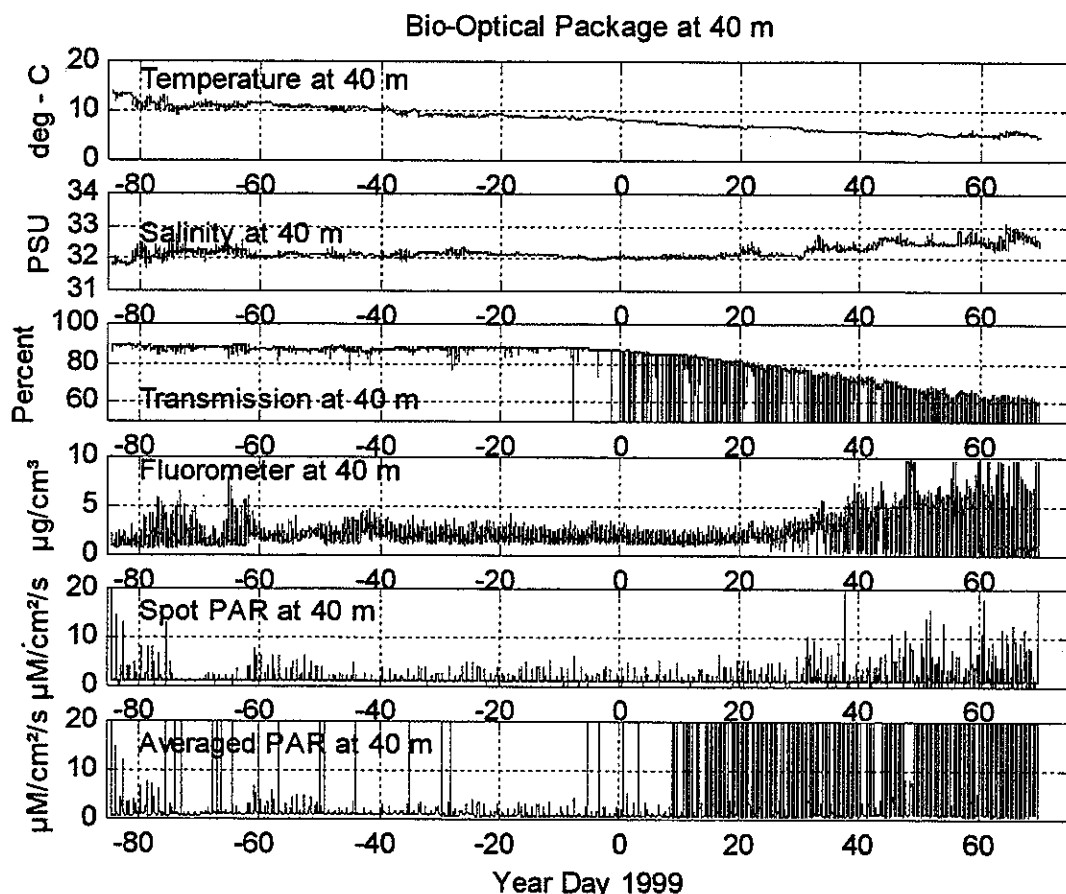
Figure 12. The unedited bio-optical results at 40 m. The top panel shows the temperature in degrees C, and the next panel the salinity in PSU. The third panel shows the beam transmissometer in percent transmission, and the fourth panel the chlorophyll-a fluorometer with nominal calibration of 10 $\mu\text{g/l}$ full scale. The fifth panel shows the last individual PAR reading while the bottom panel shows the 3.75 minute averaged PAR reading in microMoles/cm²/sec. The basic sample interval is 3.75 minutes or 16 samples/hour.

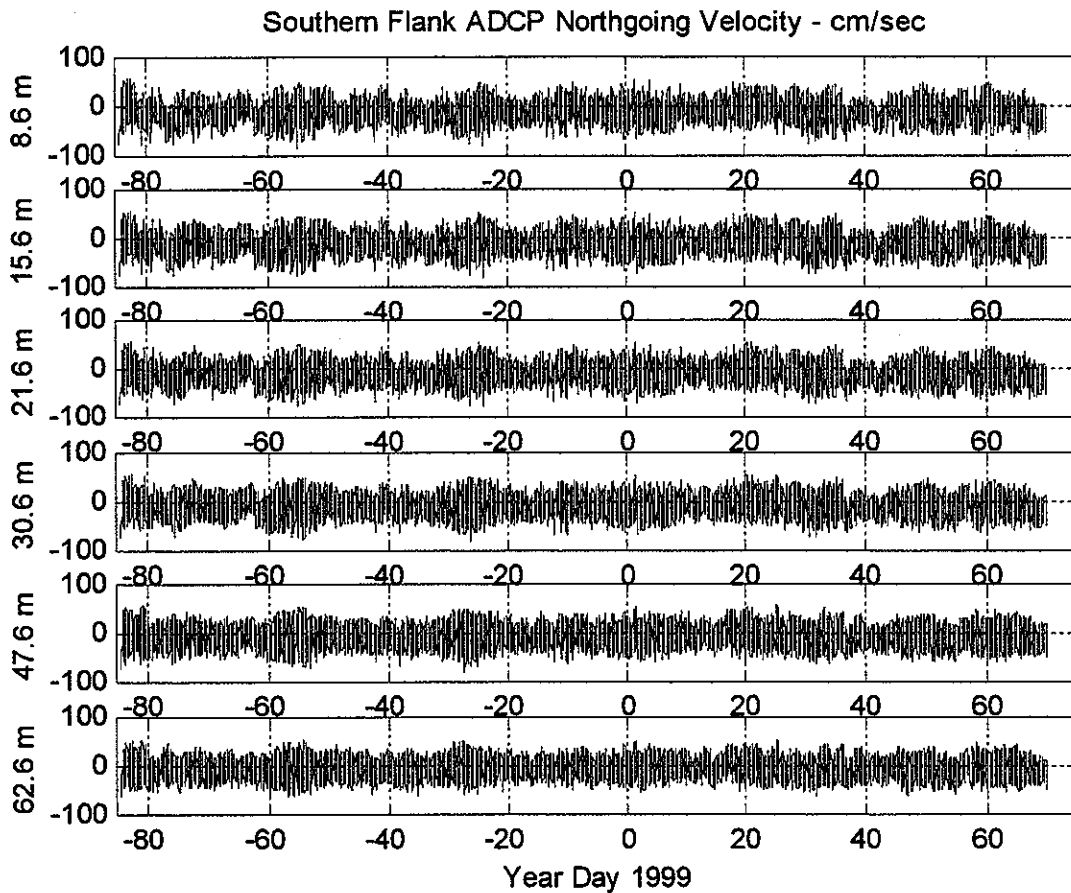
Figure 14. Southern Flank ADCP Northgoing currents. A subset of the raw, normalized, but unedited northgoing currents are shown at 8.5, 15.5, 21.5, 30.5, 47.5 and 62.5 meters depth.

The six selected series shown in Figures 13 and 14 were also analyzed by rotary spectral techniques for their frequency content (following the method outlined by Gonella (1972)). The rotary representation (a positive and negative rotating component rather than eastgoing and northgoing component) make sense in separating and visualizing some physical phenomena. The inertial current in the Northern Hemisphere rotates clockwise, so energy at the inertial frequency should show up in only one component of the rotary representation. Also, tidal currents, if they are circularly polarized, will also show up in one component. If the tidal currents are rectilinear, than they will appear with equal amplitudes in both rotary components. Figure 16 shows the rotary representation from averages of the transforms of three blocks of 1024 one-hourly values. It is obvious that the diurnal and inertial currents are nearly circular and clockwise rotating. The semidiurnal tides are also clockwise rotating, but not quite circular as some energy appears in both components. The low and high frequency components are more nearly isotropic, being nearly equally energetic in the positive and negatively rotating components, and in the eastgoing and northgoing components. There is the hint of a 4-day (peak near the 10^{-2} cph frequency), probably due to weather forced currents.

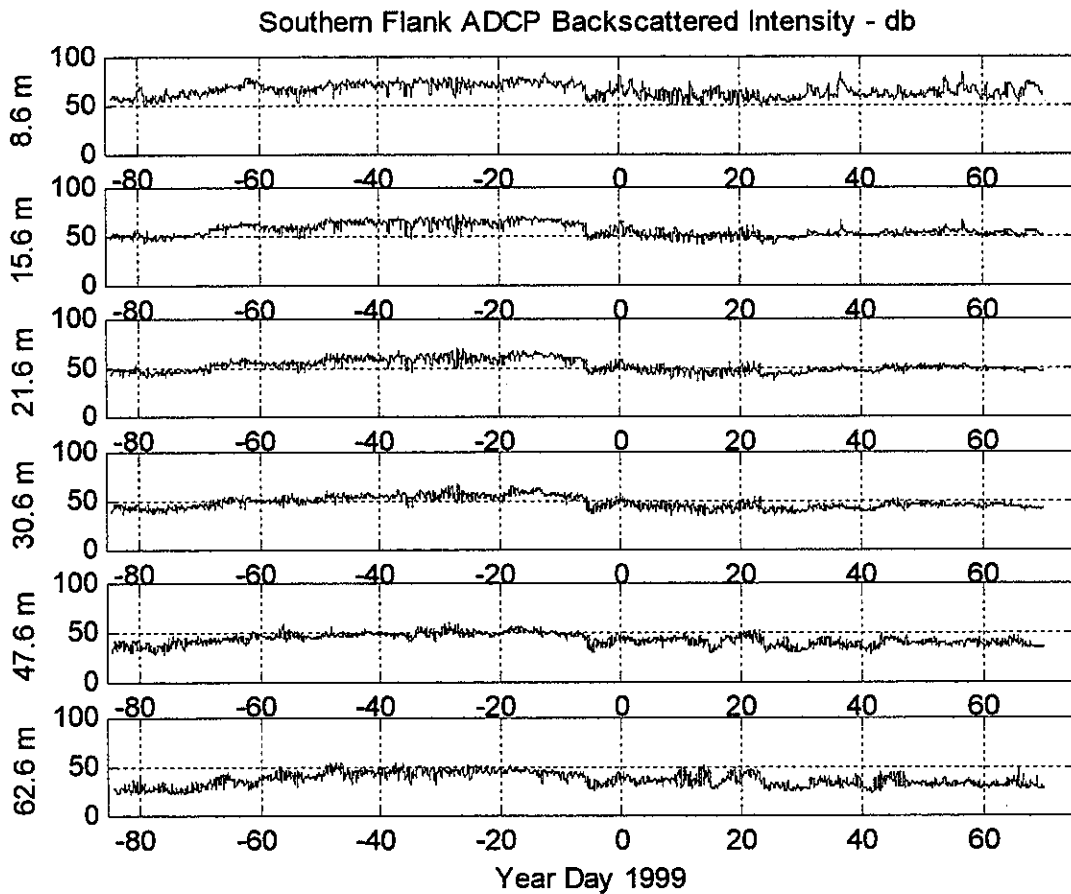
Figure 15. Southern Flank ADCP Backscattered Intensity. A subset of the raw, normalized, but unedited backscattered intensities from one transducer are shown at 8.5, 15.5, 21.5, 30.5, 47.5 and 62.5 meters depth.

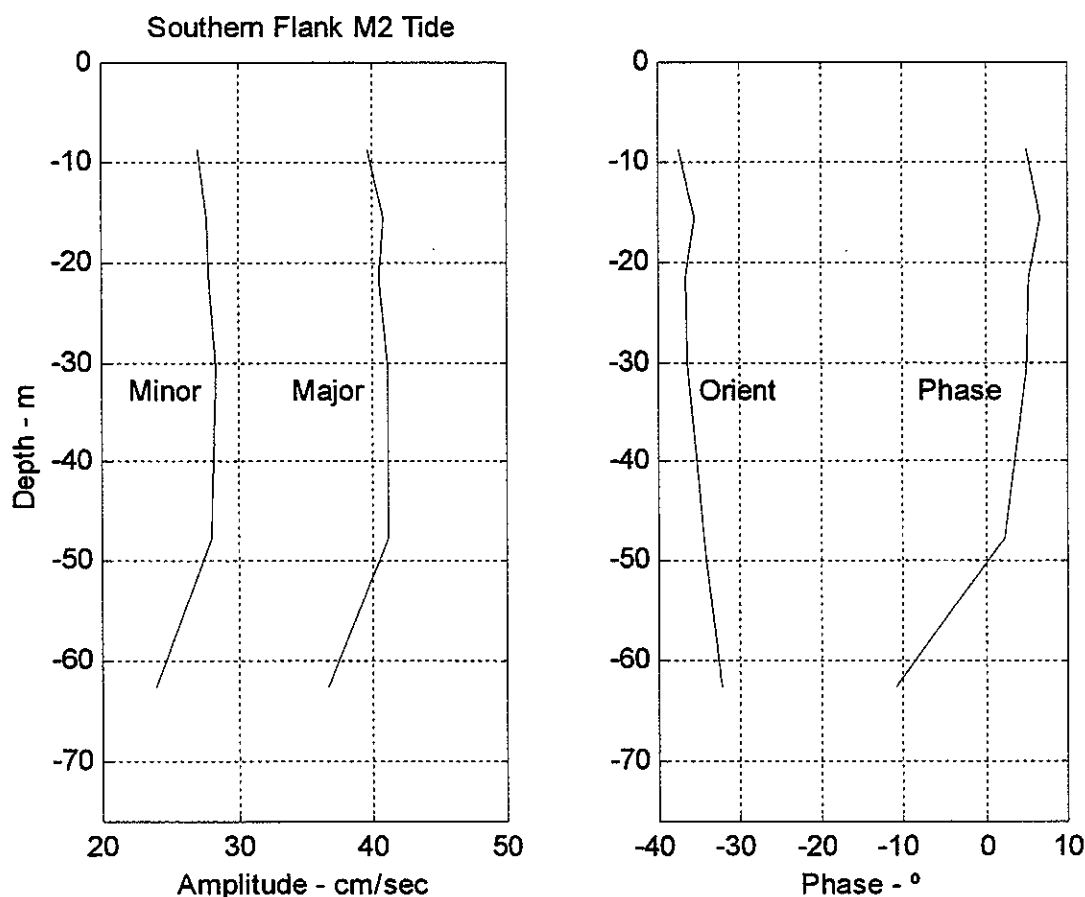
Figure 17. Southern flank ADCP M2 tidal analysis results as a function of depth as in Table 2.

The M2 component profiles (Figure 17) show the maximum flow is found below mid-depth in the 30 to 40 meter range. There is a boundary layer at the surface that slows the velocity somewhat, and a more standard boundary layer at the bottom where the velocity goes to zero. This structure is not resolved by the ADCP current profiles because the side-lobe reflections from the bottom contaminate the records below about 65 meters depth. Since the 47 m depth appears to be the most energetic, the full harmonic analysis of the eastgoing and

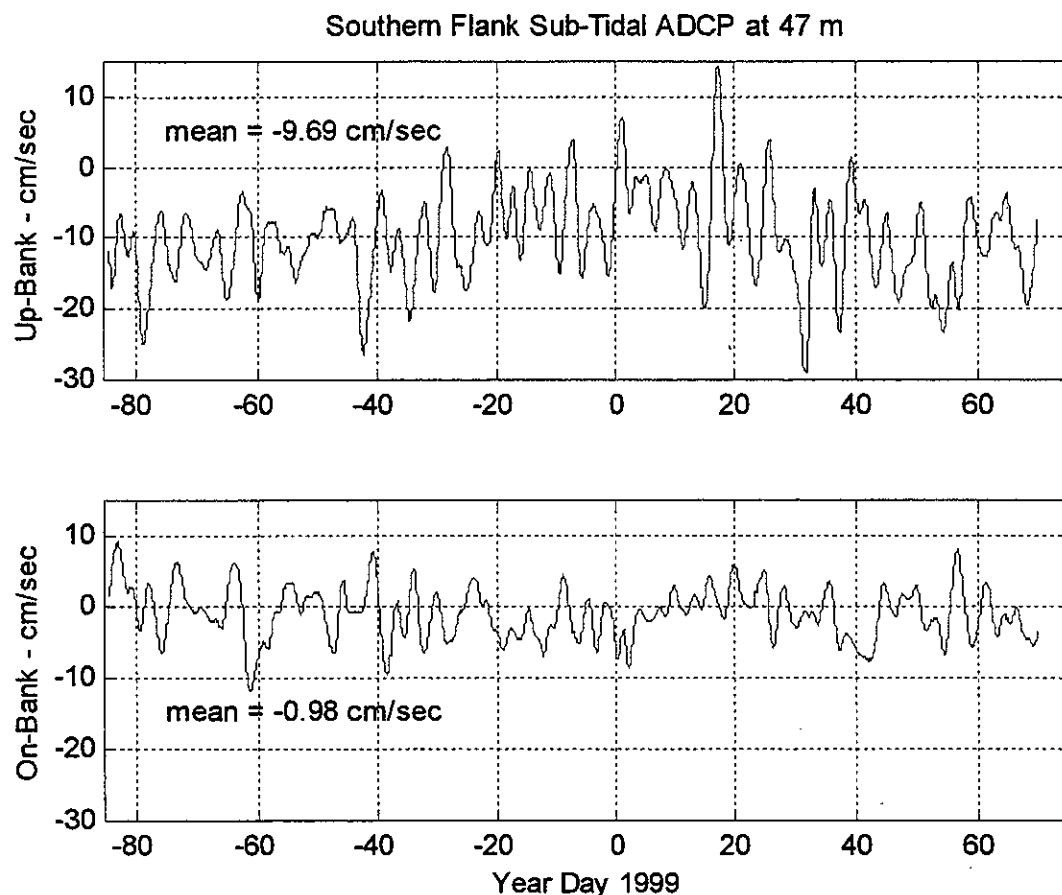
Figure 18. *Lopassed velocity at 47 meters. The components shown in Figures 13 and 14 were rotated 30° counter clockwise to align the up bank component with the average bathymetry.*

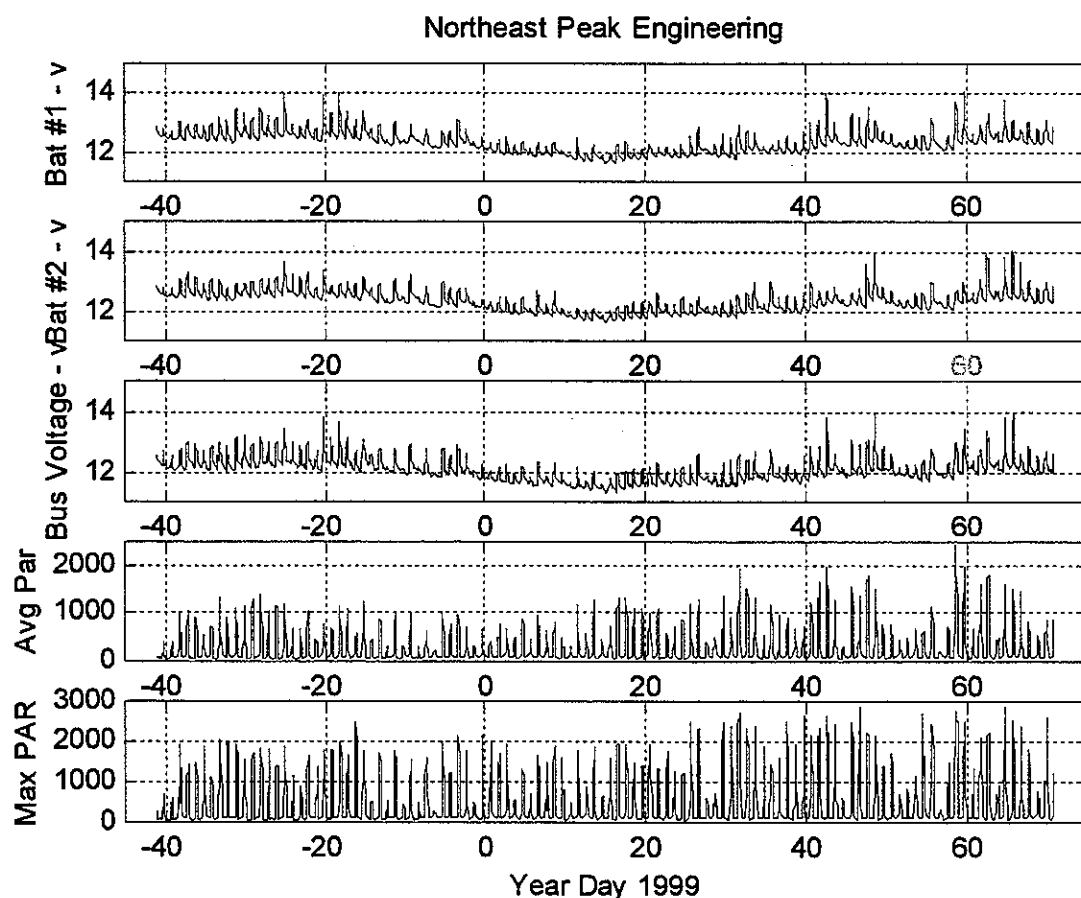
Figure 20. Northeast Peak Engineering Checks. The system batteries are shown in the top two panels and agree nicely, although #2 appears to be slightly lower. The hourly averaged PAR is shown next, with the individual 10-sec sample that is the largest during the hour shown on the bottom. The radiation (AvgPAR) and battery voltage are visually correlated with a lag.

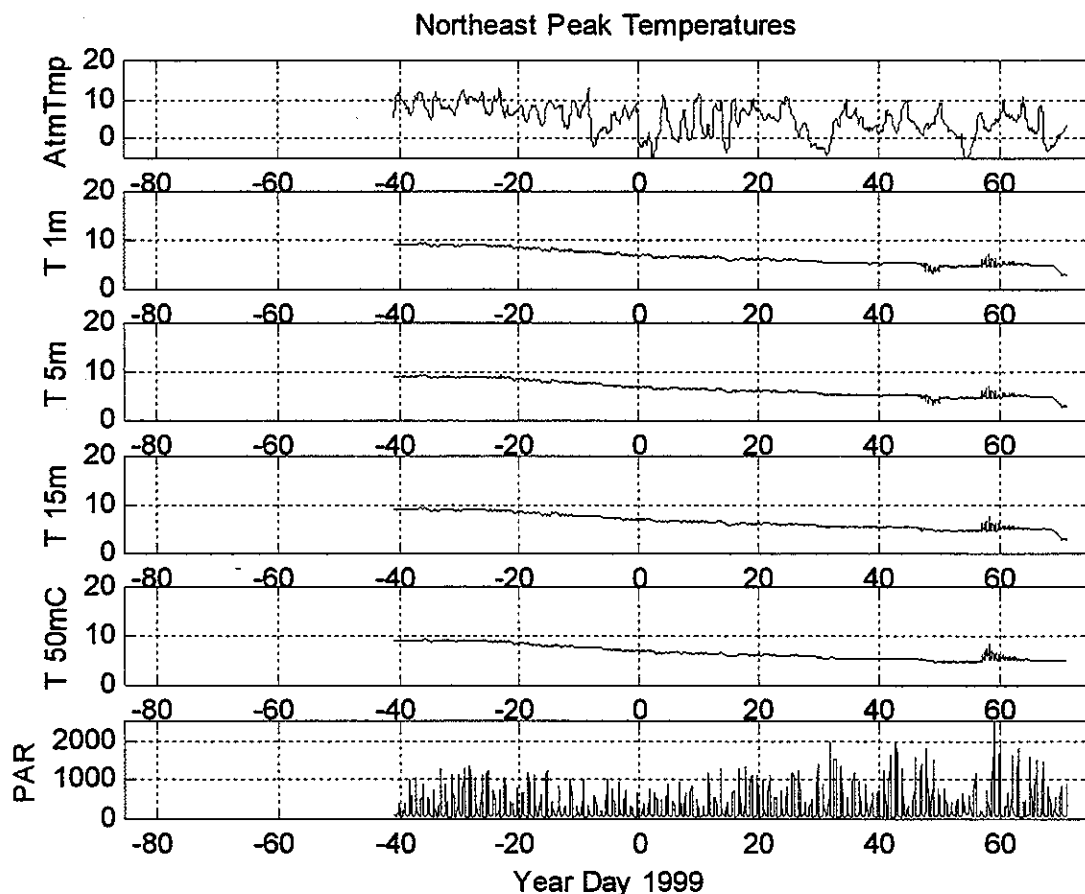
Figure 21. Northeast Peak moored temperature. The raw, normalized but unedited temperatures are shown for depths 1, 5, 15, and 50 meters depth with the air temperature in the top panel for reference.

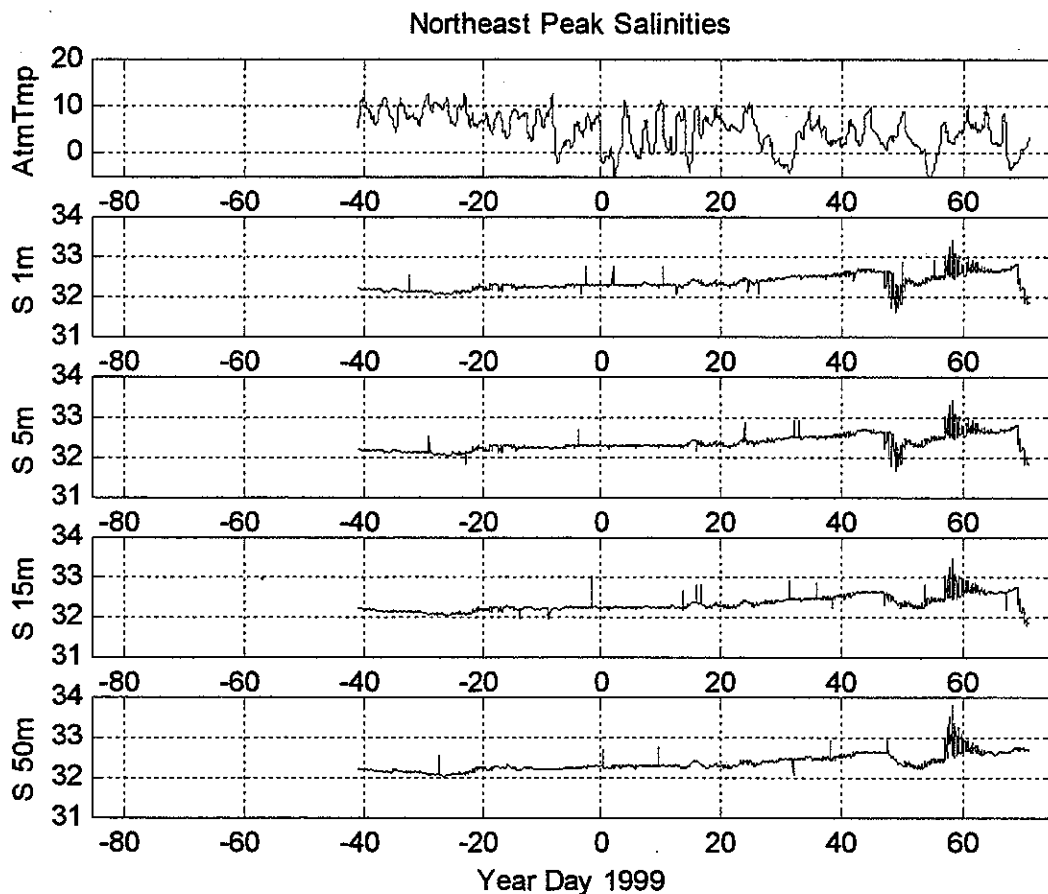
Figure 22. Northeast Peak moored salinity. The raw, normalized but unedited salinity calculated from the temperature and conductivity records is shown for depths of 1, 5, 15, and 50 meters.

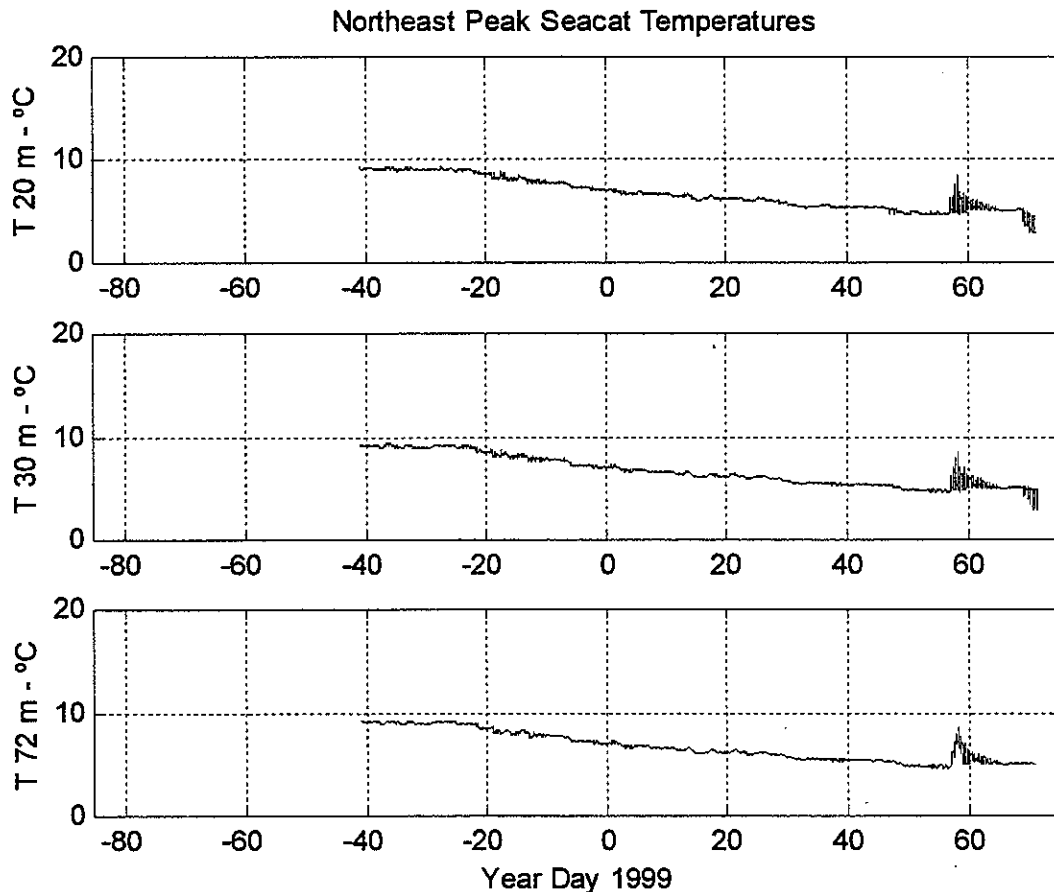
Figure 23. Northeast Peak Seacat Temperature. The raw, normalized, but unedited temperatures are shown for 20 m (top panel), 30 m (center panel) and 72 m (bottom panel).

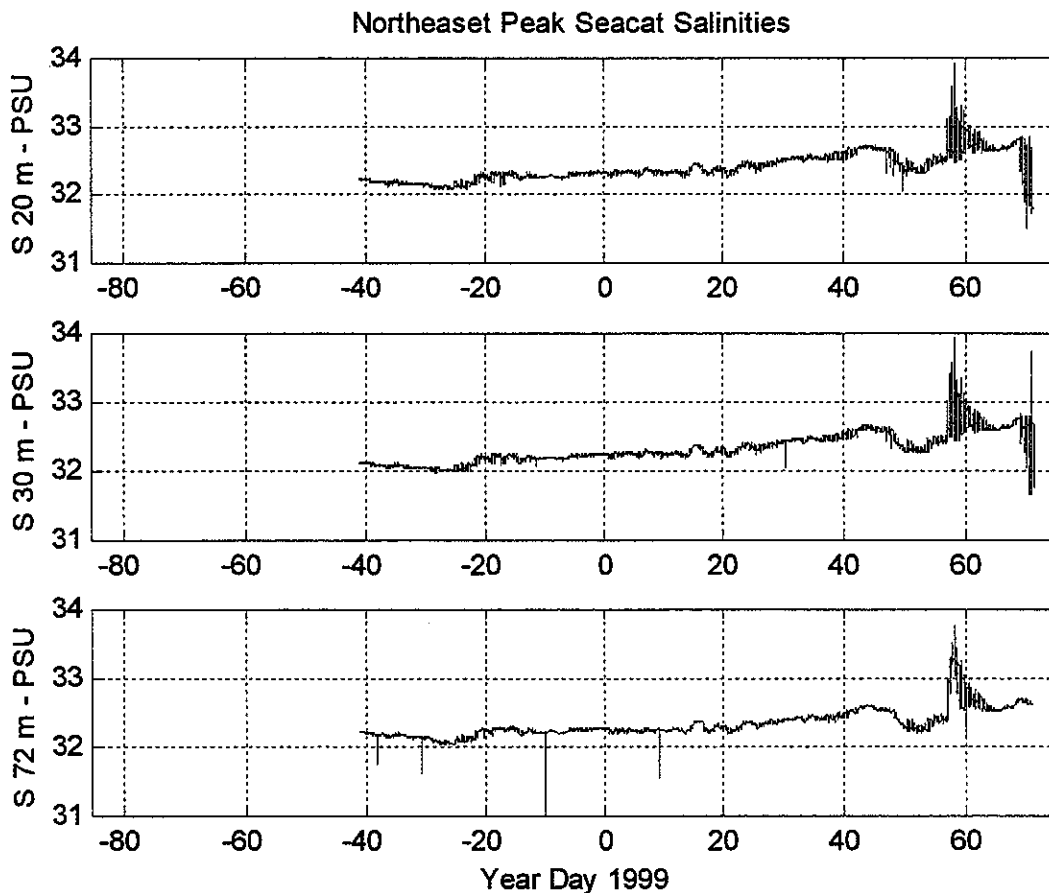
Figure 24. Northeast Peak Seacat Salinity. The raw, normalized, but unedited temperatures are shown for 20 m (top panel), 30 m (center panel) and 72 m (bottom panel).

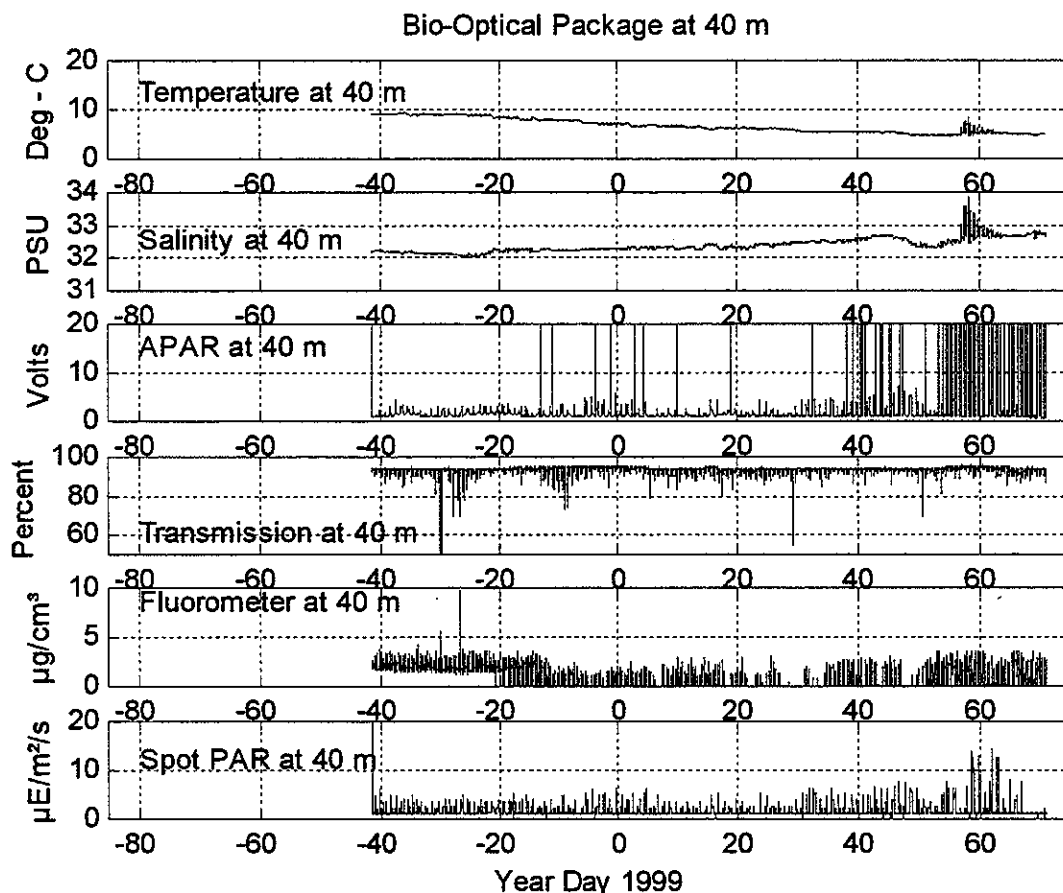
Figure 26. The unedited bio-optical results at 40 m. The top panel shows the temperature in degrees C, and the next panel the salinity in PSU. The third panel shows the beam transmissometer in percent transmission, and the fourth panel the chlorophyll-a fluorometer with nominal calibration of 10 $\mu\text{g/l}$ full scale. The fifth panel shows the last individual PAR reading while the bottom panel shows the 3.75 minute averaged PAR reading in microMoles/cm²/sec. The basic sample interval is 3.75 minutes or 16 samples/hour.
