**R/V OCEANUS Cruise 338
to Georges Bank**

8 - 13 March 1999

Acknowledgments
R/V OCEANUS Cruise OC338
U.S. State Department Cruise No. 99-014
8 – 13 March 1999

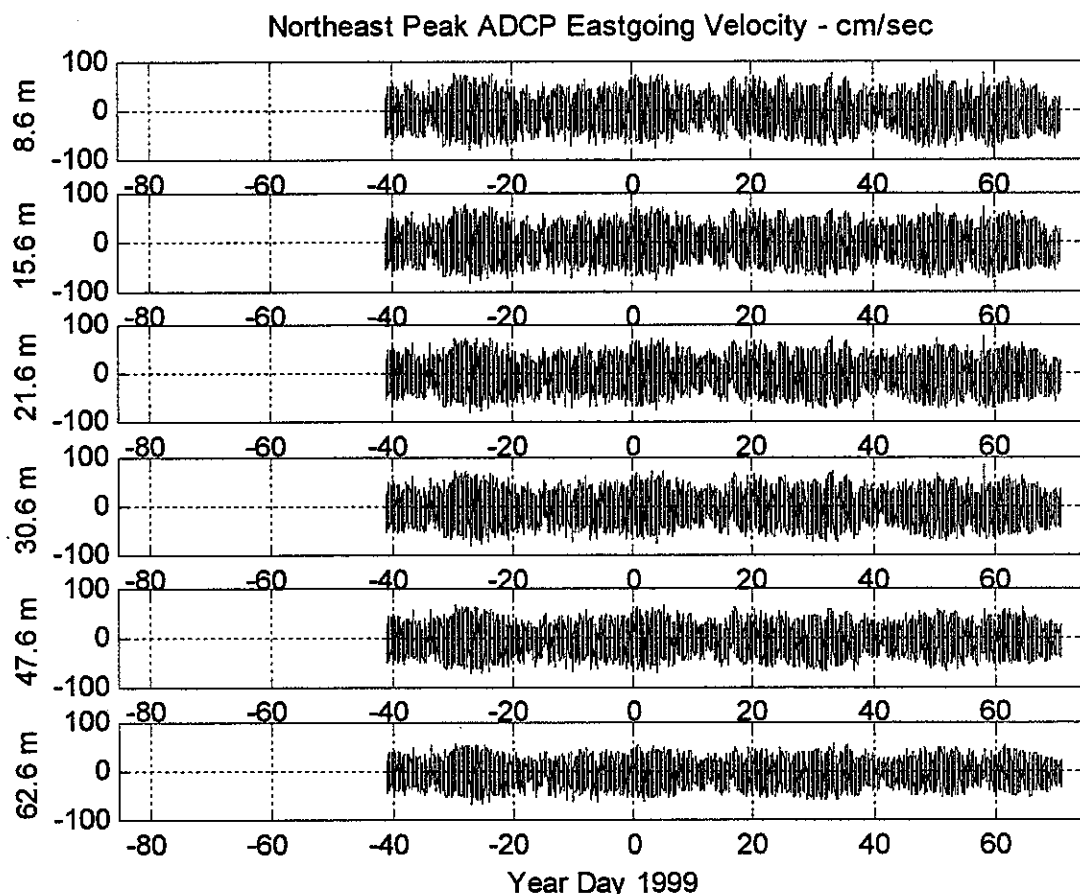
Figure 27. Northeast Peak ADCP Eastgoing currents. A subset of the raw, normalized, but unedited eastgoing currents are shown at 8.5, 15.5, 21.5, 30.5, 47.5 and 62.5 meters depth.

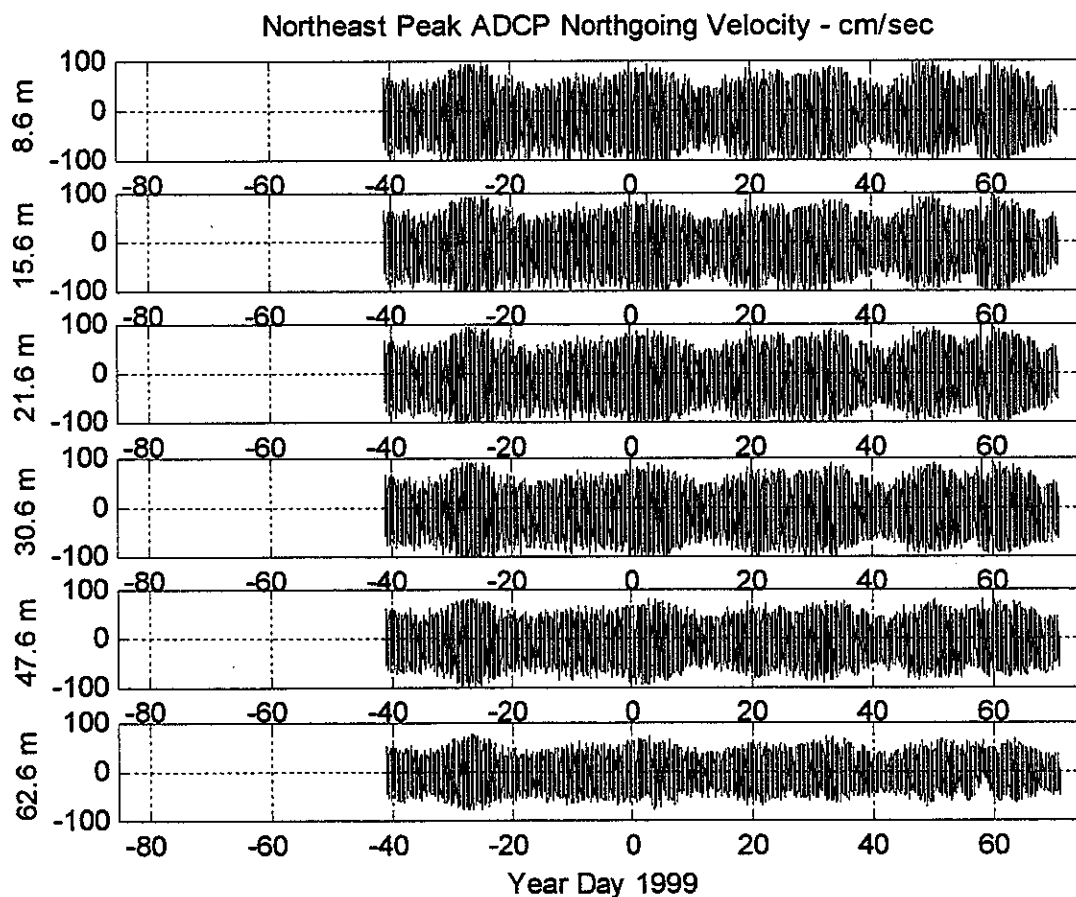
Figure 28. Northeast Peak ADCP Northgoing currents. A subset of the raw, normalized, but unedited northgoing currents are shown at 8.5, 15.5, 21.5, 30.5, 47.5 and 62.5 meters depth.

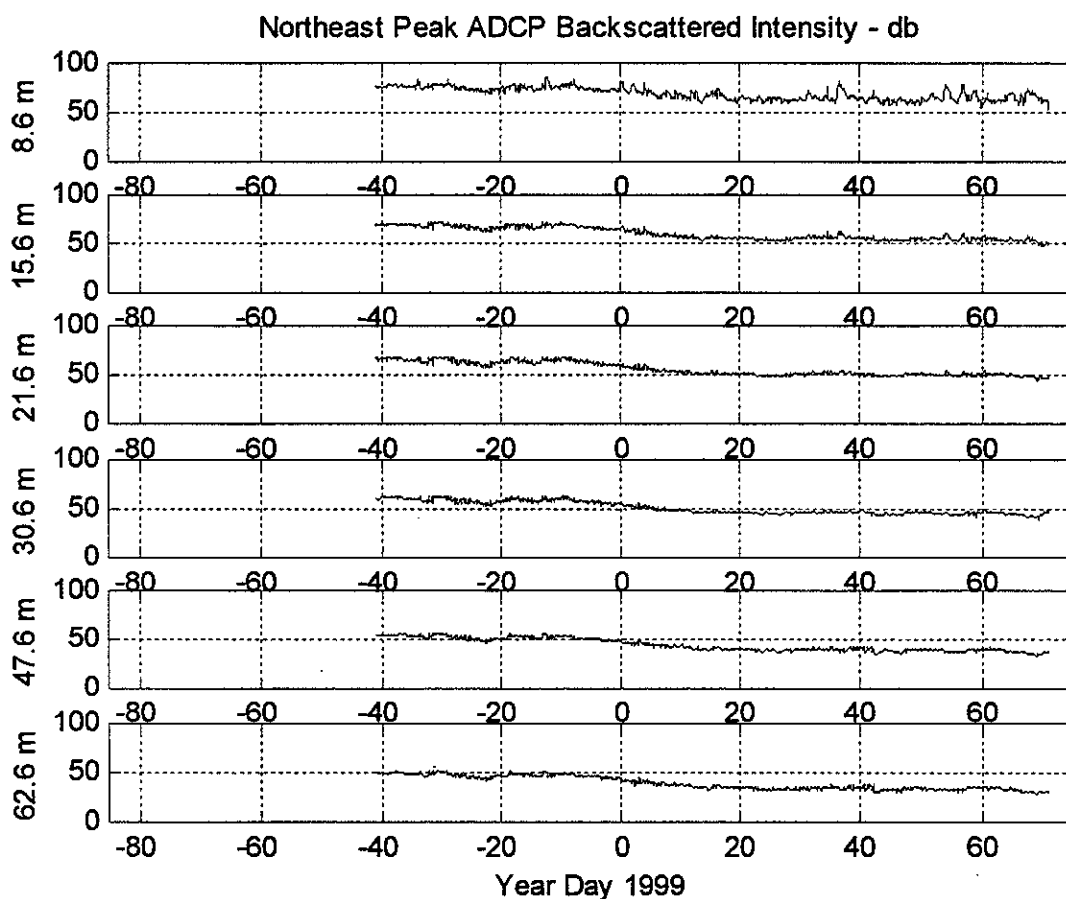
Figure 29. Northeast Peak ADCP Backscattered Intensity. A subset of the raw, normalized, but unedited backscattered intensities from one transducer are shown at 8.5, 15.5, 21.5, 30.5, 47.5 and 62.5 meters depth.

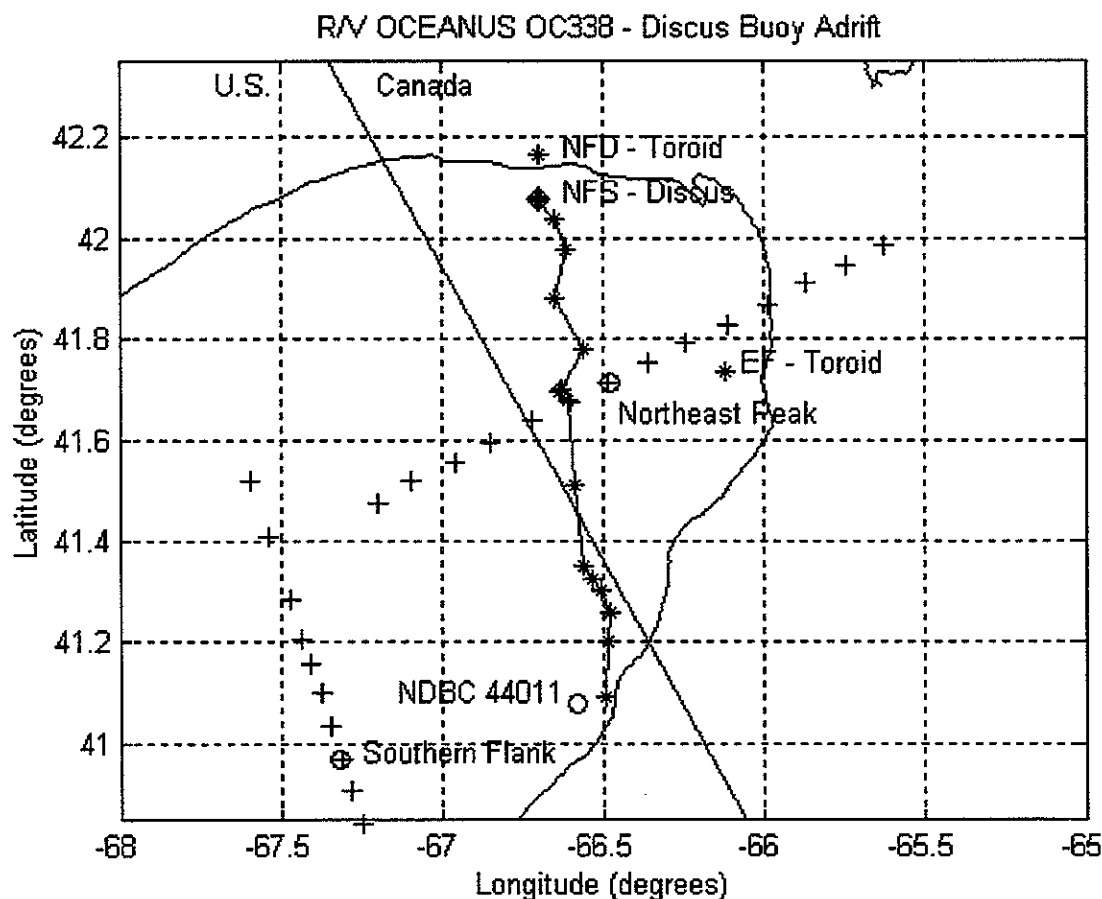
Figure 30. Crossover Experiment Discus Buoy drift path southward across Georges Bank. The three Crossover Experiment moorings are shown: Northern Flank Deep (NFD toroid), Northern Flank South (NFS – discus), and Eastern Flank (EF – toroid). The Long-Term Moored moorings sites are shown at Southern Flank and Northeast Peak. The standard CTD stations are shown as +, and the NDBC Georges Bank buoy as O.

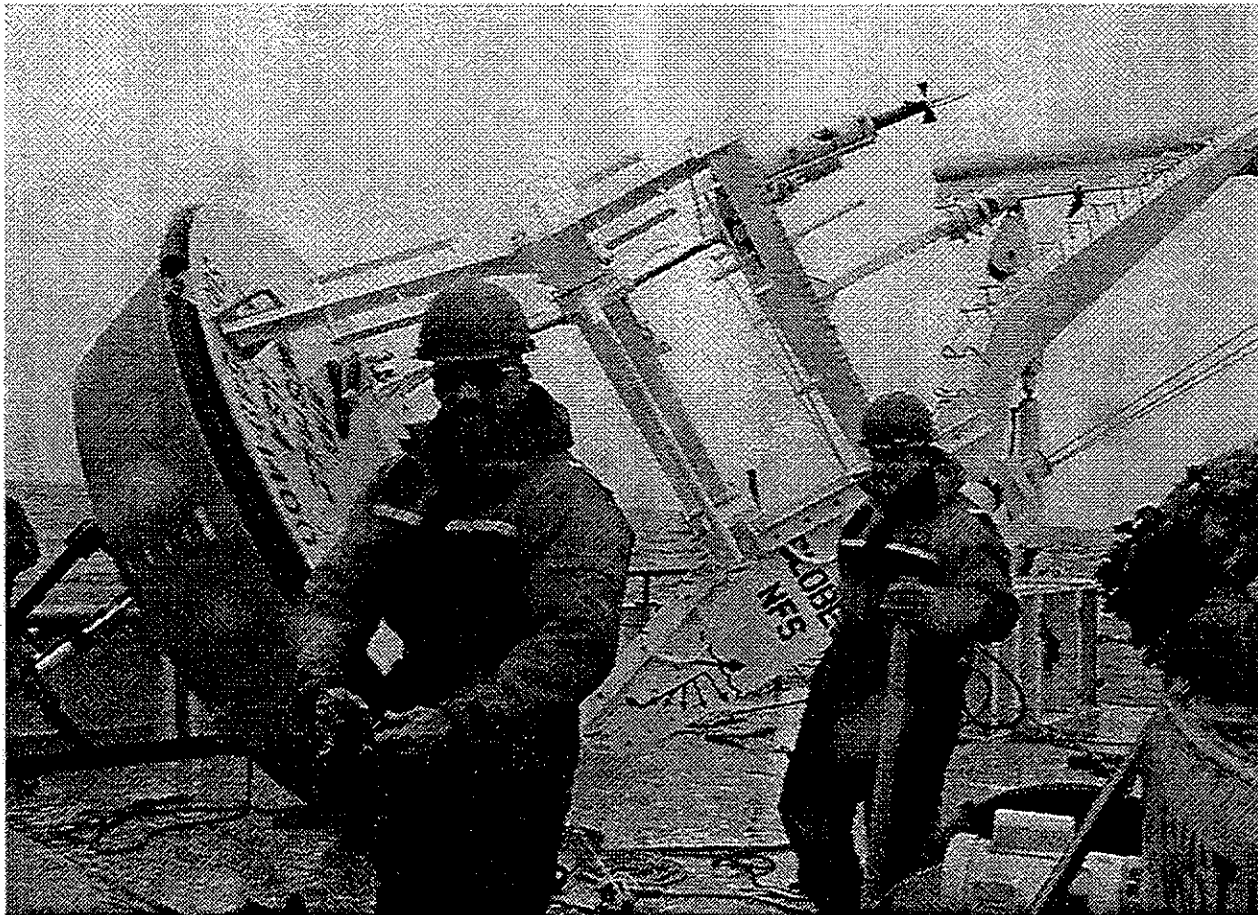
Picture 2. The disc buoy on deck of the R/V OCEANUS prior to deployment. Seamen Horace Medeiros and Pat Pike are setting up for deployment.

As the mooring hardware was in good shape, the buoy occupied the whole of the R/V OCEANUS's working deck space (see Picture 2) preventing further mooring work, and as spare anchors and mooring chain were on board, it was decided to redeploy the mooring at the NFS site first thing in the morning of 11 March 1999. While transiting to the site, the Northern Flank Deep (NFD) buoy was found freely drifting and recovered (see discussion below), probably also a mooring casualty of the storm. The NFS discus mooring with the same sensors and instrument configuration was successfully deployed (at position shown in Figure 1), but without the acoustic release first thing on 11 March 1999. The lack of acoustic release will necessitate a more difficult recovery of the mooring, but should keep the mooring in place for the rest of the deployment. As the recovery is to be in August 1999, the weather should not be a problem.

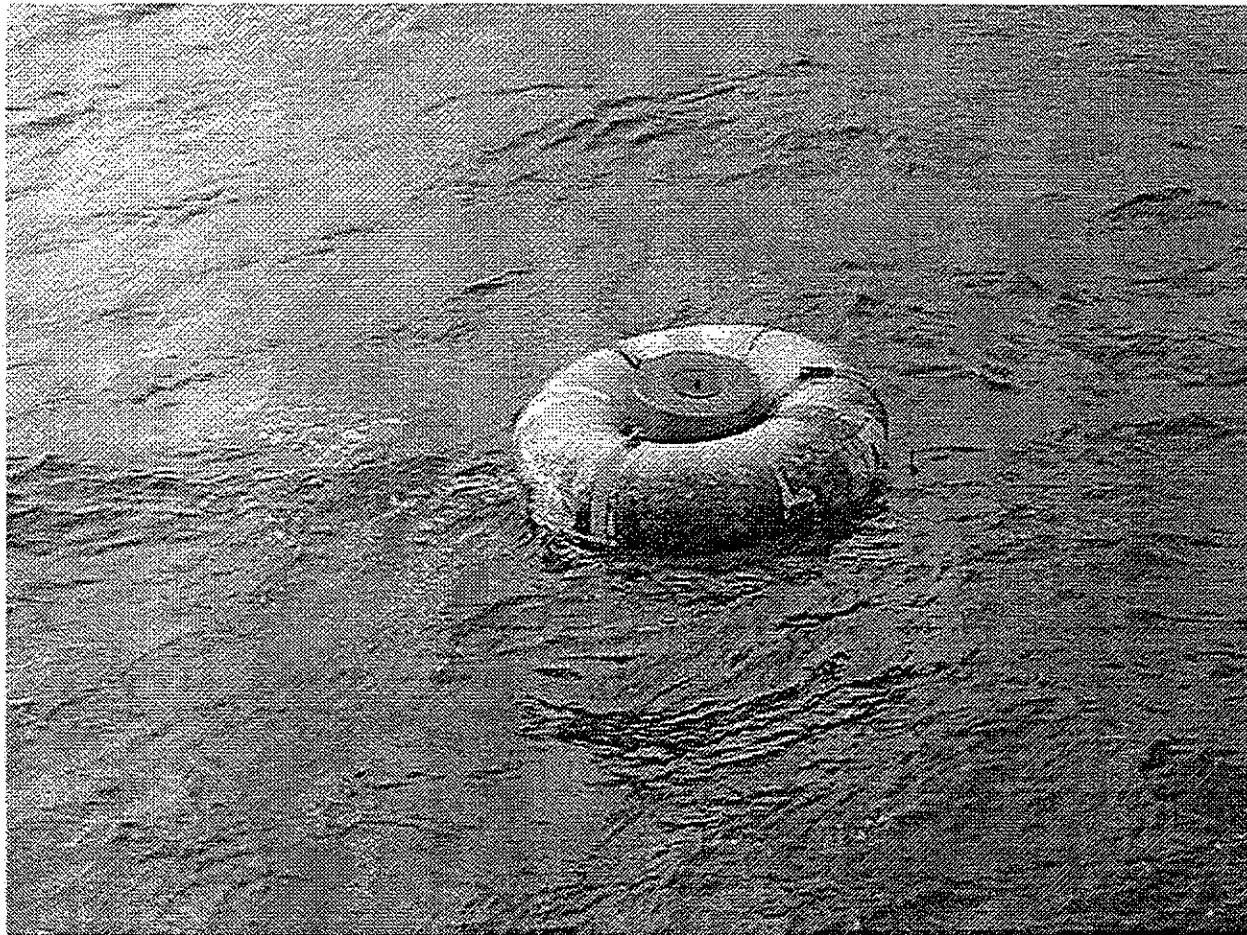
Picture 3. The NSD toroid buoy with center foam plug found floating free of the mooring, upside down on the Northeast Peak of Georges Bank.

Heading for discus NFS deployment site to redeploy
0611 - Recovered NSD toroid buoy drifting upside down,
Anchor bridle torn off
Light and ARGOS still working
1039 - Redeployed discus mooring at NSF site
42° 04.588' N x 66° 42.091' W
heading back to Long-Term Program's Northeast Peak site
1256 - Send release command to NEP science mooring B
Service, clean, dump data, new batteries, restart, etc.
Steaming over to EF mooring to replace
1730 - Recovered EF toroid mooring
release didn't work so we had to pull the whole mooring piece at a time
buoy bridle broke during recovery
decision was made that redeploying this kind of mooring was asking for trouble
call to Limeburner, mooring not to be deployed, so stow pieces for transit
back to NEP site
