WHOI-2005-XX

U.S. GLOBEC Georges Bank Long-Term Moored Program: Part 1 - Mooring Configuration

Technical Report

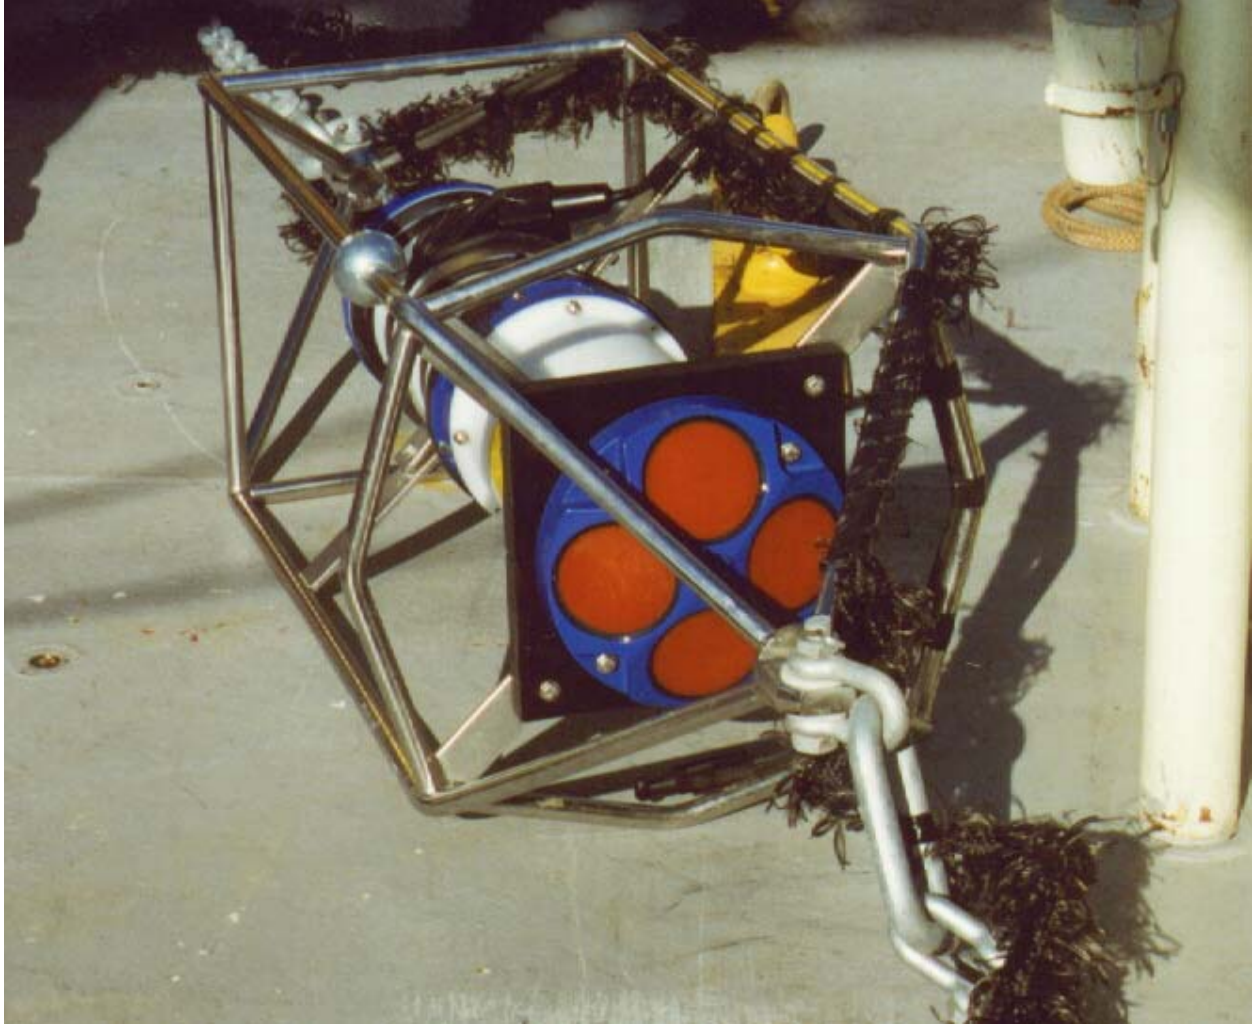
Figure 4. 300-kHz RD Instruments Workhorse ADCP mounted in a downward looking configuration in an in-line frame with auxiliary battery pack. The frame was connected to the buoy with 1 m of chain to decouple the buoy tilting motion from the current observations. The mooring cable (Kevlar strength member with electrical cables and poly anti-strumming hair is the black cable taped to the ADCP frame.

4. Water Velocity Profiles: Water velocity profiles were measured with a 300-kHz RD Instruments Workhorse ADCP (Acoustic Doppler Current Profiler) mounted at the top of the mooring in a downward looking configuration (Fig. 4). The ADCP pinged at as high a rate as possible with the power available in the ADCP with auxiliary battery pack – 900 pings at 4-second intervals so that the expected uncertainty in the velocity measurement was less than 0.5 cm/sec. The 1-hour (or sometimes 0.5 hour) averaged horizontal velocities were measured in 1-m vertical bins from about 8-m depth to about 10 m above bottom. The loss at the top was due to blanking to remove transducer ringing, and the loss at the bottom was due to sidelobe reflection from the direct downward path to the bottom. The amplitude of the backscattered signal was also recorded in the 1-meter bins and used to monitor the time and depth changes in backscattered signal (related to biological scatterers in the water column). The ADCP also “saw” the instrumentation along the mooring line as side-lobe reflection contamination of the records. This was not apparent in short records (1 week), but becomes obvious with 6-month long record averages. The amplitude of the backscattered signal has an increased level and the Doppler velocities decreased at the depths of the sensors. The decreased velocity estimate is because the signal reflected from the stationary sensors has zero Doppler shift and biases the velocity estimate toward zero.

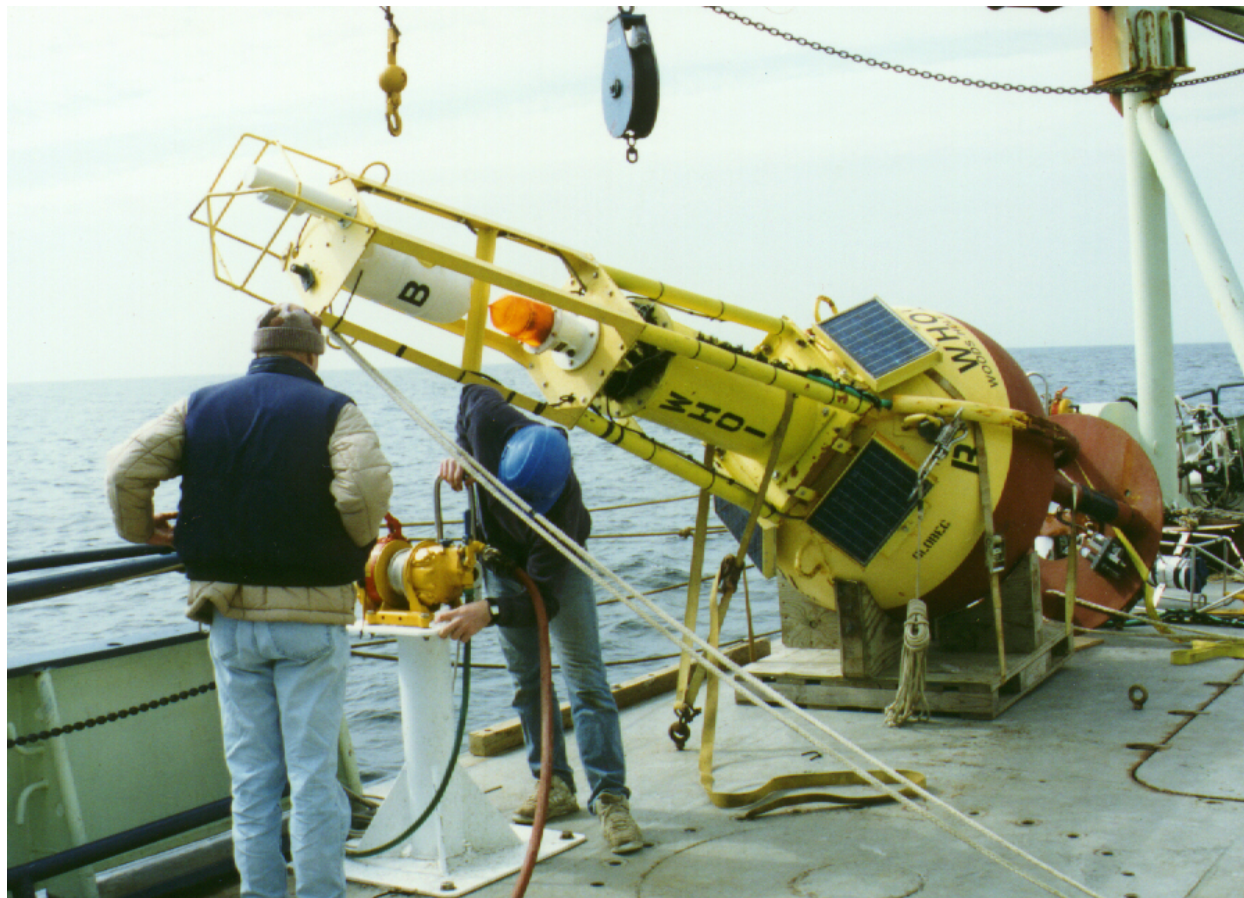
Figure 9 Crest and Northeast Peak buoy on deck of R/V KNORR prior to deployment in April 1997. The PAR sensor can be seen in the buoy tower top, with the Gill radiation shield partially hidden by the GOES/ARGOS antenna. The electronics and batteries are housed in the large cylinder in the base of the tower. Four 10-Watt solar panels provide power for the system. The sensors in the water are identical to the Southern Flank mooring.

The Crest mooring had two basic configurations (Fig. 8 and Table 4). The buoy (Fig. 9) was a reworked steel float as used in the Gulf of Maine (Irish et al., 1987, Irish et al., 1992 and Wood and Irish, 1987). For the first six-month deployment, only surface sensors were put on the buoy because we were unsure of the survivability of the system in the harsh environmental conditions found on the Crest of Georges Bank. A load cell was placed between the buoy and mooring cable to monitor the tension in the mooring (the data system calculated the mean and standard deviation within the hour sample). This was used to evaluate the elastic tether technology (see below and Paul, et al., 1999). The second six-month deployment had a bio-optical package at 10 m depth to monitor surface to 10-m stratification, and to get an estimate of the bio-optical variability. This mooring and its sensors survived for the first year, but was eliminated in favor of the Northeast Peak mooring with GLOBEC reallocation of priorities and resources.

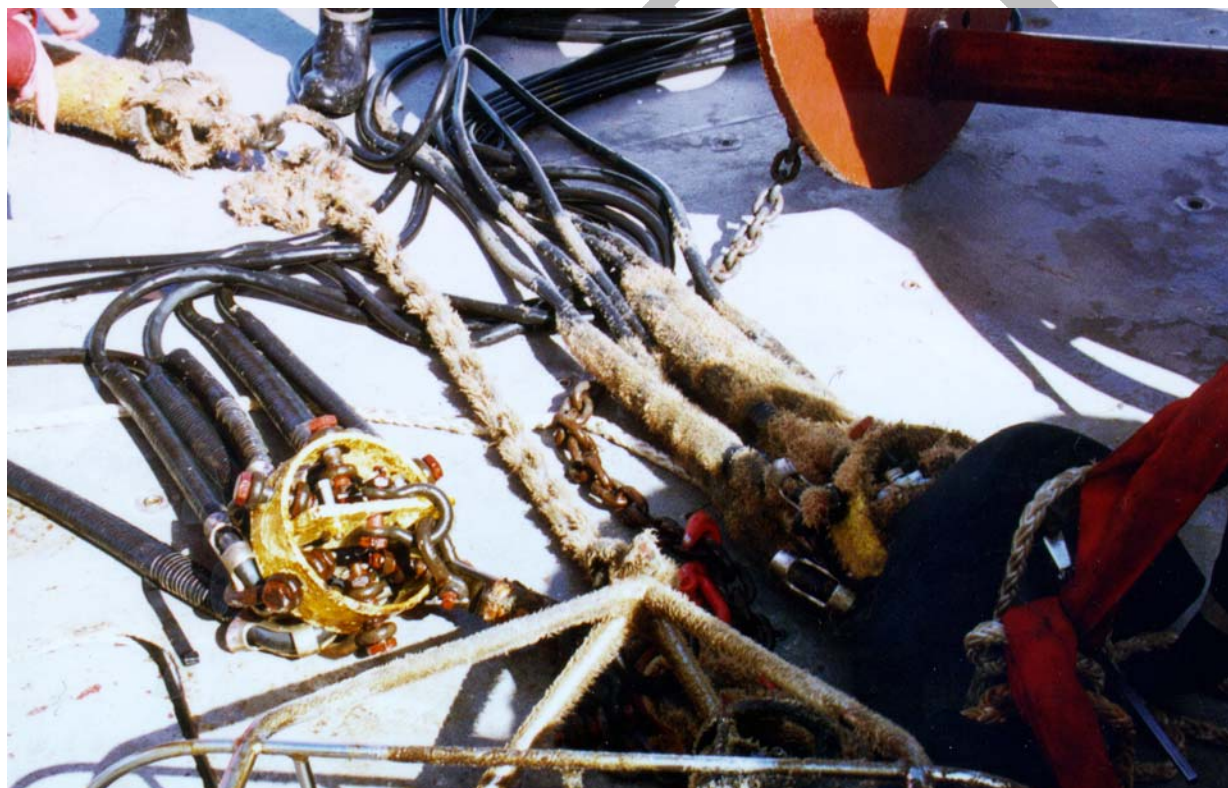
Figure 10. Compliant Elastic Tethers after recovery. The round bridle to which the six 10-m unstretched length elastics are shackled is seen in the left center of the picture. Six 1" diameter tethers are used to give the required stiffness, and the 10-m length provides the compliance to allow the mooring to move with the currents and tides, and still allow the buoy to move up and down with the waves. They provide about 500 lbs downward tension on the buoy.

Each elastic tether element (Fig. 10) must be terminated so there is minimal stress concentration in the rubber material at the splice. The splices were done by Buoy Technology Inc. of Concord, NH who specializes in elastic tethers (Wyman, 1982). Also, the tether must be kept from twisting so a swivel was placed between the tether and electromechanical cable. One tether assembly on the Northeast Peak mooring broke because a bad swivel was used, and the tether

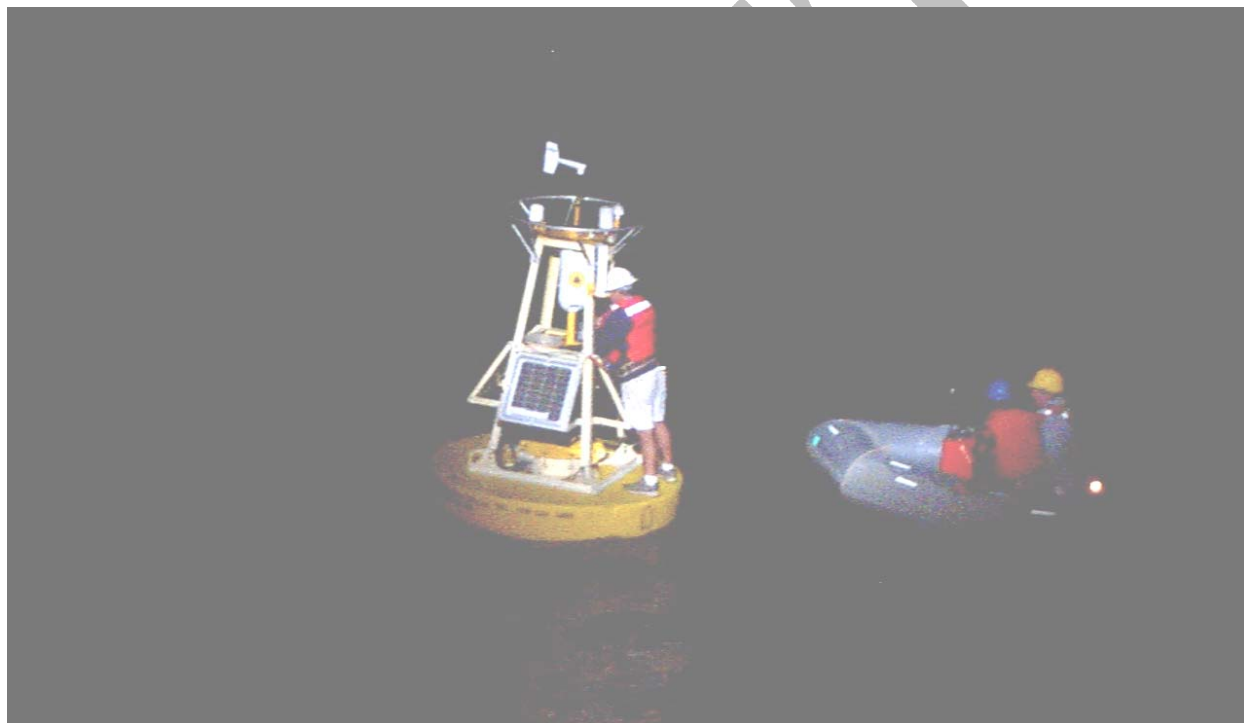
Figure 11. Scott Worrilow stands on the Southern Flank buoy one night in July 1999 in calm seas to repair the guard light. The buoy is stable because of the elastic tether constant downward force.

The stability of the buoy with compliant elastic mooring was demonstrated (Fig. 11) when the light on a newly deployed buoy did not operate and the weather was calm enough (July 1999) to allow *in-situ* servicing. Scott Worrilow was able to stand on the buoy without it tipping significantly and easily replace the light.

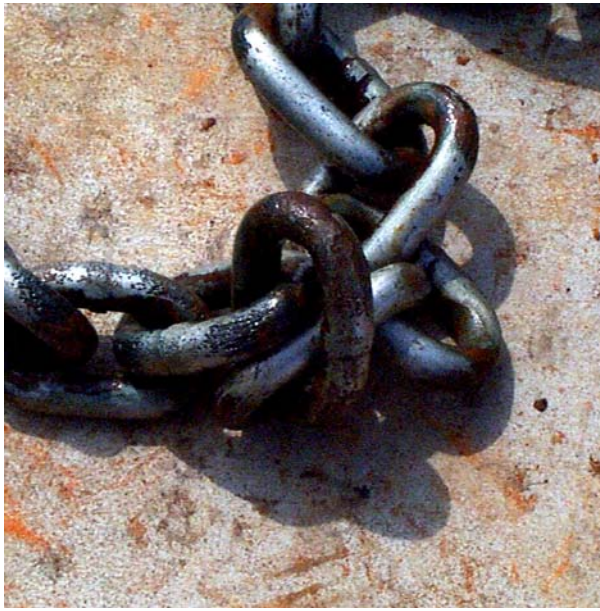
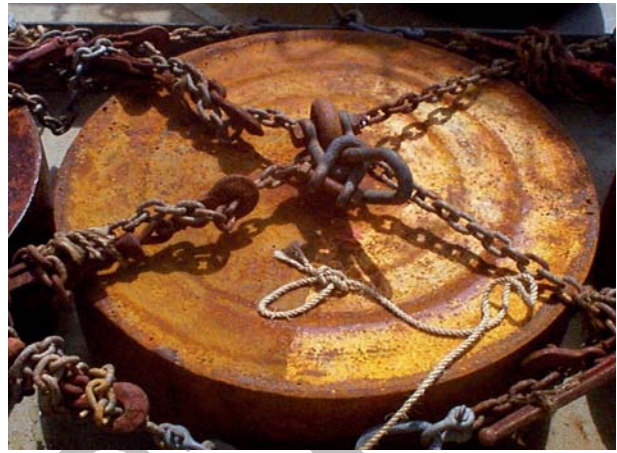
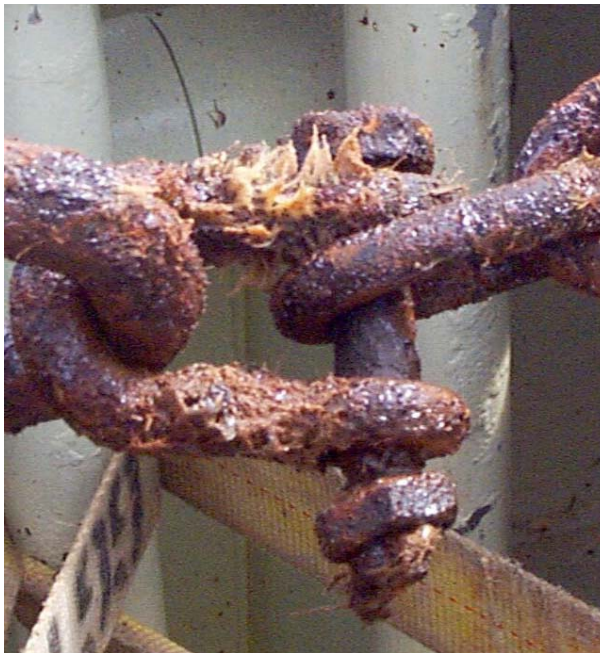
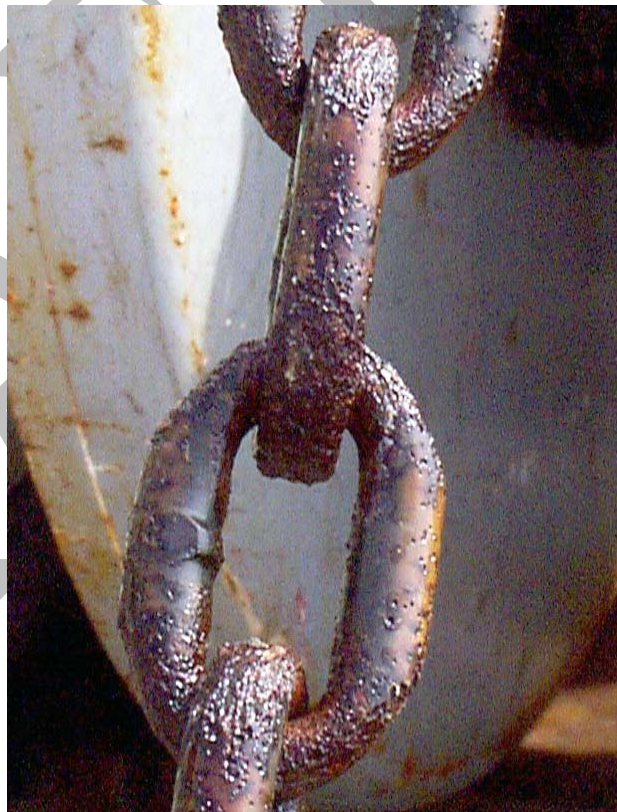
Figure 13. Guard buoy mooring chain. The $\frac{3}{4}$ " chain (upper left) was shiny when recovered. The wear between links is minimal. A recovered anchor (upper right) shows wear due to the motion of the buoy around the anchor. The shackle between the $\frac{3}{4}$ " and $\frac{1}{2}$ " chain (lower left), shows wear on the threads and the nut was only held on by the cotter pin. Finally, the $\frac{1}{2}$ " chain in the water column (lower right) showed pitting and corrosion on the outside of the links, losing up to $\frac{1}{2}$ the material (and strength).

Unlike the elastic tether moorings, the chain catenary mooring hardware showed significant wear during the 11-month deployments. When newly recovered, the $\frac{3}{4}$ " chain was shiny where it was moved about the anchor by the elliptical tidal currents on Georges Bank that

effectively removed any galvanizing and corrosion products. The wear in the top of a retrieved anchor (Fig. 13 top right) showed this continual motion of the buoy and chain around the anchor. The shackles that caused the marks on the anchor, showed little wear, so this was not a significant factor in mooring life. The wear between links (Fig. 13 upper left) is minimal and not a significant problem. However, the pitting on the outside of the chain was the major source of wear and loss of strength in the chain. The chain in the figure was not the most corroded, but about normal or less than normal after 11 months on Georges Bank. Even more surprising was the loss of material on the ½” chain in the water column that had no abrasive effects of the bottom. The chain appears to be pitted, particularly at the highly stressed corners where the material was bent to form the links, showing significant corrosion and loss of material (Fig. 13 bottom right). This corrosion was the main loss of strength in the guard mooring chain, not wear and tear in the movement of the mooring with the waves.

The most significant problem with the chain moorings was observed (Fig. 13 lower left) at the shackle where the ¾” chain joined the ½” chain. This was comfortably off the bottom and out of the abrasion of the sand. However, the bolt in the chain shackle was not threaded all the way to the end past the cotter pin hole. The corrosion and movement of the nut wore the threads off the bolt, so that they no longer held the nut in place. In this case (the most extreme example during GLOBEC) the nut is only held on by the cotter pin, and it was possible to remove the nut by hand, meaning that the cotter pin would be the only thing holding the mooring together. The movement of the bolt with the loose nut, wore the holes in the shackles to the point that it would

soon be possible to pass the cotter pin through the shackle, and allow the chain to separate. This was never observed to happen on shackle bolts with the threads extending all the way to the end.
