Cruise Report

**R/V ENDEAVOR Cruise 274
to Georges Bank**

29 September - 5 October 1995

GLOBEC R/V ENDEAVOR CRUISE EN-274

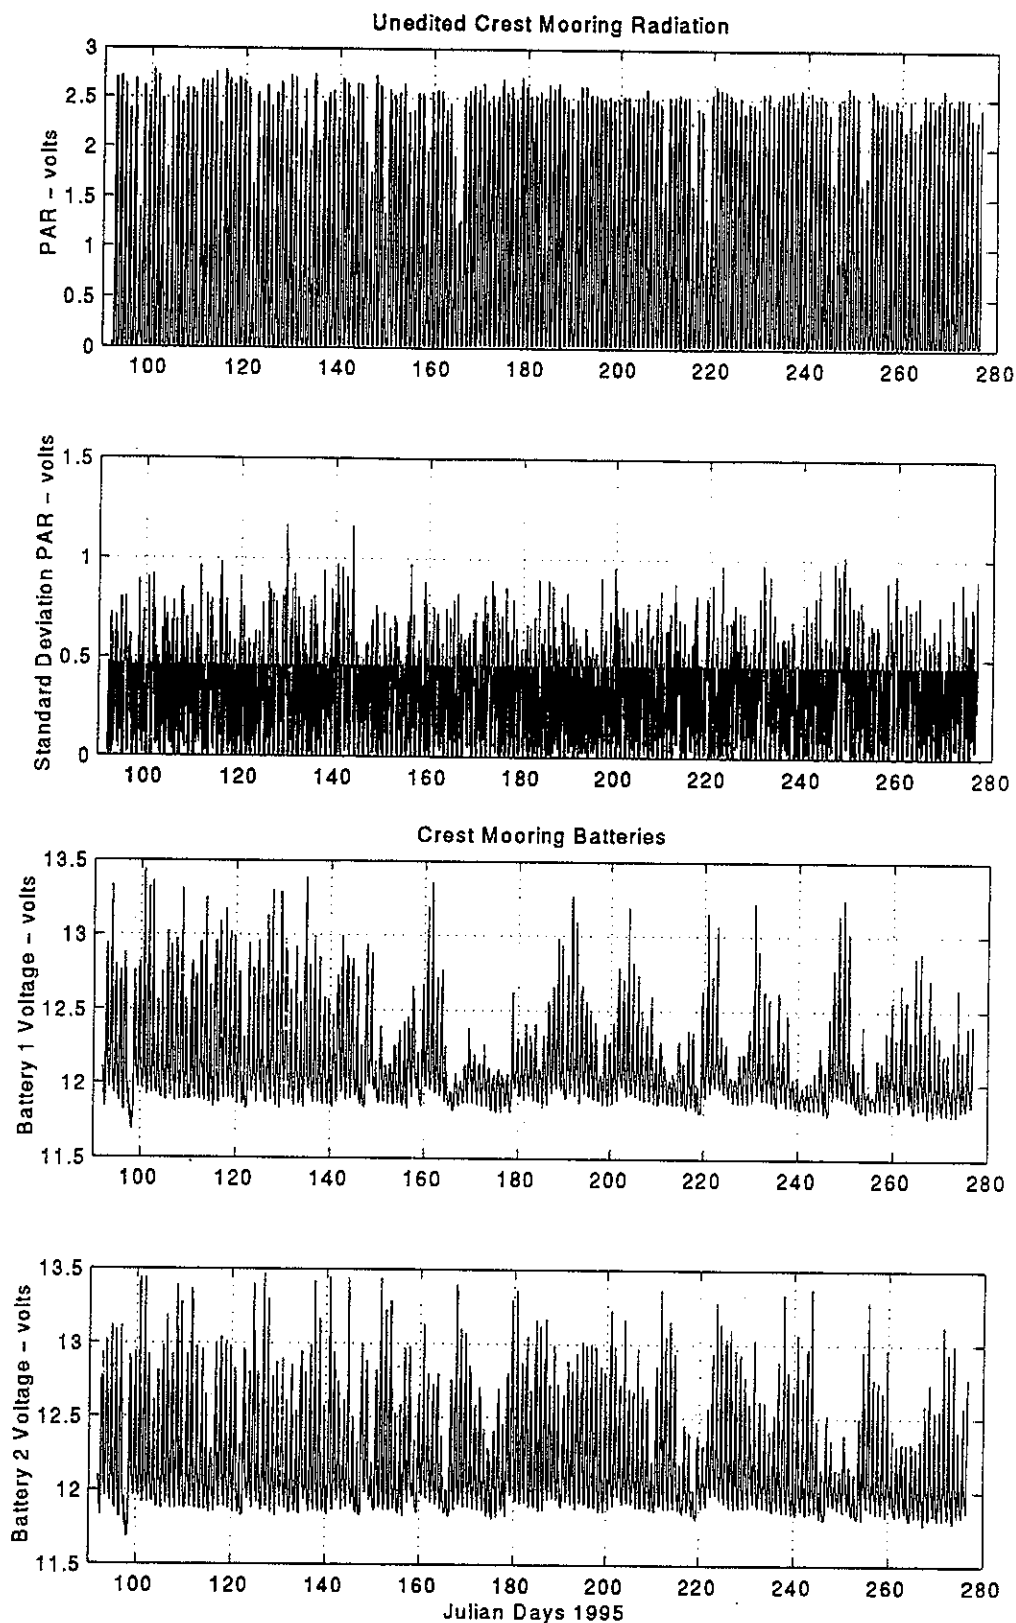
The PAR sensor on the surface buoy shows more variability, but the low radiation about JD165 is clearly seen in both PAR and solar panel/battery records. The fluorometer record abruptly stops around JD210 because of cabling problems. The transmissometer shows a steadily deteriorating record from about JD140 due to biofouling and is unusable after about JD210.

Figure 3. Crest mooring radiation. The PAR average, and standard deviation over the hourly samples are shown on the top two panels, and the output of the solar panels to the two batteries shown in the bottom two panels.

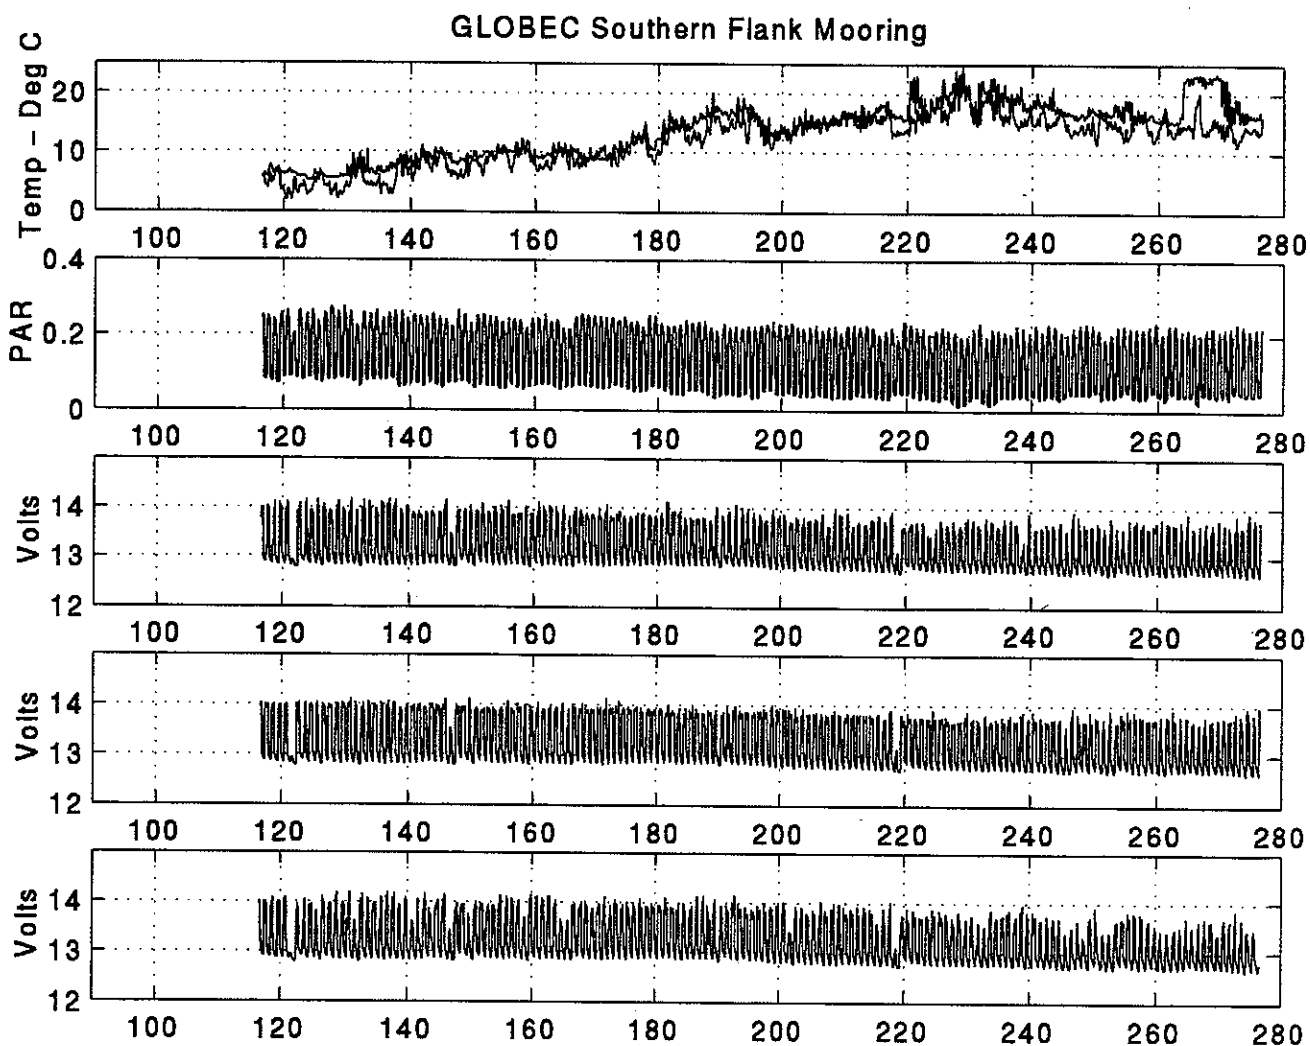
Although the data from the scientific mooring was successfully returned via ARGOS and GOES for the full duration of the deployment, the data was dumped from the internal PCMCIA recorder and processed for analysis. (This data has no telemetry errors, and so is easier to process.) Figure 5 shows the air temperature, sea surface temperature, PAR and battery voltages. Again, the solar panel-battery voltages show a relationship with PAR. The temperatures from 5 m through 50 m (Figure 6) show large fluctuations associated with tidal advection of horizontal gradients past the sensor at tidal periods, plus large longer term temperature changes associated with different water masses, in particular the warm core rings and movement of the shelf slope front. The event seen around Julian day 30 is seen mostly in the bottom of the water column. The events around Julian day 220 are seen in the upper part of the water column. The final event around Julian day 270 is seen at all depths. This same pattern is seen in the salinities (Figure 7). However, note that the broad temperature event around Julian day 190 is barely seen in the salinity record.

Figure 5. Southern Flank buoy observations. Air temperature and sea surface temperature are shown in the top panel. Air temperature appears colder than the sea surface temperature. The PAR record and solar panel and three battery voltages are shown below as for the Crest buoy.

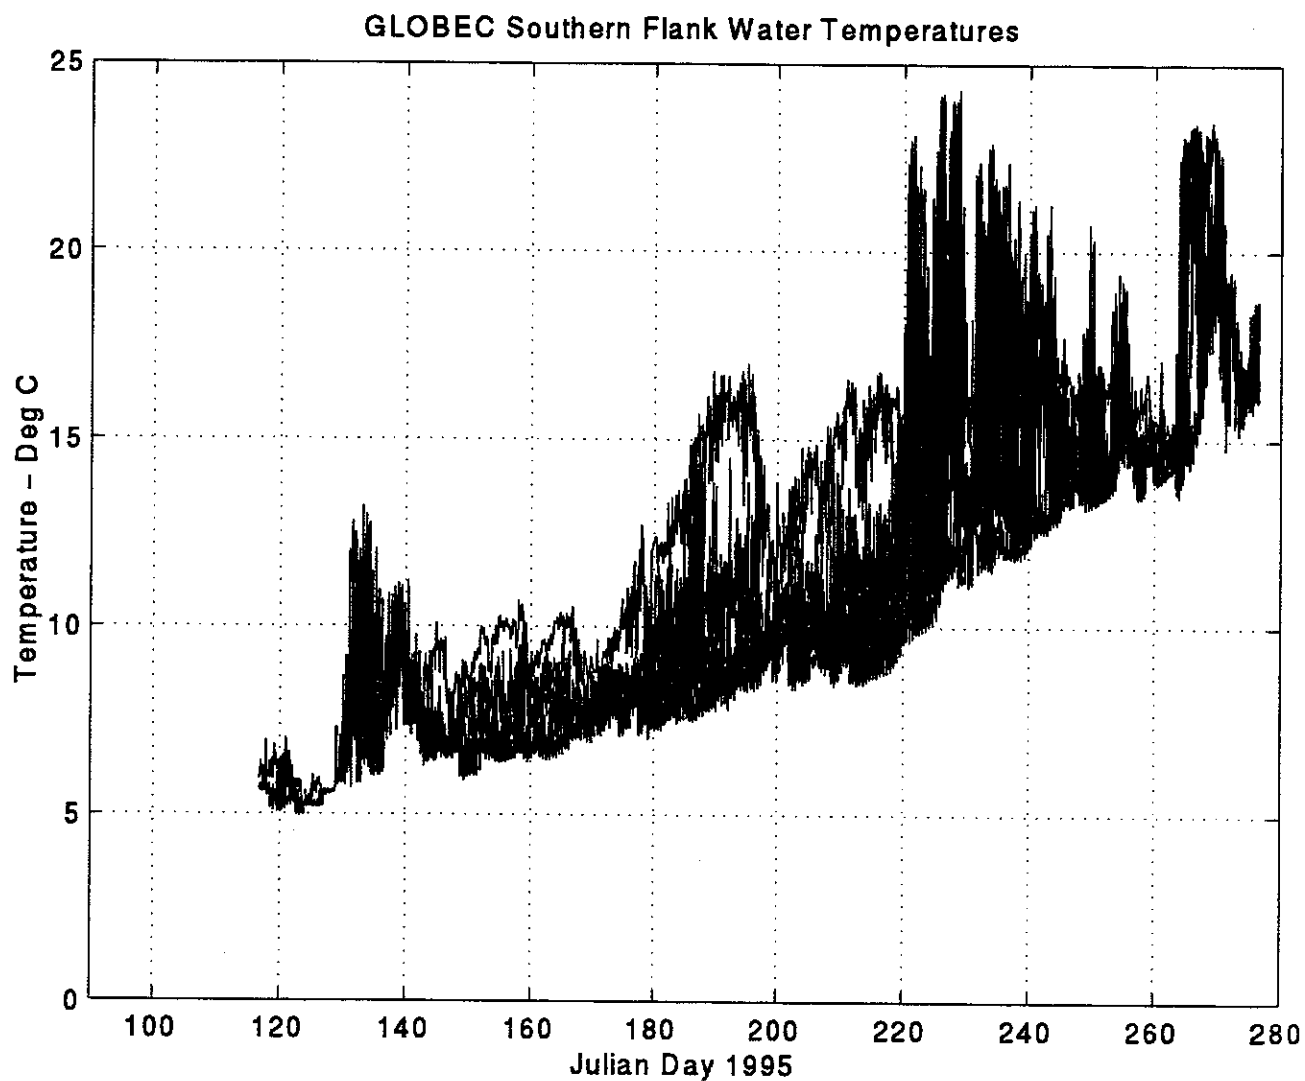
Figure 6. Southern Flank mooring water temperatures. The temperatures from 5 through 50 meters depth are plotted on one another. The general seasonal trends in temperature are nearly masked by the large changes due to tidal advection of horizontal structure, and the advection of different warmer water masses past the mooring.

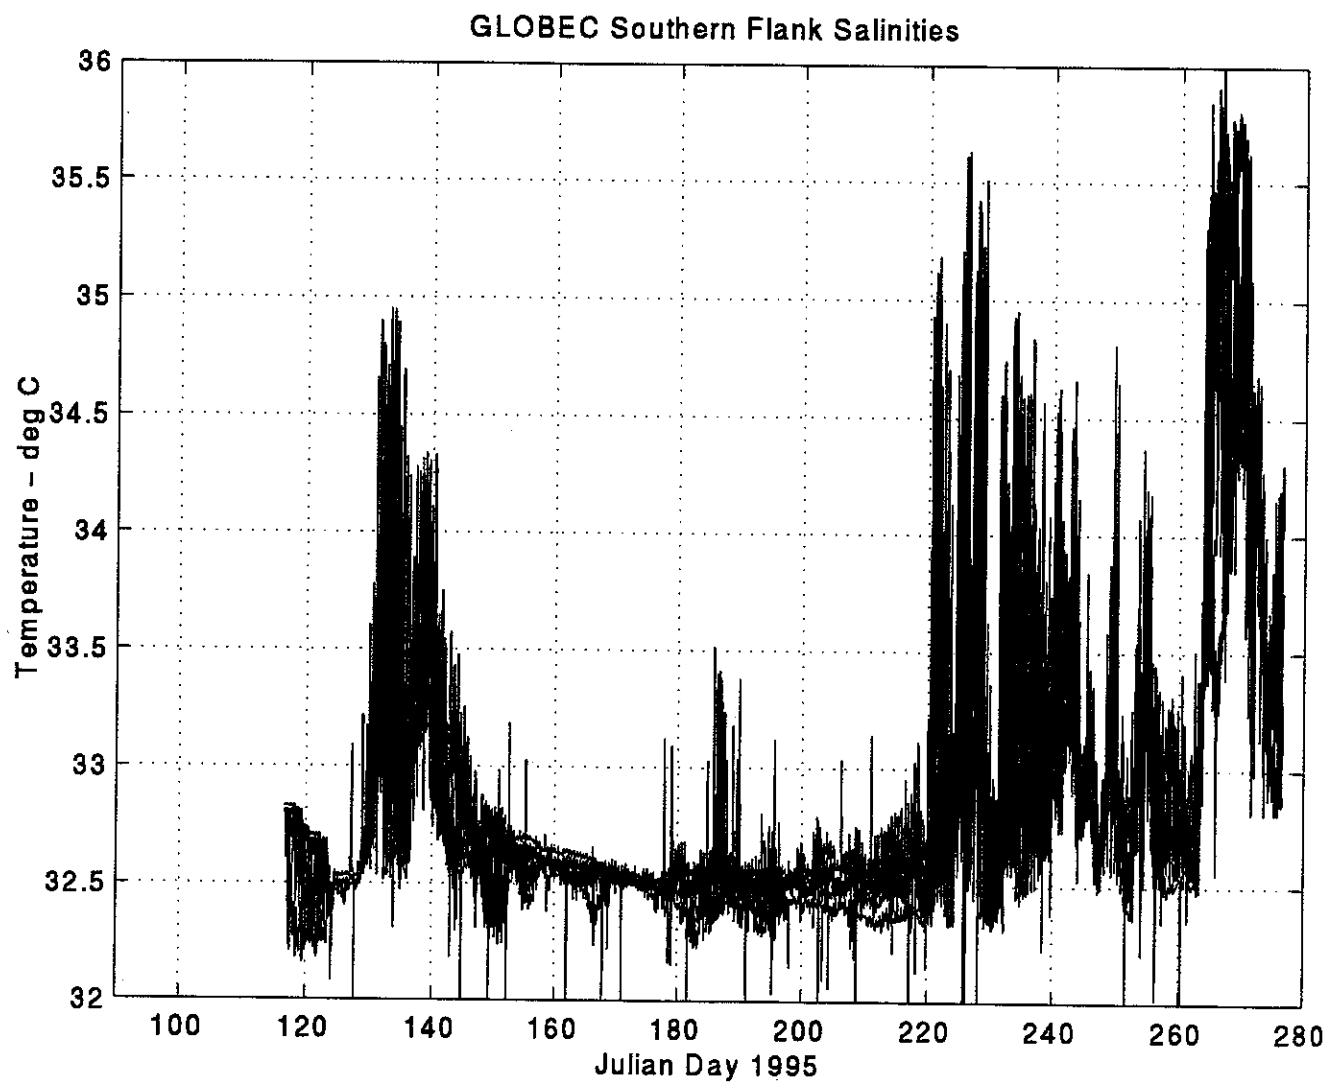
Figure 7. Southern Flank mooring salinities. The salinities from 5 through 50 meters depth are plotted on one another. The general seasonal trends in salinity are nearly masked by the large changes due to tidal advection of horizontal structure, and the advection of different saltier water masses past the mooring.

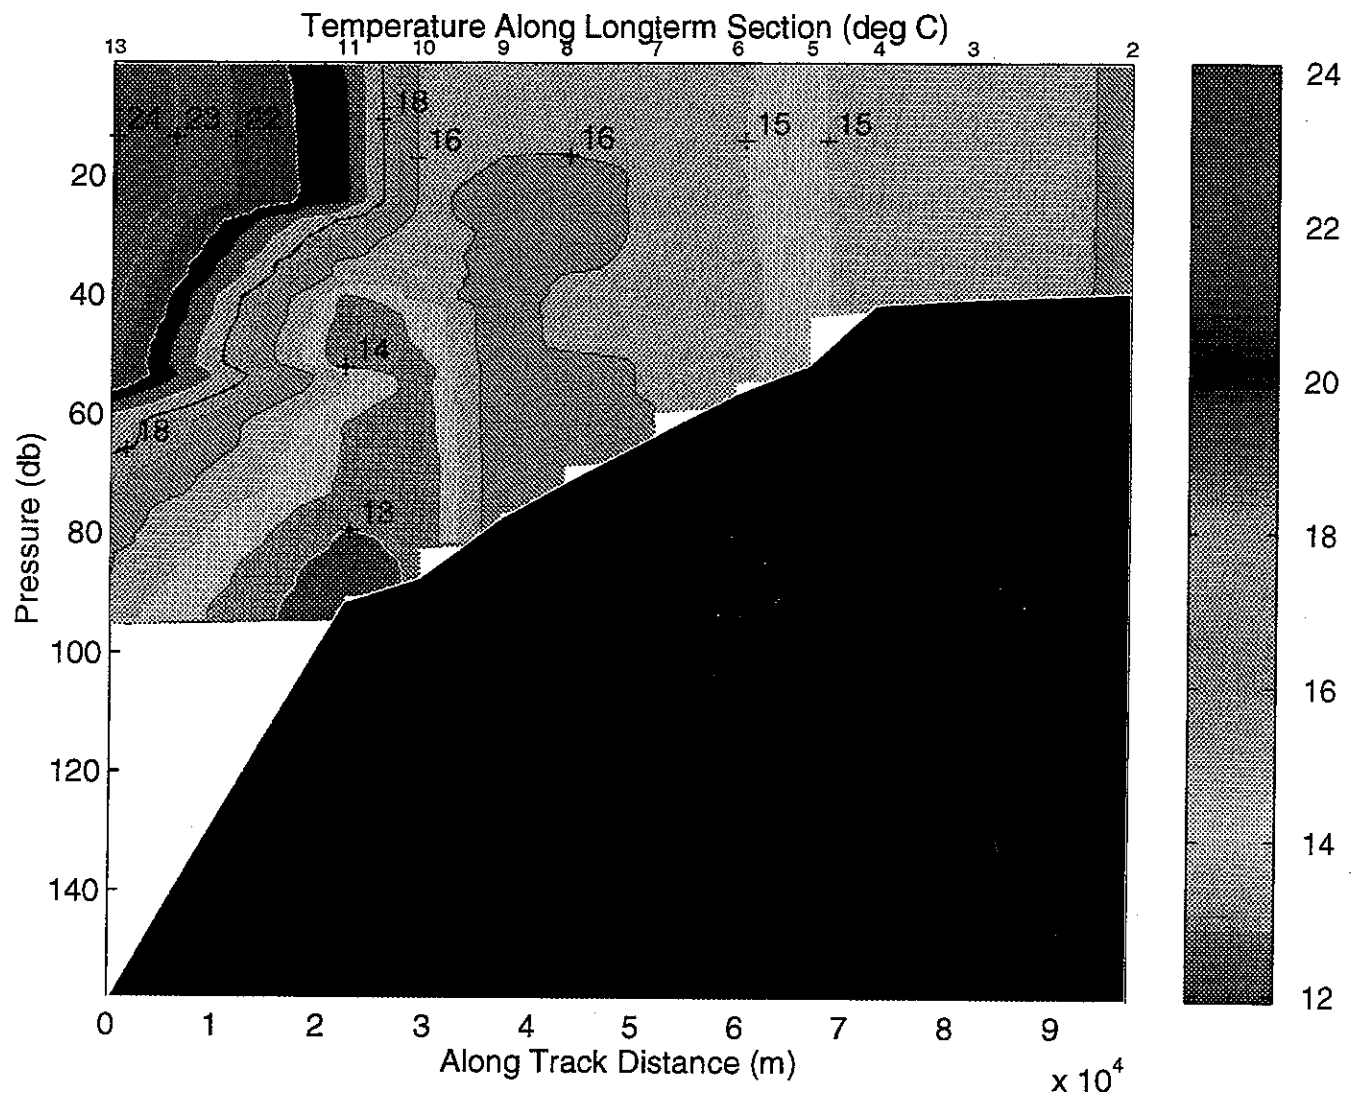
A temperature section is shown in Figure 12, and the corresponding salinity and density sections are shown in Figures 13 and 14 respectively. The temperature and salinity were well mixed vertically at stations shallower than 60 meters. There was a tendency of the temperature to cool off going off the crest and reaching a minimum at water depths about 60 meters. The surface waters warmed up going off the bank, while the bottom waters had a minimum in temperature at about 90 meters (the shelf break). Salinity remained fairly constant coming off the crest until about 80 meters depth where there was a deep water relative maximum, then minimum associated with the cold water at 90 meters. Then both the salinity and temperature increased as the shelf slope front was reached. Obviously the fall cooling has had a major effect on the region and it is well underway toward winter conditions, although there is still some stratification remaining at the Southern Flank station. The T-S relationship from the section (Figure 15) is interesting in that the offshore station is definitely in different water, but the sections across the bank also show different T-S relationships indicating a variety of waters present from various sources, indicative of the complexity of the region during the fall cooling period.

Figure 12. Long-Term Temperature Section from the shelf slope front up onto the crest through the two moorings.

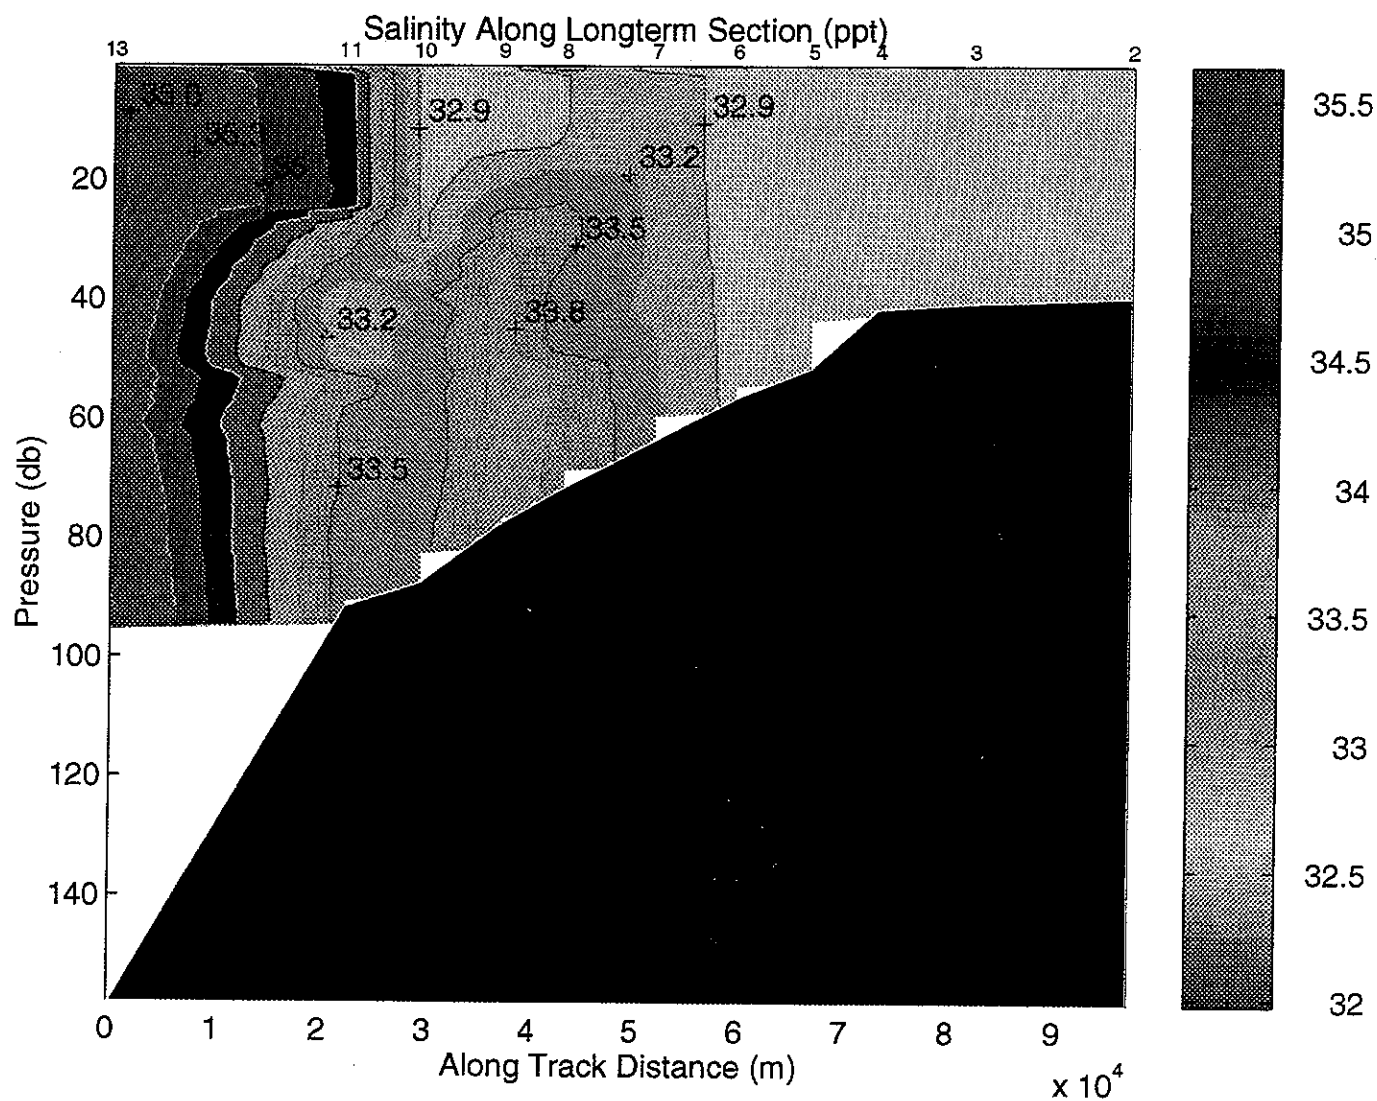
Figure 13. Long-Term Salinity Section from the shelf slope front up onto the crest through the two moorings.

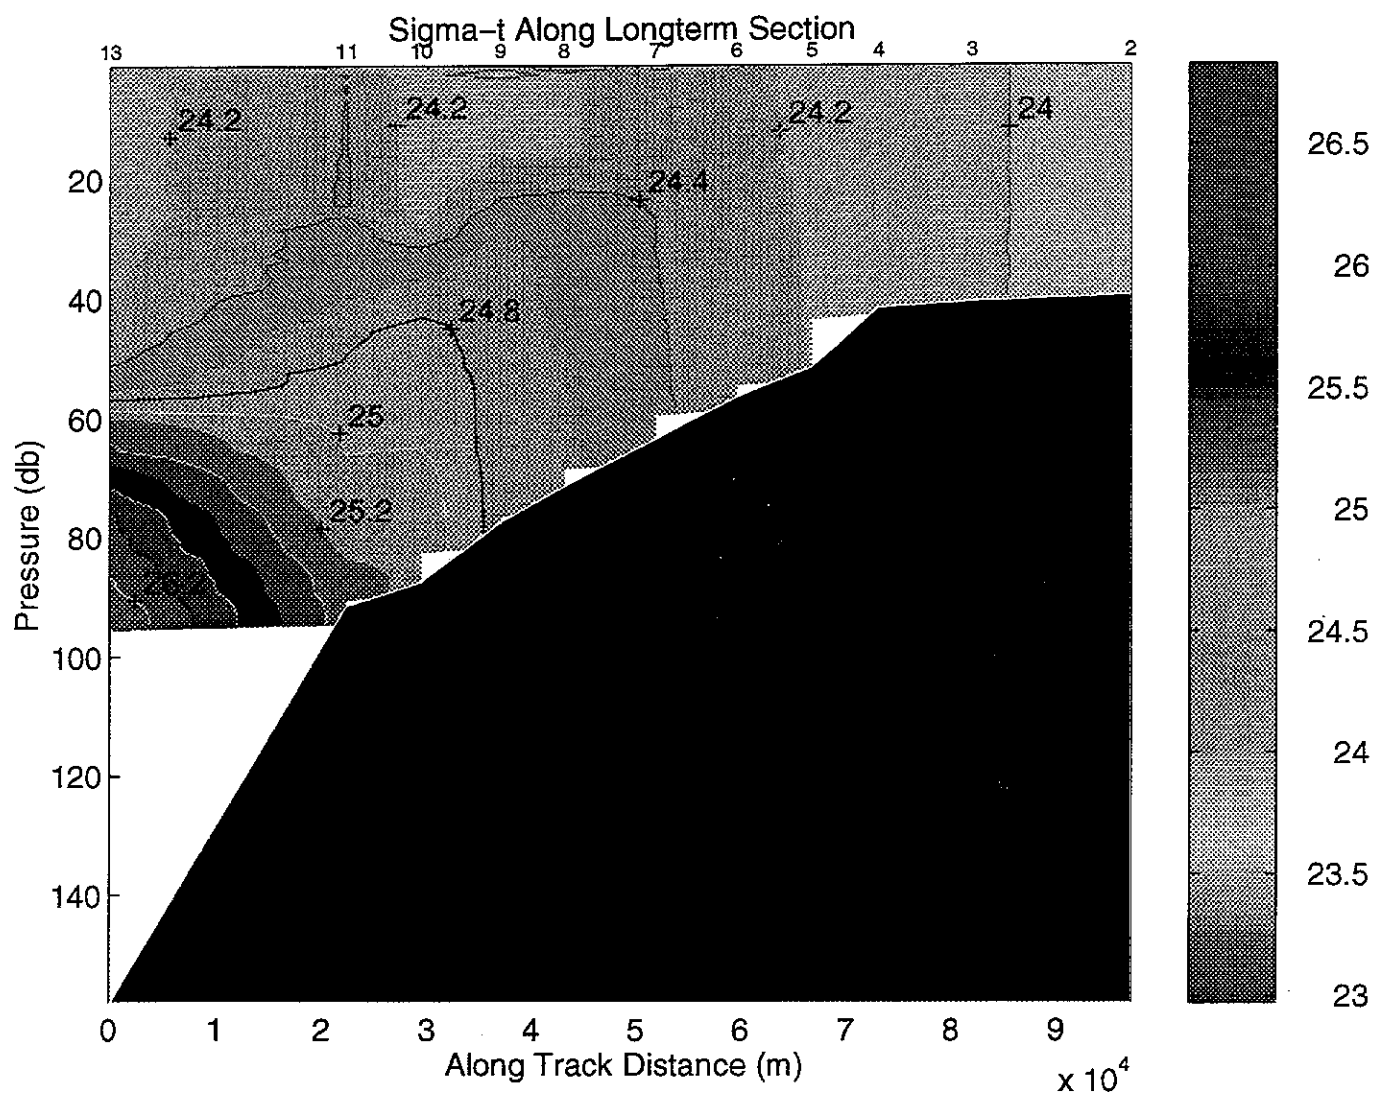
Figure 14. Long-Term Density (Sigma-t) Section from the shelf slope front up onto the crest through the two moorings.

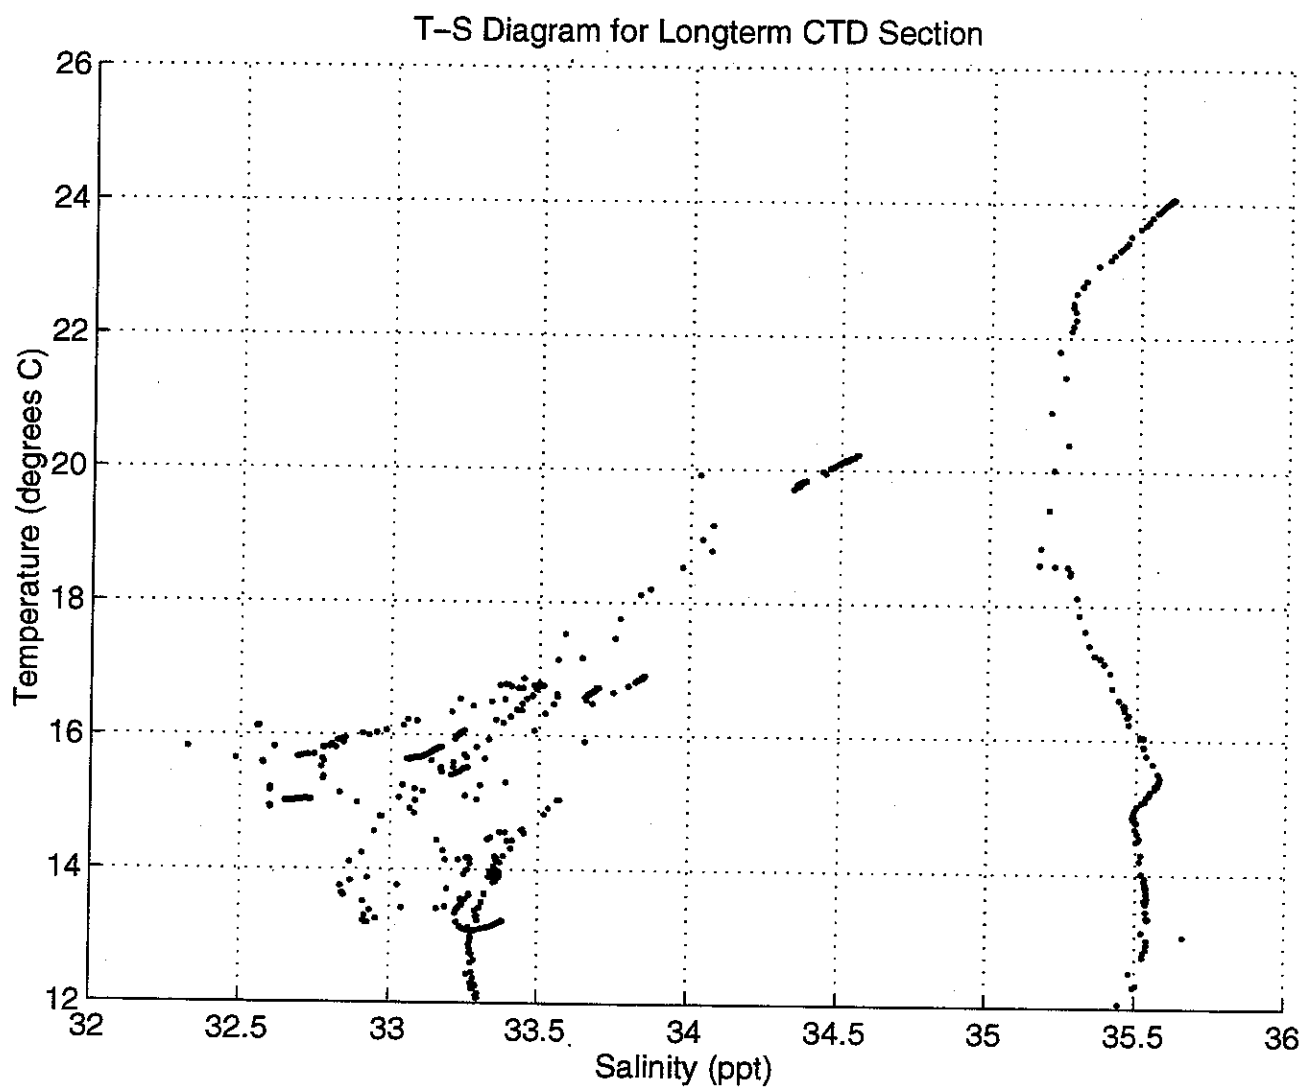
Figure 15. Long-Term Temperature - Salinity relationship from the section from the shelf slope front up onto the crest as shown in Figures 12 and 13.

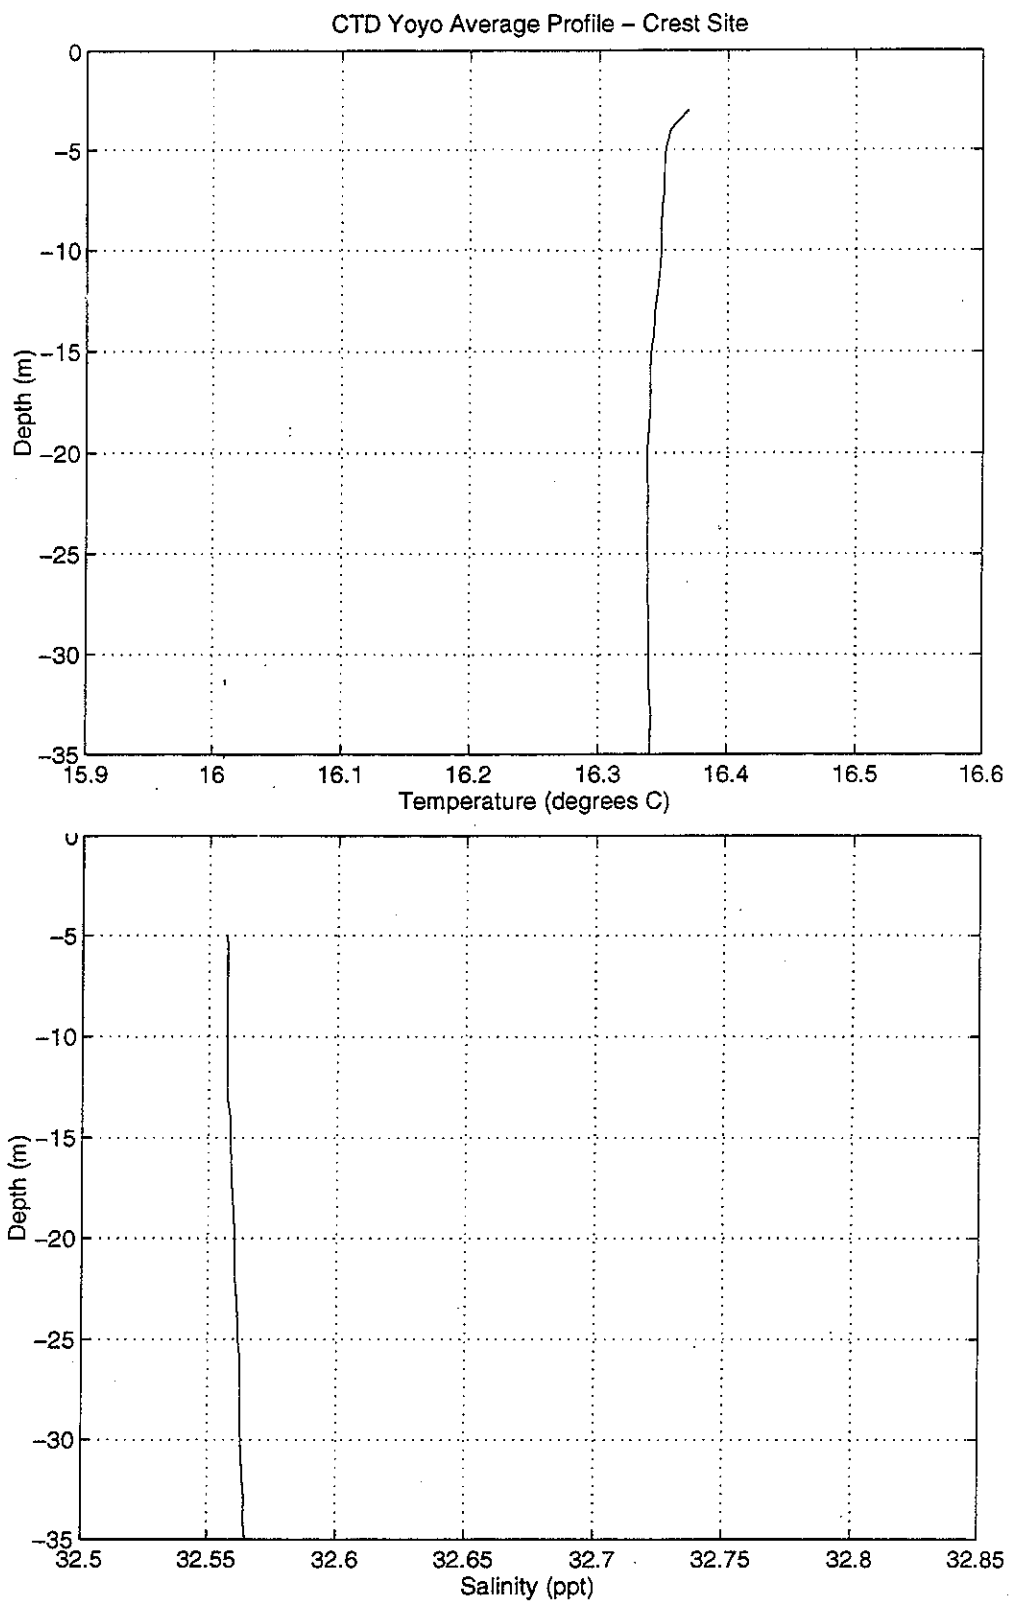
For an end-of-deployment calibration, a 1 hour series of yo-yo CTD profiles were made by the moorings. The Crest mooring average (Figure 16) shows that the temperature and salinity are fairly well mixed (temperature to within 0.02°C and salinity to within 0.01 PSU), as is normally observed at this site. The Southern Flank yo-yo average (Figure 17) does show some stratification remaining, but not nearly as large as observed earlier in the year.

Figure 16. Average Crest temperature and salinity profiles from an hour yo-yo series beside the Crest mooring.

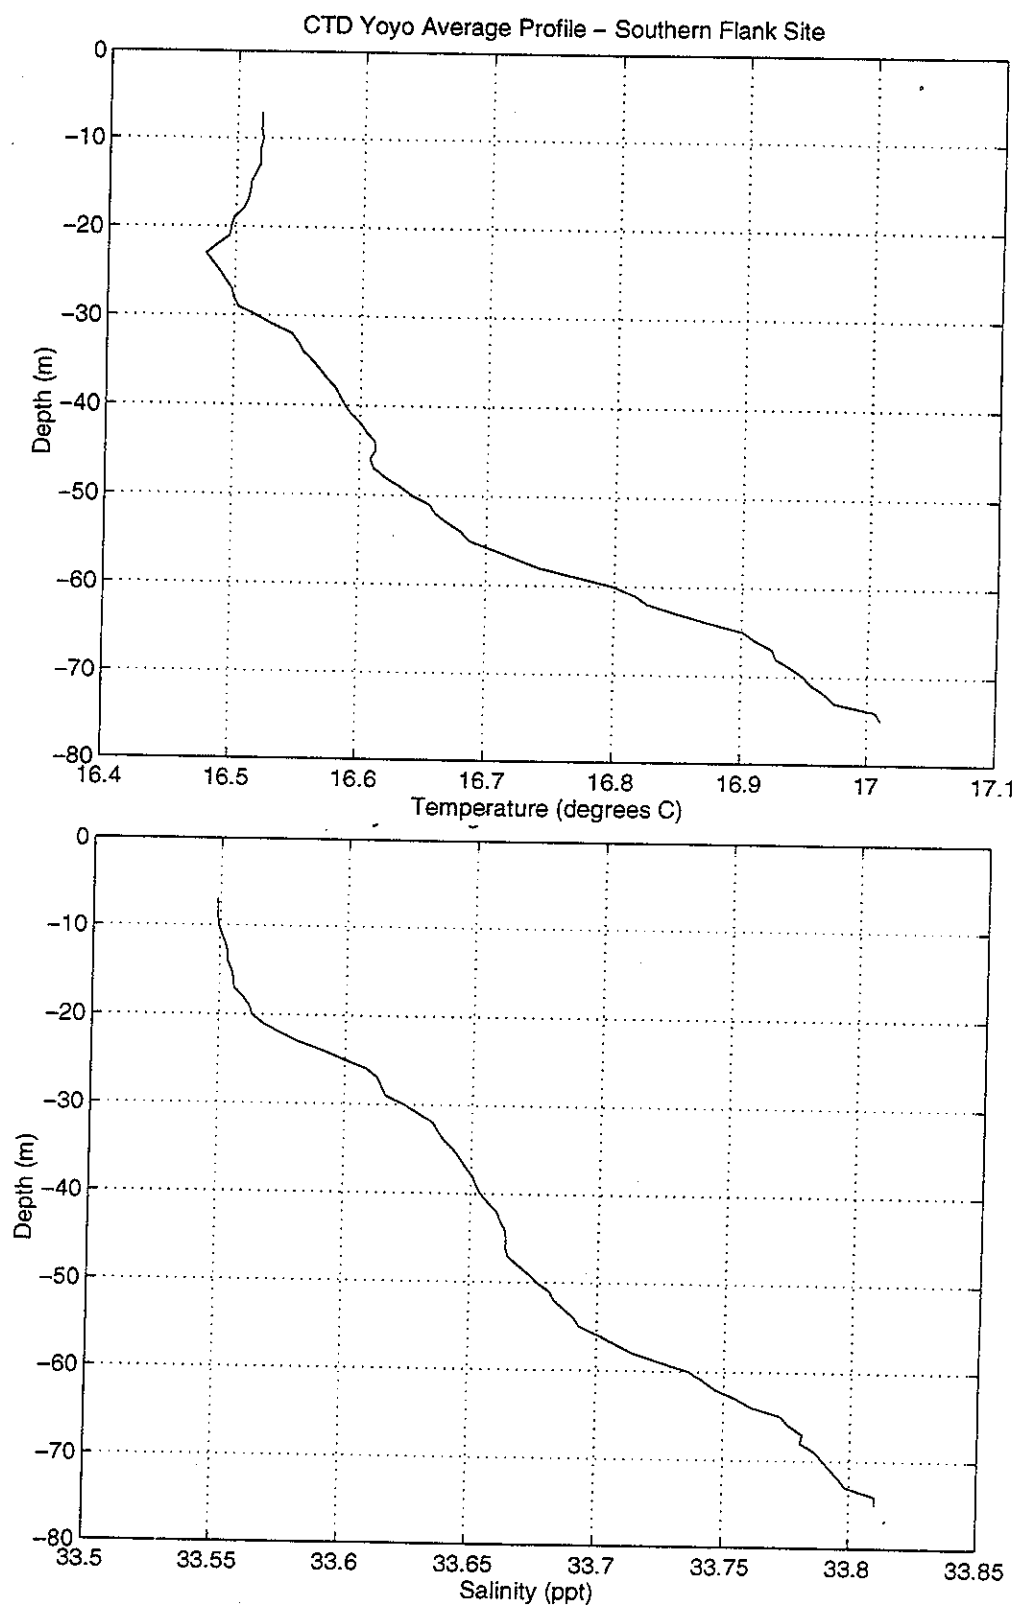
Figure 17. Average Southern Flank Temperature and Salinity profiles from an hour yo-yo beside the Southern Flank mooring
