Cruise Report

**R/V SEWARD JOHNSON Cruise SJ95-04
to Georges Bank**

27 March - 4 April 1995

GLOBEC R/V SEWARD JOHNSON Cruise SJ95-04

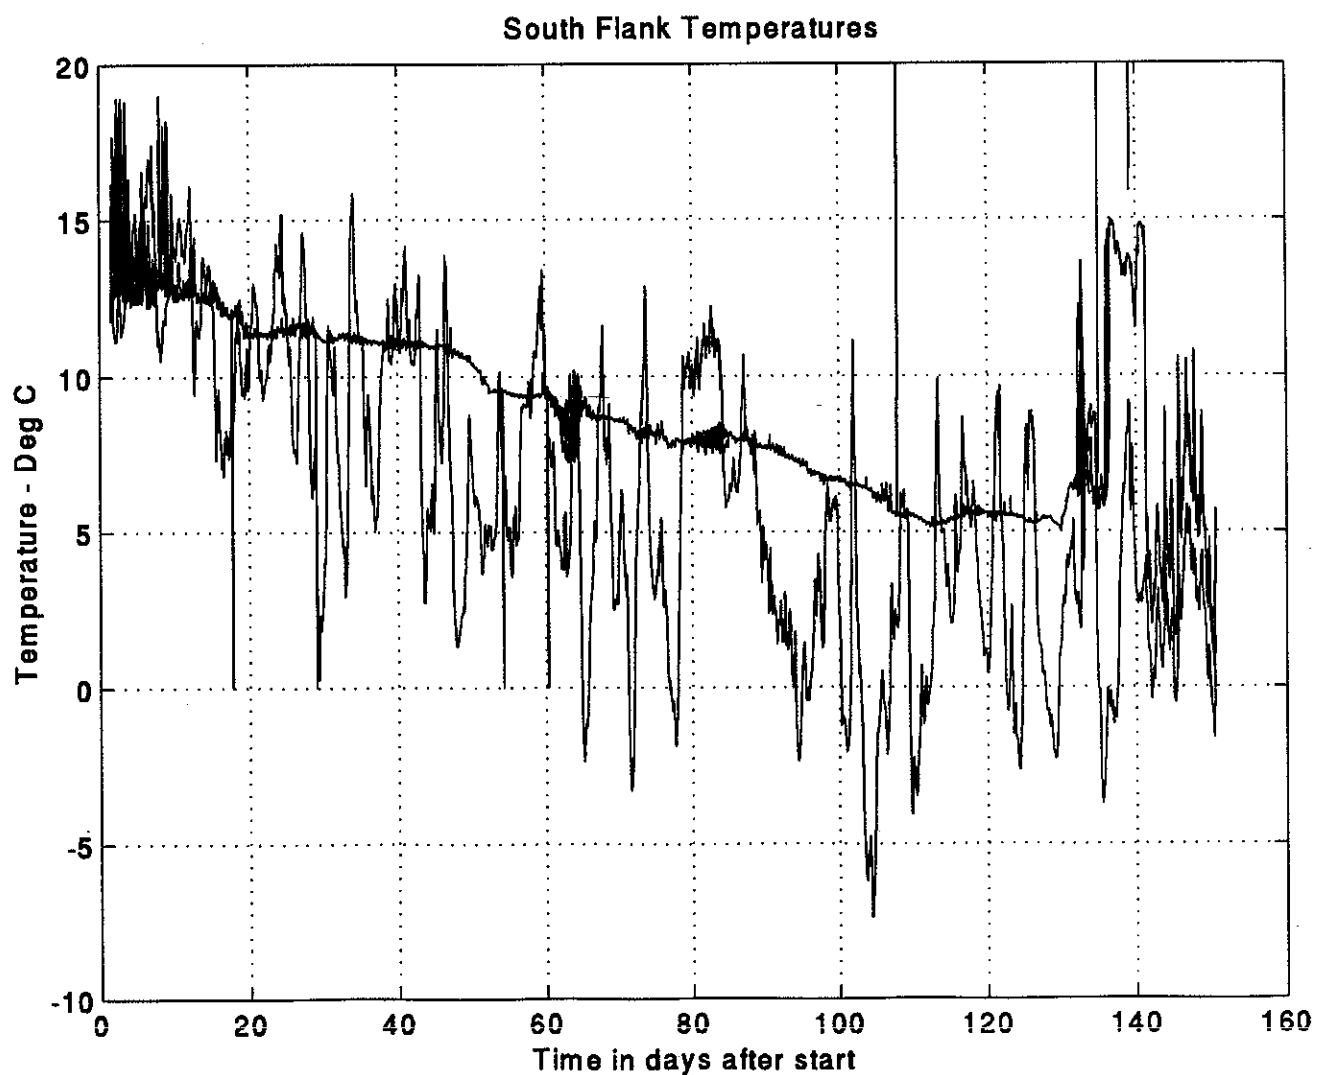
Figure 2. South Flank Moored Temperature. The large fluctuations are from the air temperature sensor 3 meters above the water. Water temperature at 1, 5, 15, 20, 25, 30, 35, 45, and 50 meters are plotted on top of each other to show the isothermal nature of the water column. Exceptions are the warm core ring effects during the first 10 days and around day 132, and the intrusion seen on day 65 in both temperature and salinity (Figure 3).

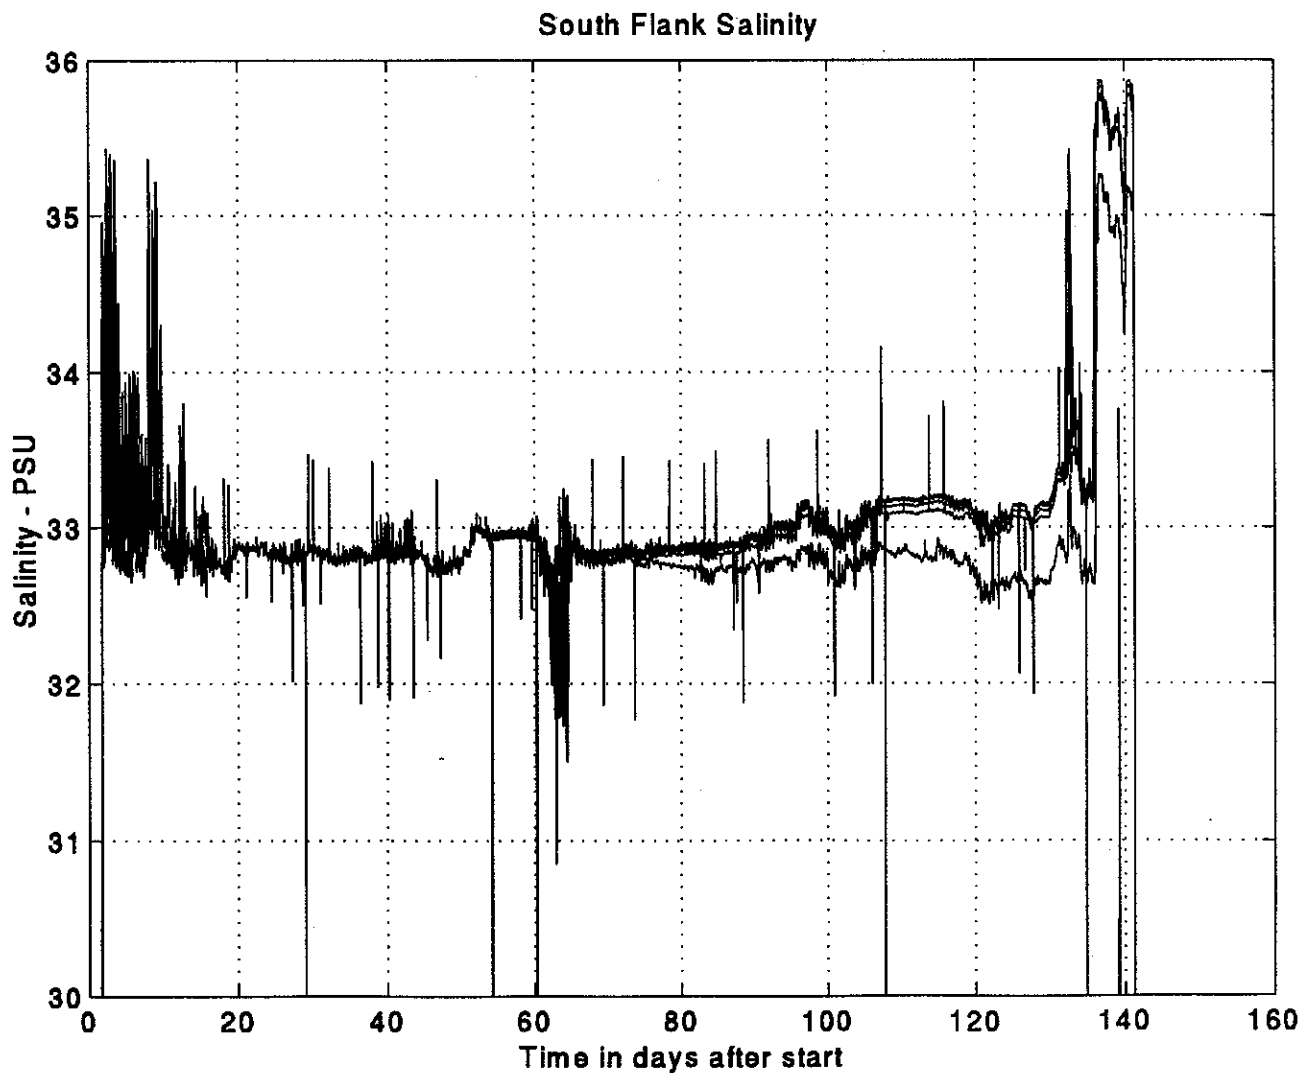
Figure 3. South Flank Moored Salinity. Salinities from 5, 15, 20, 25, 30, 35, 45, and 50 meters are plotted on top of one each other. The drift seen in the salinity records toward the end is probably due to biofouling, and these effects will have to be removed by comparisons with CTD profiles taken on the Broad Scale Survey Cruises.

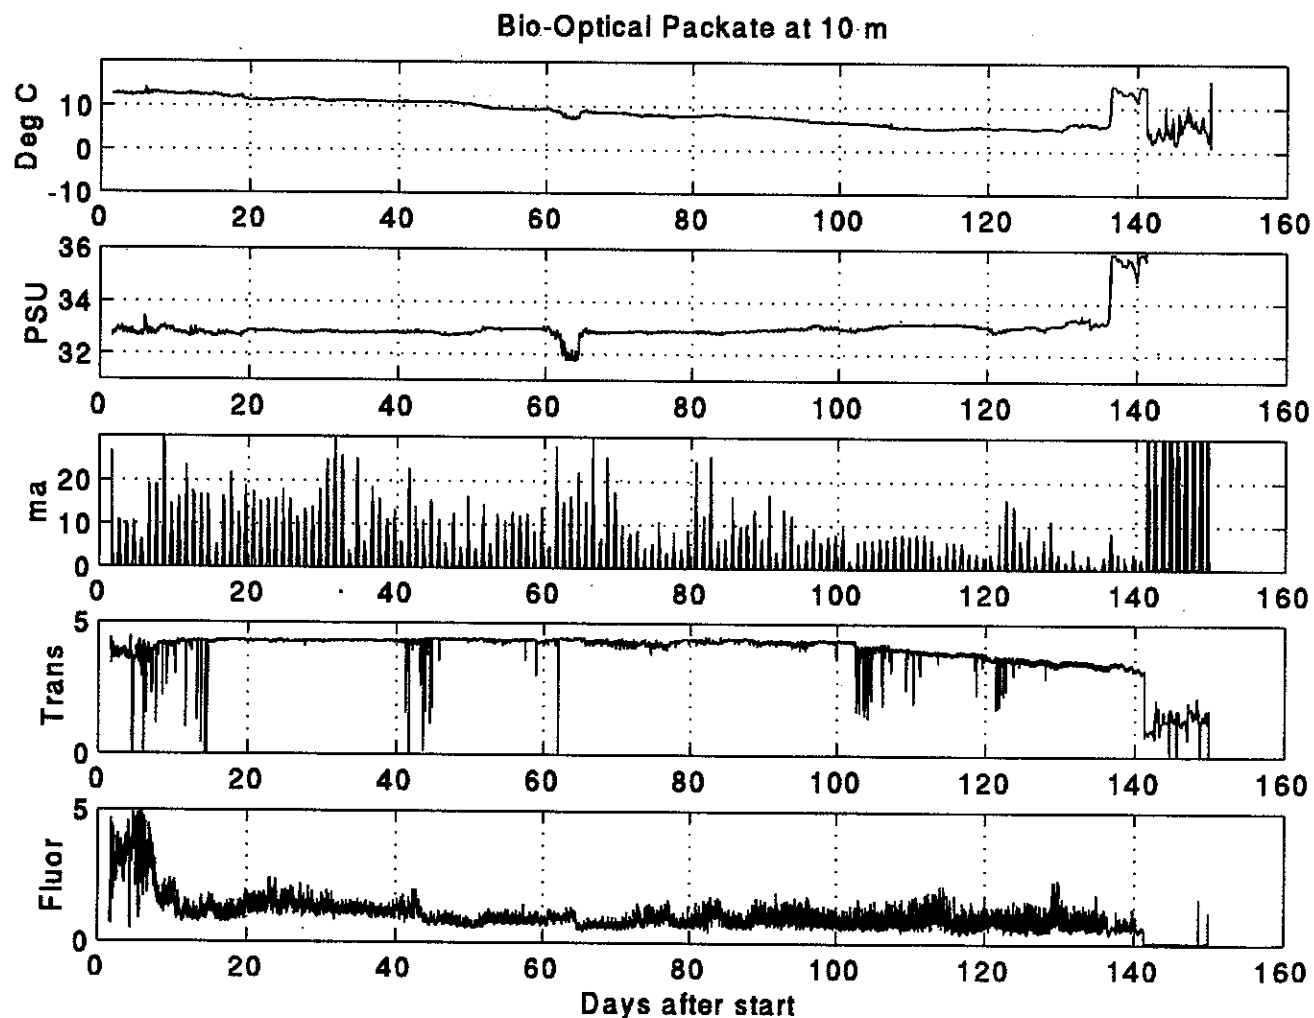
The fluorometer on the bio-optical package at 10 meters (Figure 5) showed higher chlorophyll-a concentrations at the time the warm core ring water was seen at the mooring. Also a slight increase was seen on day 132 when the warm, salty water was again seen. These effects are also seen at 40 meters (Figure 6), but to a lesser extent. The 10 meter depth transmissometer appears to show some drift after 100 days, and the 40 meter transmissometer while it doesn't show any appreciable drift, appears "noisy" in the 120 to 140 day range. The 10 meter depth PAR sensor shows the daily radiation changes, which hardly penetrate to the 40 meter depth. Basically, the Southern Flank Temperature/Conductivity Mooring appeared to be working well, with the except of the telemetry (which did not cause data loss), the two sensor failures, and the mooring being cut loose.

Figure 5. South Flank Moored Bio-optical package at 10 m. The temperature, salinity, PAR, transmissometer and fluorometer data are plotted against start time. The high fluorometer reading during the warm core ring event at the start is clearly efficient. Also the transmissometer drift probably due to biofouling is also evident after 100 days. The PAR sensor clearly shows when the package was recovered on the R/V SEWARD JOHNSON. The temperature and salinity agree with the other observations shown in Figures 2 and 3.

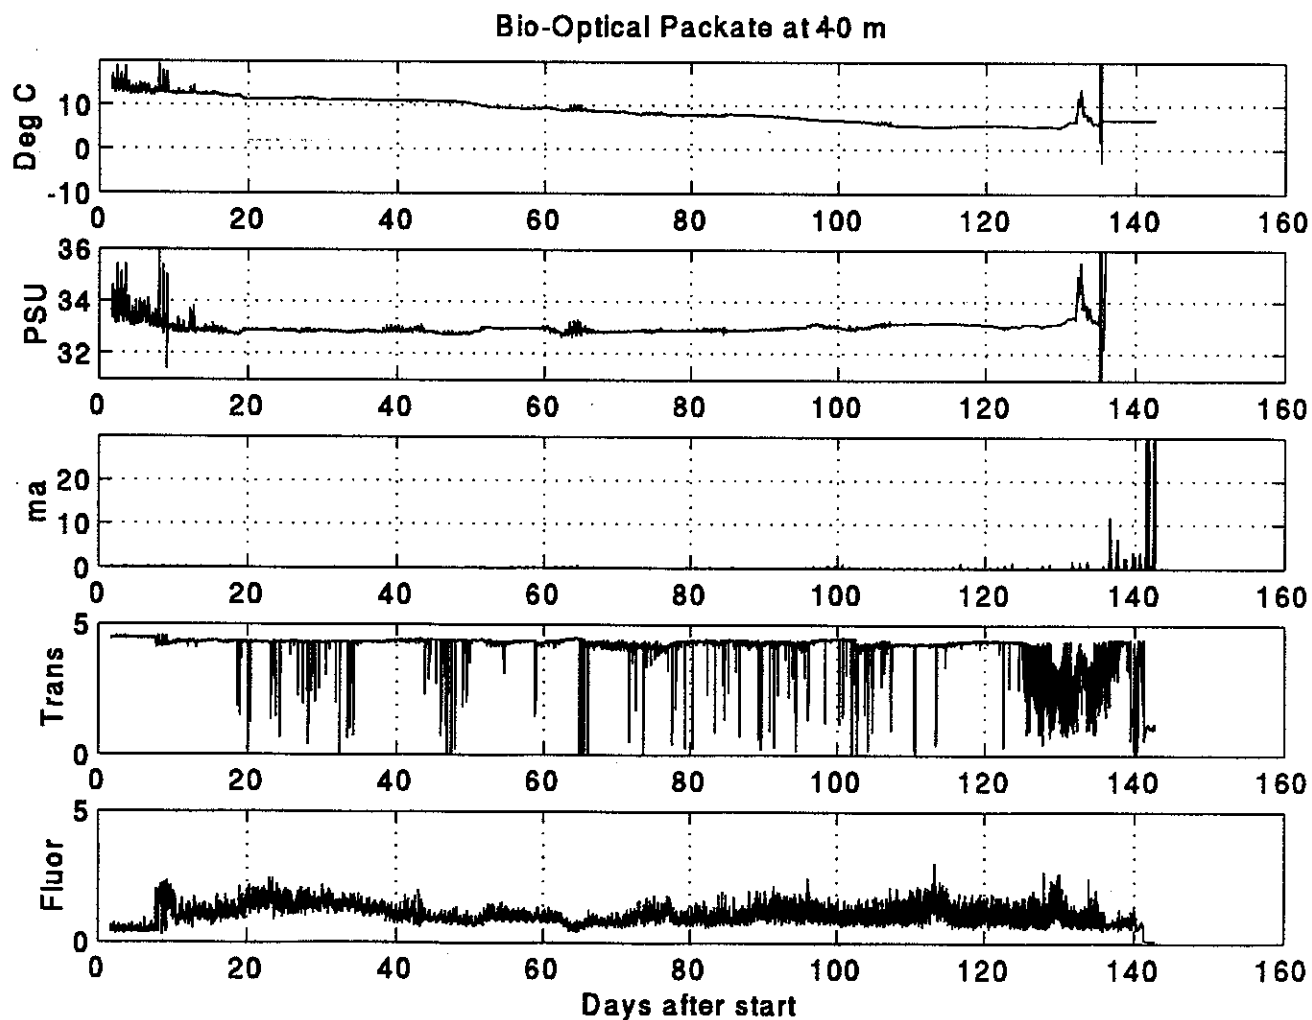
Figure 6. South Flank Moored Bio-optical package at 40 m. The temperature, salinity, PAR, transmissometer and fluorometer data are plotted against start time. The high fluorometer reading during the warm core ring event at the start is efficient. The PAR sensor clearly shows when the package was recovered on the R/V SEWARD JOHNSON. The temperature and salinity agree with the other observations shown in Figures 2 and 3.

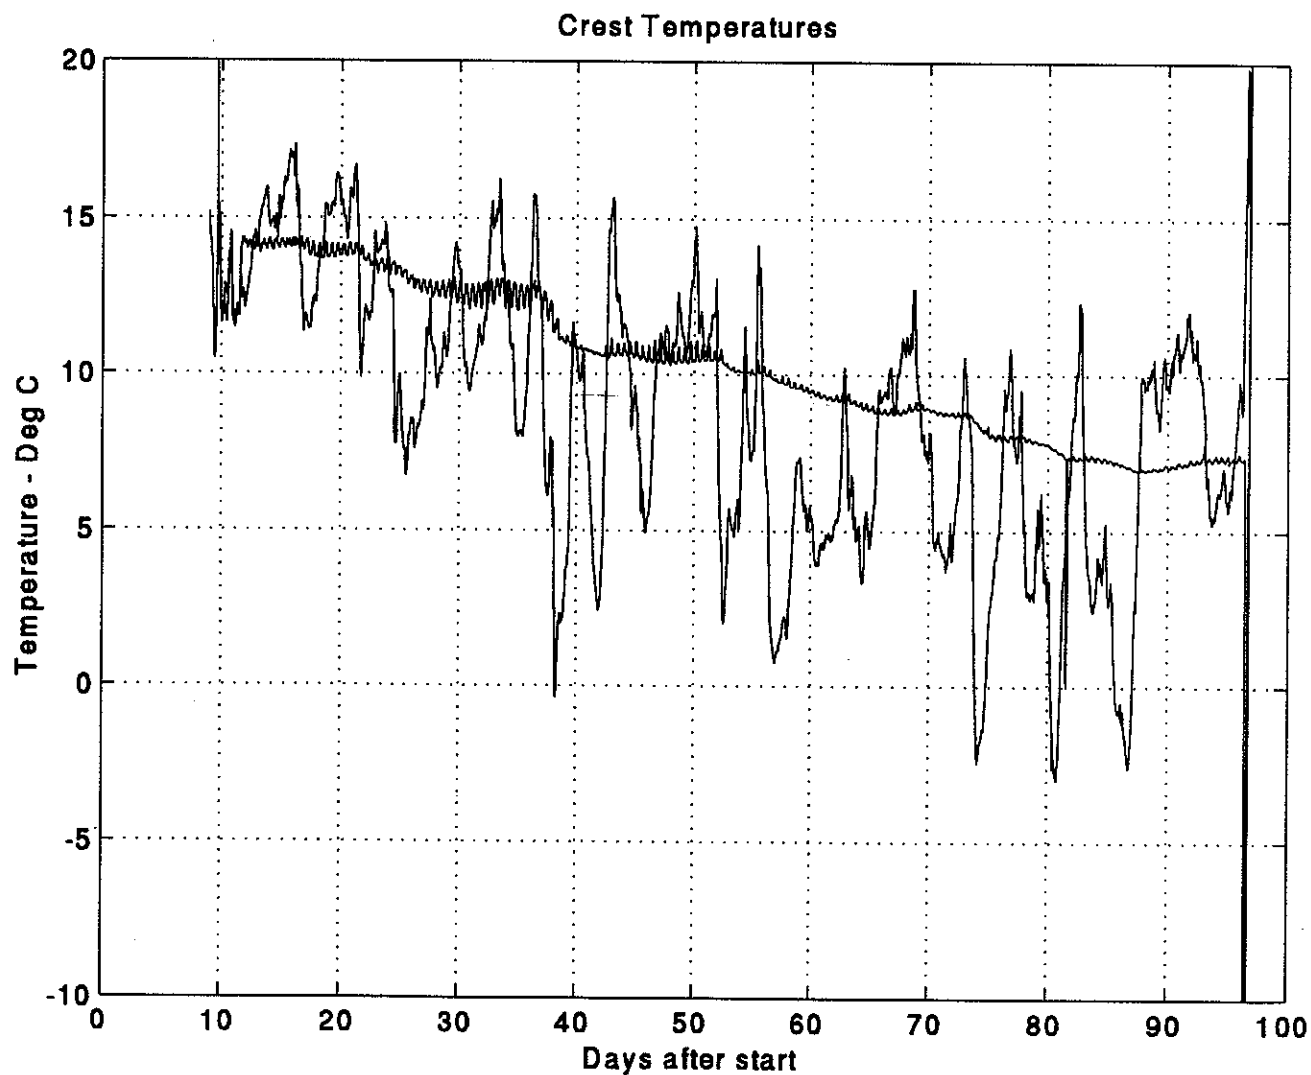
Figure 7. Crest Moored Temperature. The signal with large fluctuations is the air temperature at 3 meters above the water, and the smoother record is the sea surface temperature at 1 meter under the buoy. The tidal signal due to horizontal advection of temperature gradient is evident in the sea surface temperature.

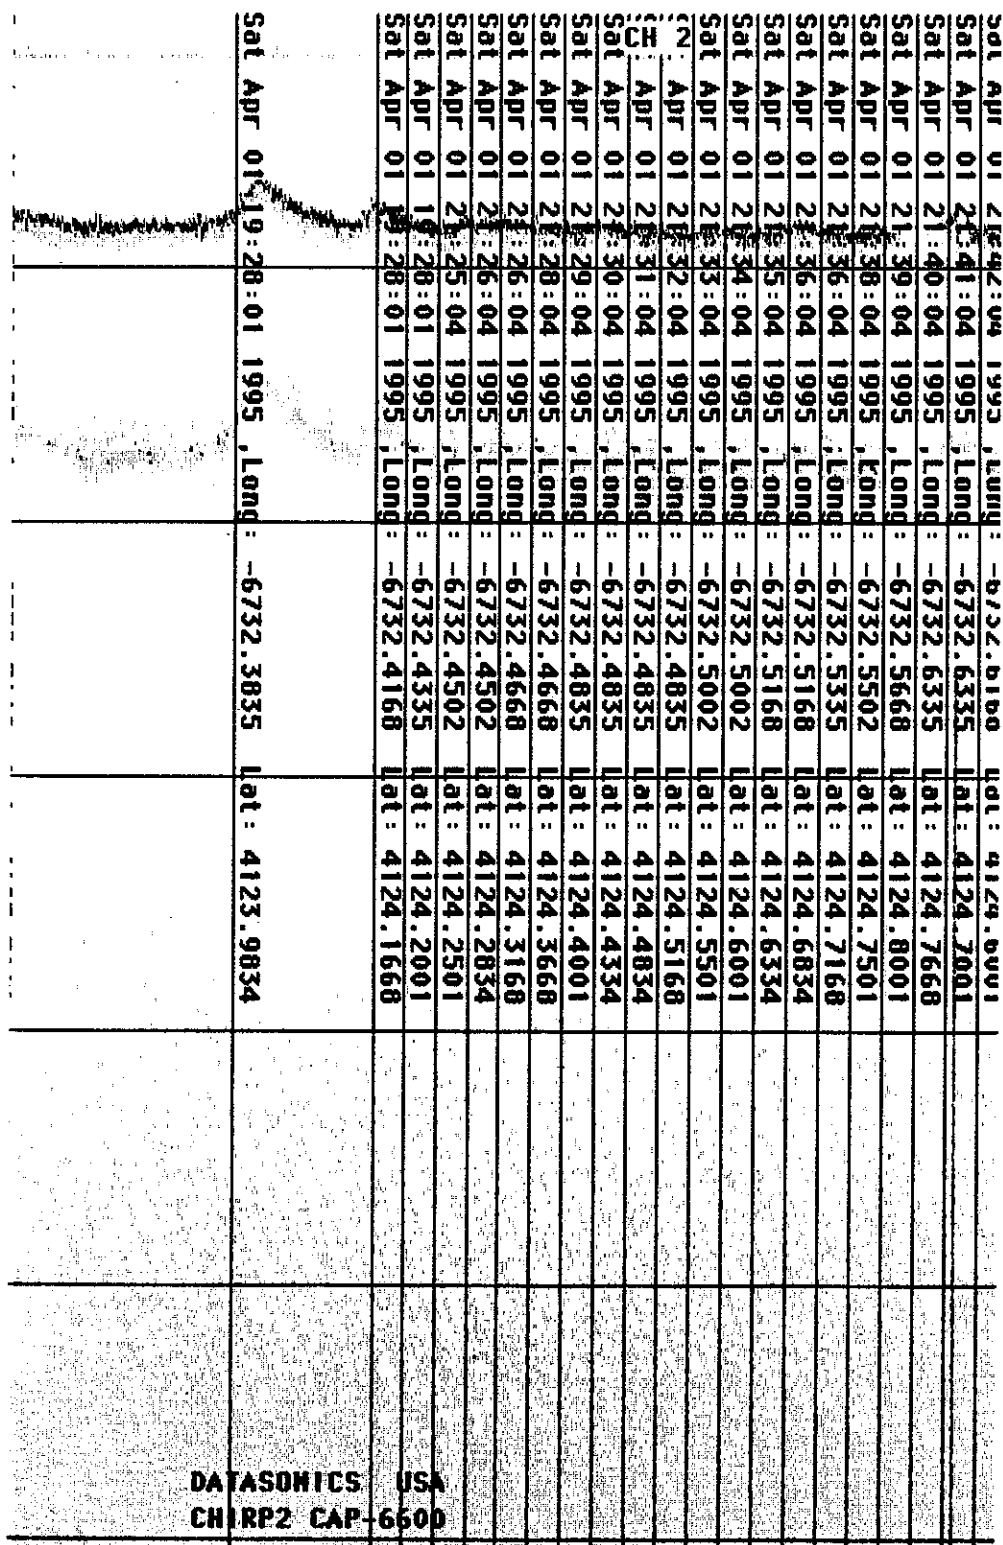
The buoy was assembled on deck, tested once and deployed at the same position, (see Table 1). As a check on the water depth, a DataSonics Chirp Sonar profile (Figure 11), was run across the mooring site before deployment. This again showed a flat bottom 40 to 41 meters deep between the sand/gravel ridges. When redeployed, the mooring did not have the load cell, but did have an addition of a bio-optical package (temperature, conductivity, PAR, fluorometer and transmissometer with internal recorder) at 10 m depth. The mooring configuration with the bio-optical package is shown in Figure 12. Telemetry from the ARGOS transmitter received on board the R/V SEWARD JOHNSON after deployment, indicated that the system was working well, and that we were back to collecting oceanographic data. The ARGOS telemetry was again monitored several days later when doing comparative CTD profiles by the buoy, and again the data looked good.

Figure 11. DataSonics Chirp Sonar bathymetry on a South to North section through the Crest mooring site. The flatness of the bottom at the 40 to 41 meter depth between the 10 to 15 meter ridge bathymetry confirms proper mooring site.

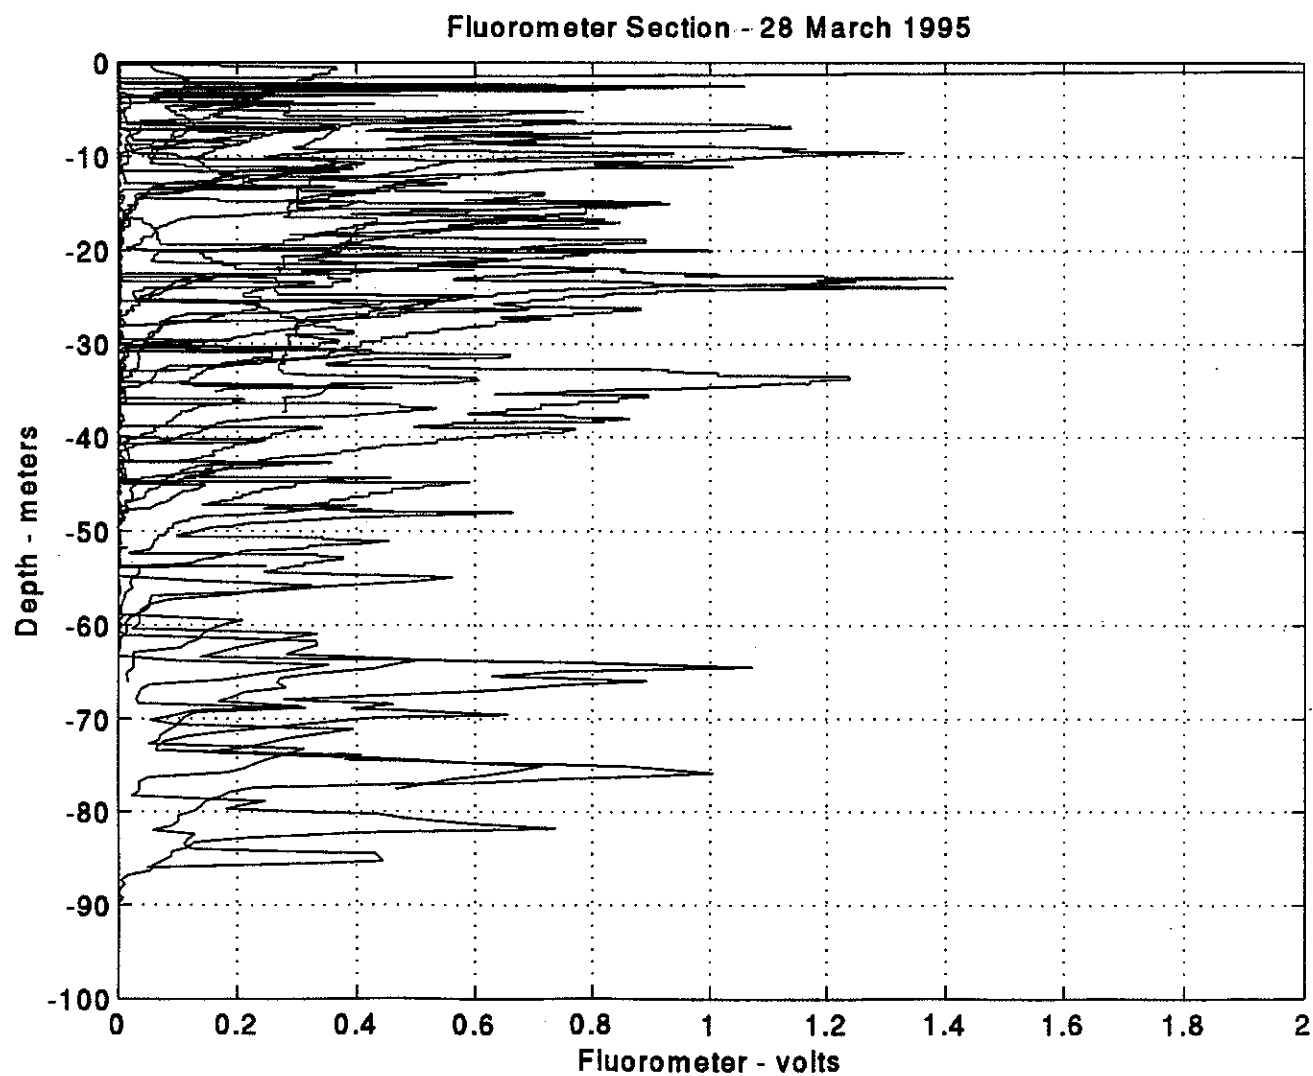
The transmissometer profiles (Figure 18) records showed very little vertical structure, while the fluorometer profiles (Figure 19) showed many sharp spikes. Although we were suspicious of this structure, the Miami technicians checked the CTD's A/D, the cables, and the output of two different fluorometers with dye, and everything checked OK. Therefore, these signals are probably real, but with nature of the well mixed water, the layers of high fluorescence appear anomalous. The PAR profiles (Figure 20) showed attenuation with depth, and no signal at night. They were not compared with shipboard radiation, but the data would normally be used for *in-situ* calibration of the PAR sensors on the moored bio-optical packages.

Figure 19. Long-Term Moored Section Fluorometer from 11 unedited and uncorrected profiles taken at positions shown in Figure 13.

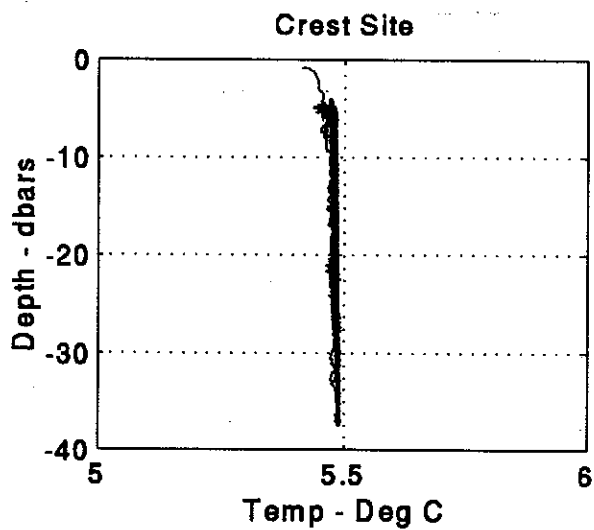
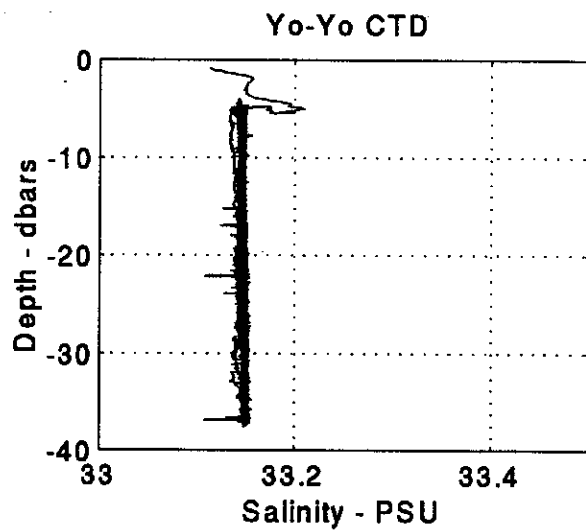
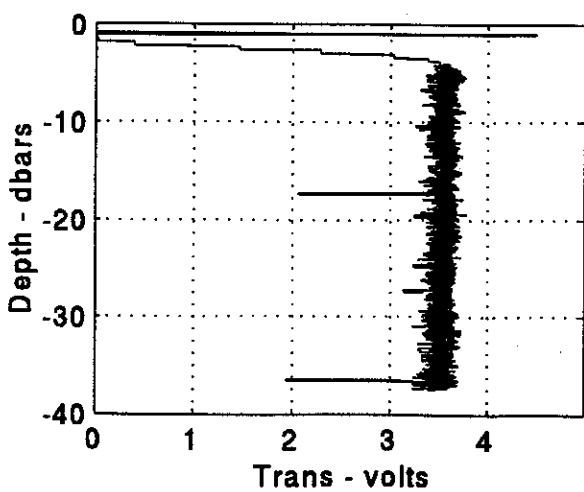
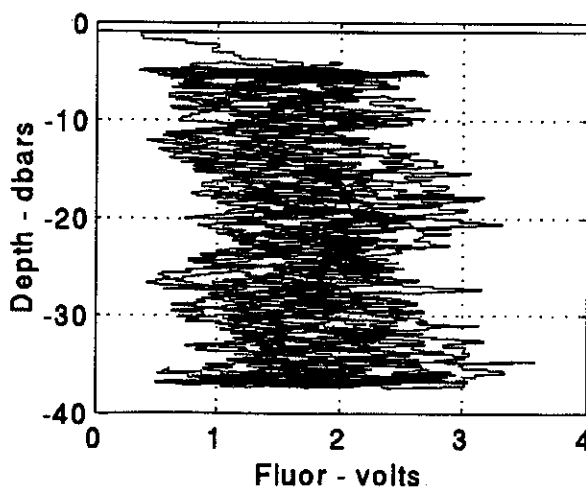
Several days after the Crest mooring was deployed, a series of profiles was made next to the buoy. (See Figure 21) These profiles show the well mixed temperature and salinity of the earlier profiles, but a much higher mean fluorometer level, perhaps indicative of increased biological activity in the calm few days after the storm just before the Main Line CTD Section was started. There is little obvious correlation in the vertical structure of the fluorometer and transmissometer signals.

Figure 21. Crest Mooring Site CTD yo-yo. Six profiles were made beside the Crest Mooring in a 15 minute time span without removing the CTD from the water. The results will be used as an initial *in-situ* calibration of the bio-optical sensors.
